**Document ID:** IK1600251  
**Revision:** 2  
**Created:** 3/15/2019  
**Last Modified:** 3/17/2022  
**Author:** Steven Bautz

**Title: Water Leaks Past Plastic Vapor Barrier Sheet in the Inner Cavity of the Cab Entry Door**

**Applies To: Any Cab Entry Door on LT, RH, HV, MV, LoneStar, New Steel Cab HX**

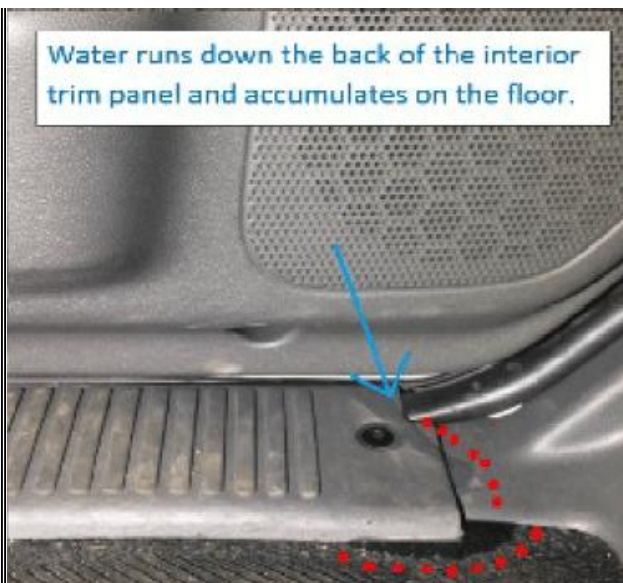
Water runs down the back of the interior trim panel and accumulates on the floor.

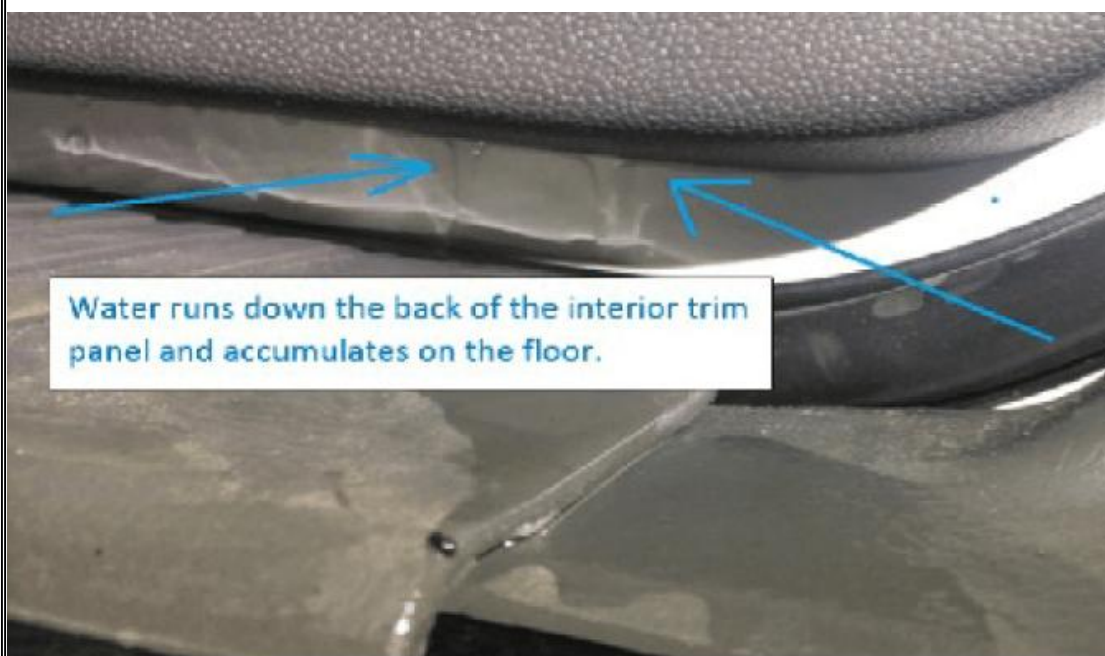
Water runs down the back of the interior trim panel and accumulates on the floor.

vapor barrier to the door panel at each opening for proper adhesion to metal door panel. Water can be poured at base of the outer door window to observe if water leaks past seal bead at any given location. (See photos)

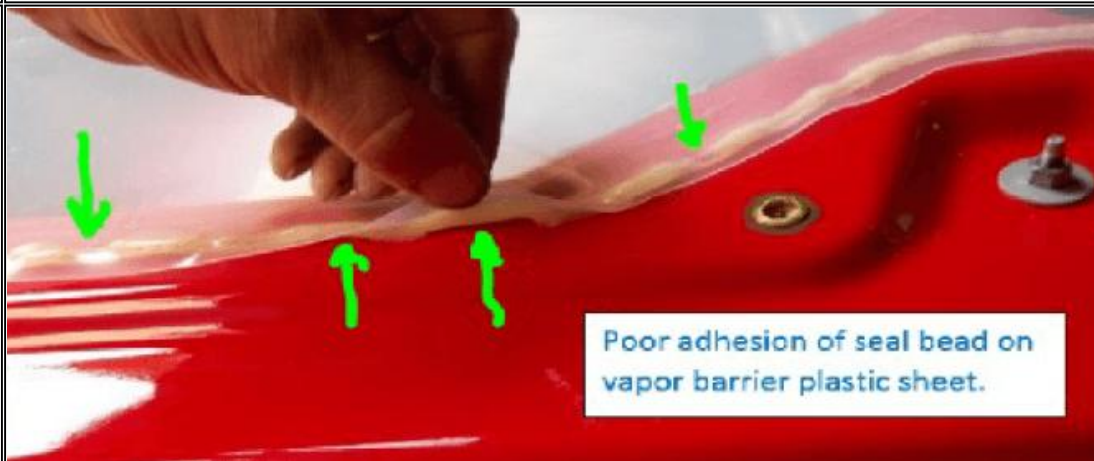
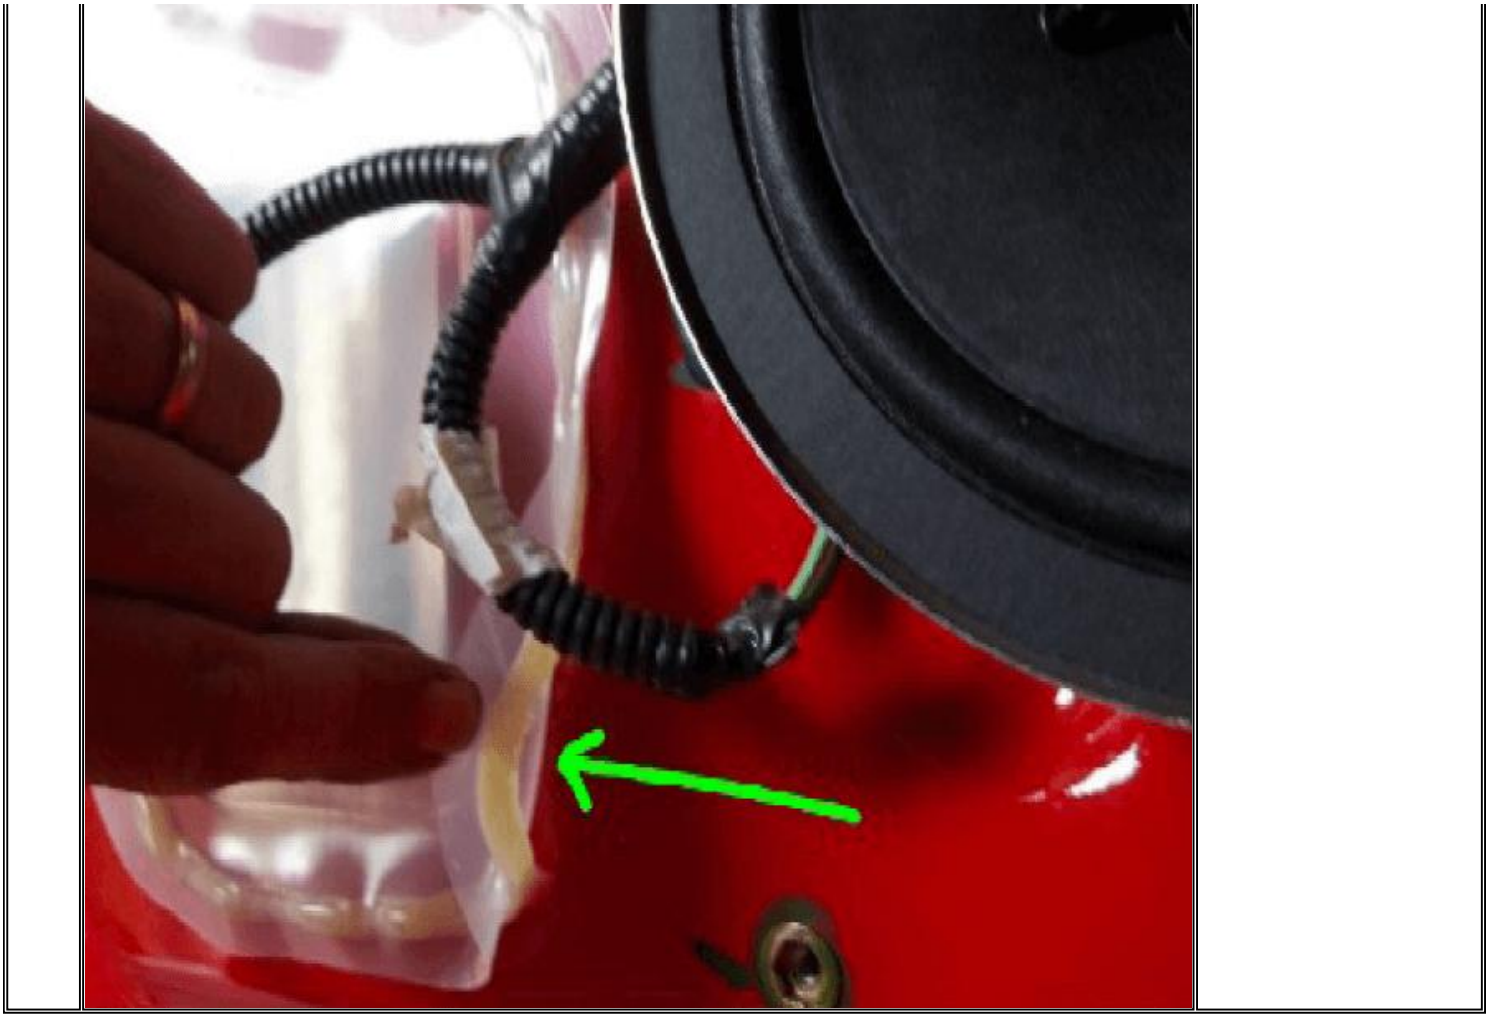
1. Check for adhesion of the seal bead around the area where water is leaking or dripping

2. Slightly lift plastic vapor barrier all around each sealed location to check for adhesion to metal door panel.

Note: If the areas of the bead that are not adhering are minor the seal bead can be cleaned and resealed or an additional bead of Butyl seal tape can be added.
