# McLAREN 765LT – REMAINING PARKING DAYS DISPLAY INCORRECT

| <b>Campaign reference:</b> | SCB 14 M 005 |
| <b>Affected vehicles:</b> | McLaren 765LT |
| <b>Date:</b> | 31 <sup>st</sup> March 2022 |

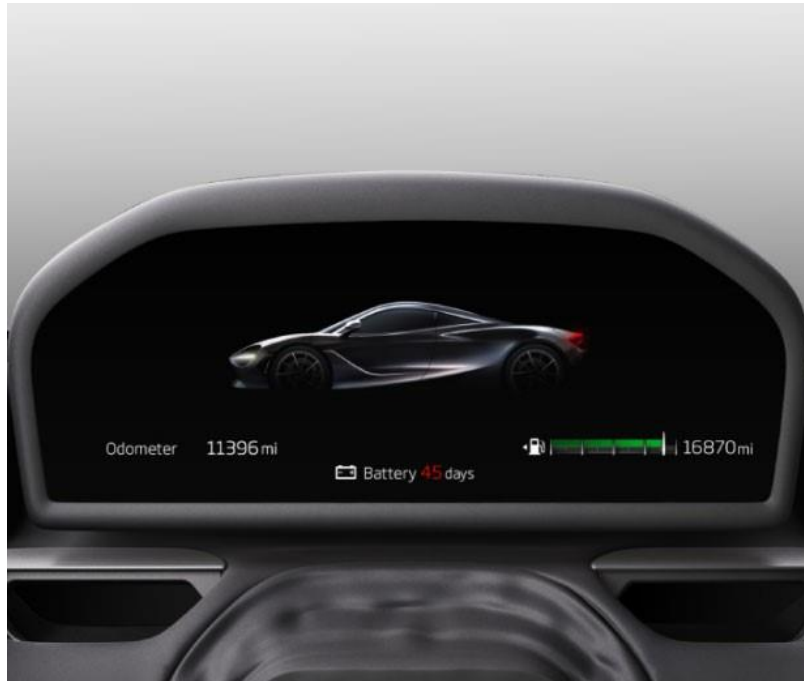
Through continuous product quality monitoring, it has been identified that on certain McLaren 765LT vehicles the number of parking days remaining displayed in the instrument cluster is incorrect. Therefore, a McLaren Diagnostic System (MDS) Sequence has been released in order to re-configure this feature.

Image 1 – Example of remaining parking days display

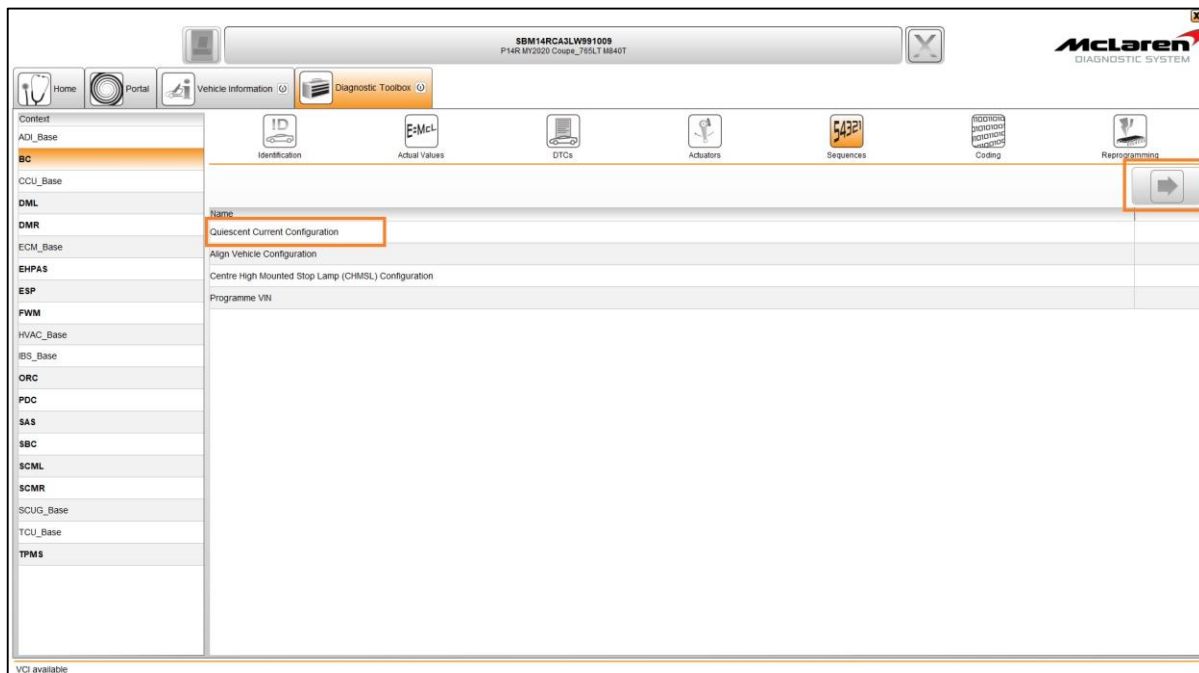
Image 2 – Quiescent Current Configuration Sequence location in the MDS

Select the sequence named **Quiescent Current Configuration** from the list

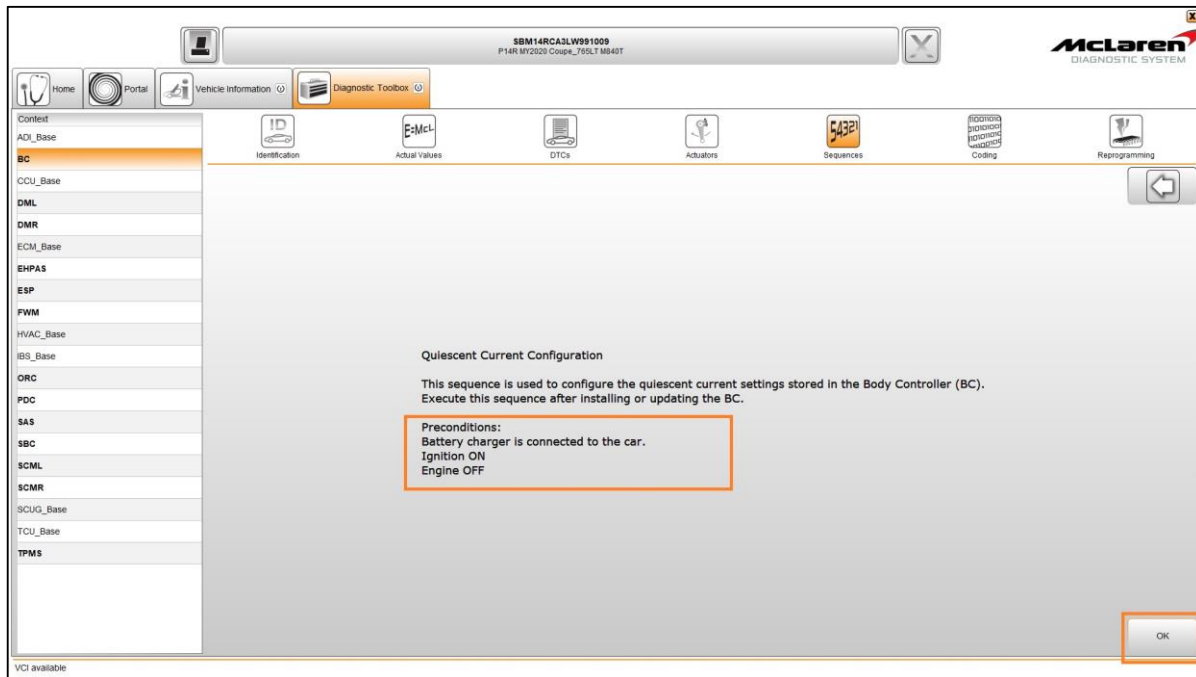
Image 3 – Sequence Preconditions

Ensure the preconditions displayed on-screen are met and click '**OK**' to execute the sequence

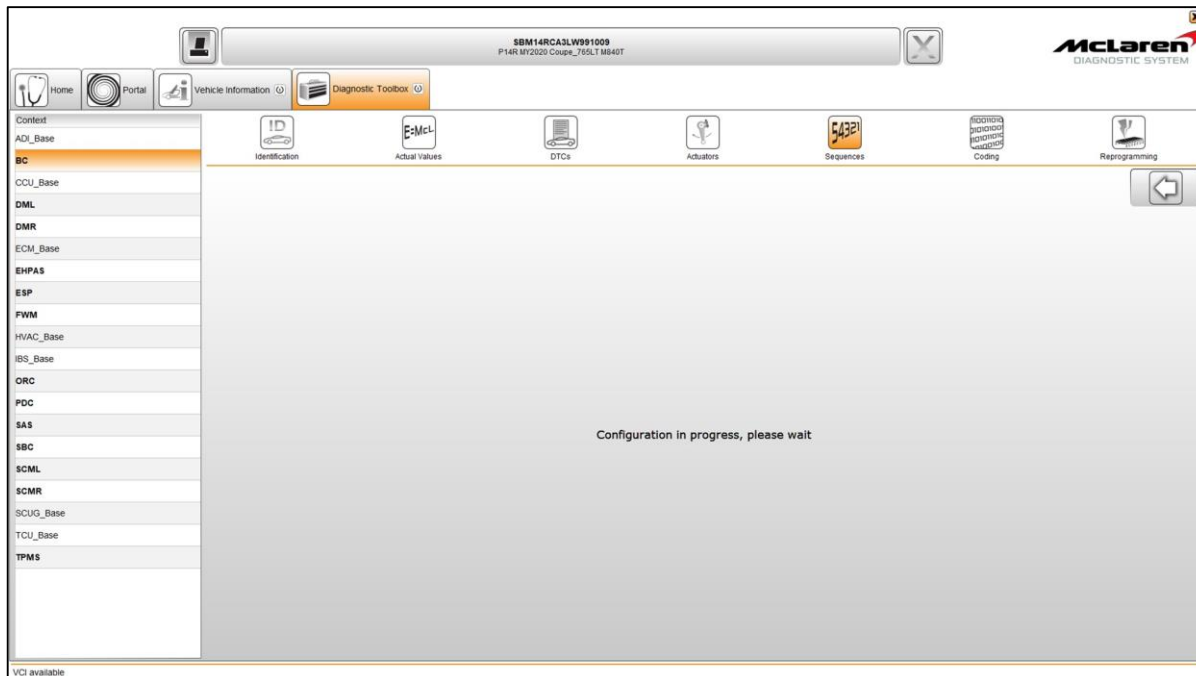
Image 4 – Sequence in progress

Monitor the MDS screen while the sequence is in progress – do not interrupt the operation

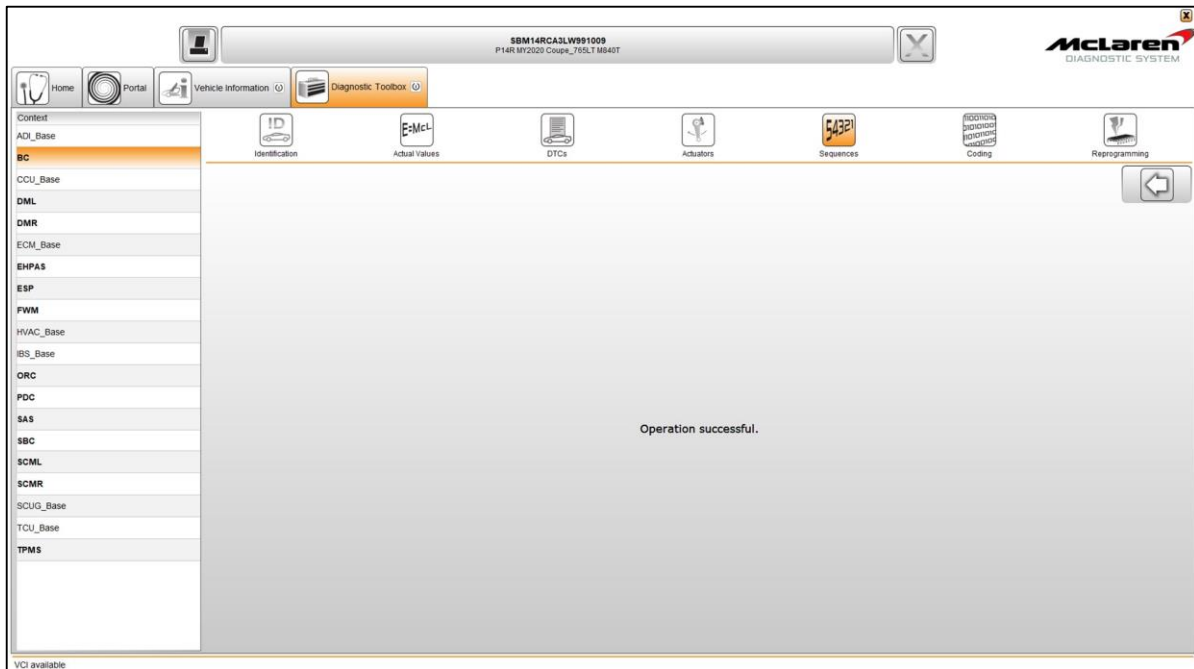
Image 5 – Successful completion of the Quiescent Current Configuration Sequence

Upon completion of the configuration, the MDS screen will display **‘Operation Successful’** to confirm the operation was completed successfully
