DRIVER'S AIRBAG RESISTANCE CHECK

Bulletin type:	Service Campaign
Reference number:	N/A
Campaign reference:	SCB 00 N 010 - V2
Attention:	Retailer Aftersales Managers, Retailer Service Managers, Retailer Service Advisors, Retailer Technicians, Retailer Parts Managers
Affected vehicles:	McLaren Elva, McLaren Speedtail
Situation:	The driver's airbag electrical circuit resistance may be out of tolerance due to partial engagement of the driver's airbag connectors
Procedure:	Action affected vehicles during next Retailer visit. Please refer to the information outlined in this document to complete the checks required
Date:	17 th March 2022

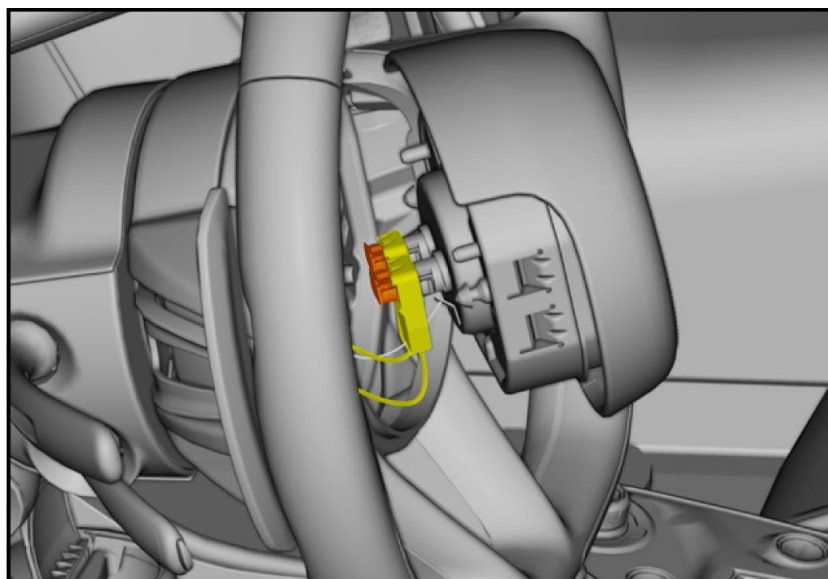
Through continuous product quality monitoring, it has been identified that on certain vehicles, an unexpected resistance may be present in the driver's airbag circuit. To correct the issue, a resistance readout using the McLaren Diagnostic System (MDS) must be completed and compared against the correct resistance tolerance limits stated within this document.

Image 1 - Driver Airbag Connectors (example taken from the Service Information System (SIS))

Disconnect the driver's airbag connectors and visually inspect them for any anomalies, then fully re-connect the connectors. Make sure both stages of the connectors (including secondary locking mechanism) are correctly locked and engaged. The connector may otherwise be installed, but not locked

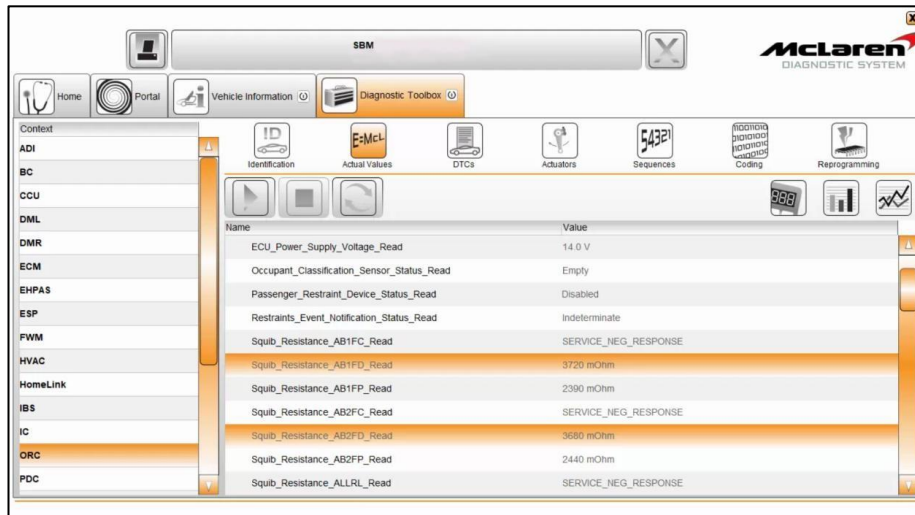
Image 2 - Example Screenshot of MDS Airbag Resistance Actual Value Location
