# McLAREN GT HVAC HIGH PRESSURE HOSE IDENTIFICATION & POTENTIAL REPLACEMENT

| <b>Campaign reference:</b> | SCB 22 F 001 - V2 |
| <b>Situation:</b> | Identification of HVAC hose batch and potential replacement |

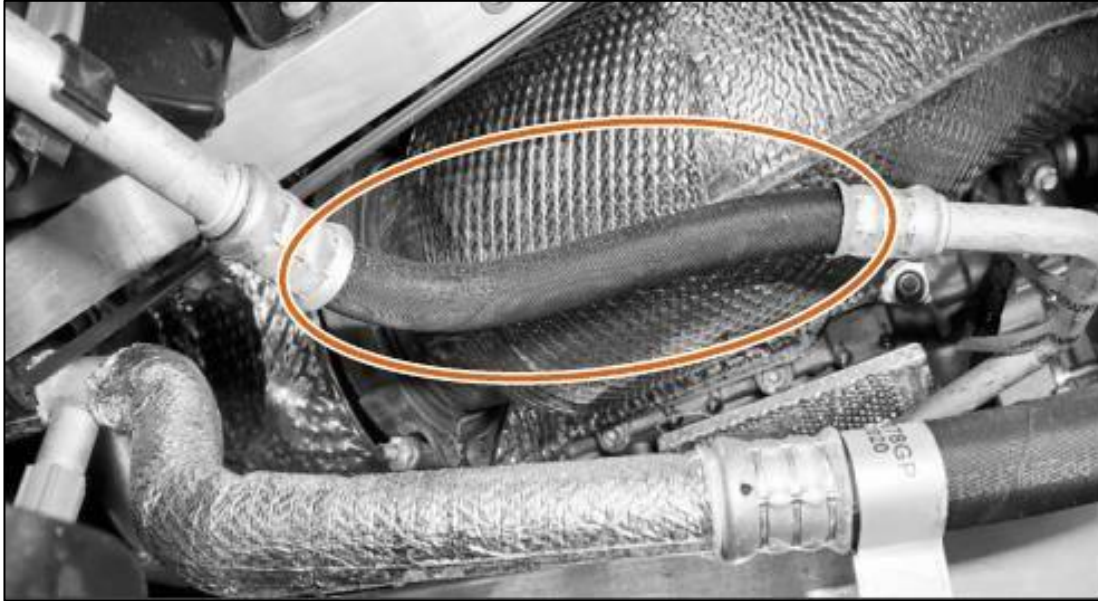
Through continuous product quality monitoring, McLaren Automotive has identified that a number of McLaren GT vehicles may have been fitted with an HVAC high pressure hose with a potential manufacturing issue. The hose supplier has identified and communicated the batch number and production dates of the hoses in question. Therefore, inspection of the part and potential replacement may be required.

Image 1 – Location of HVAC hose

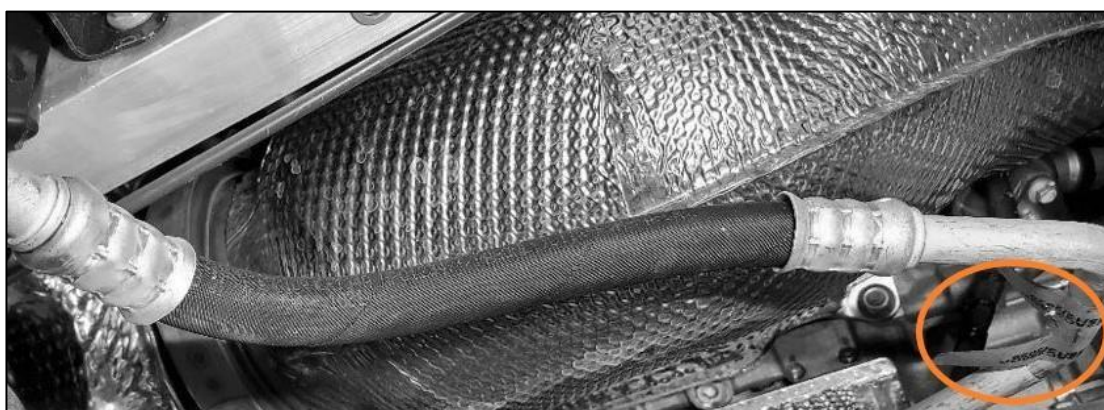
Locate the part number label on the hose assembly (refer to section 4 'Warranty Information', 'Image 2' for location of the label)

Make a note of the date printed on the label

Image 2 - Location of part number label on the hose assembly

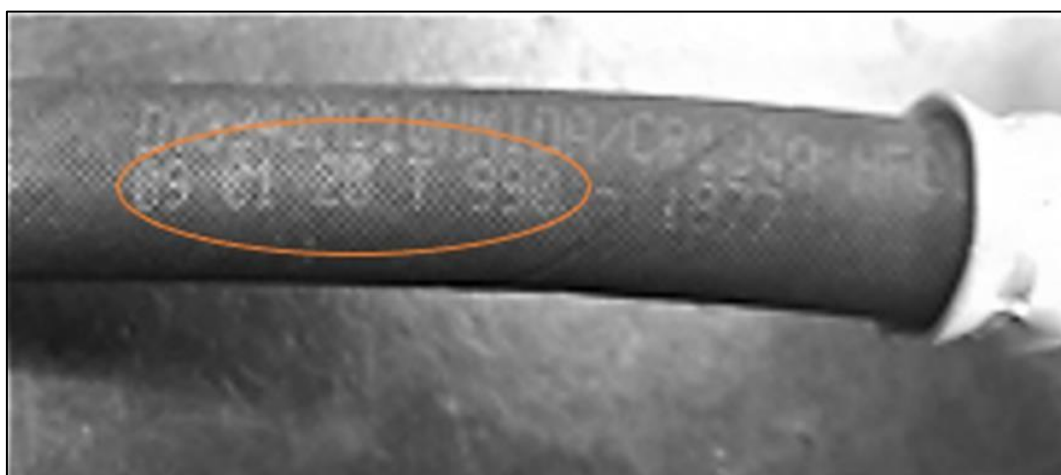
Locate the batch code printed on the rubber section of the hose assembly (refer to section 4 'Warranty Information', 'Image 3' for location of the batch code on the part)

Please ensure when claiming for a replacement hose, you include a photograph of the concerned batch code which can be found printed on the rubberised section of the part as shown below (Image 3). Failure to do so will result in the claim being returned for correction. A photograph of the part number and production date label attached to the hose (Image 4) is also required in the Warranty claim submission.

Image 3 - Example of batch number location

If the assembly date printed on the label is inside date range (16/12/2020 – 30/12/2020) and the batch code is 09 01 20 T 990 the hose must be replaced

If the assembly date printed on the label is inside date range (16/12/2020 – 30/12/2020) and the batch code cannot be determined the hose must be replaced

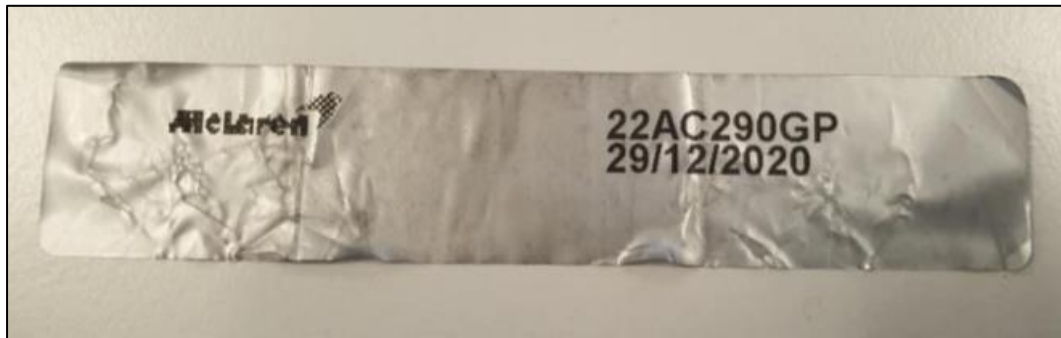
Image 4 - Example of part number label
