Service Bulletin

Bulletin No.: 22-NA-054

Subject: Check Engine Lamp Illuminated on the DIC (Driver Information Center), Temperature Gauge Inaccurate and/or Cooling Fans Continue Running after Vehicle is Turned Off, with DTC P0128 Set

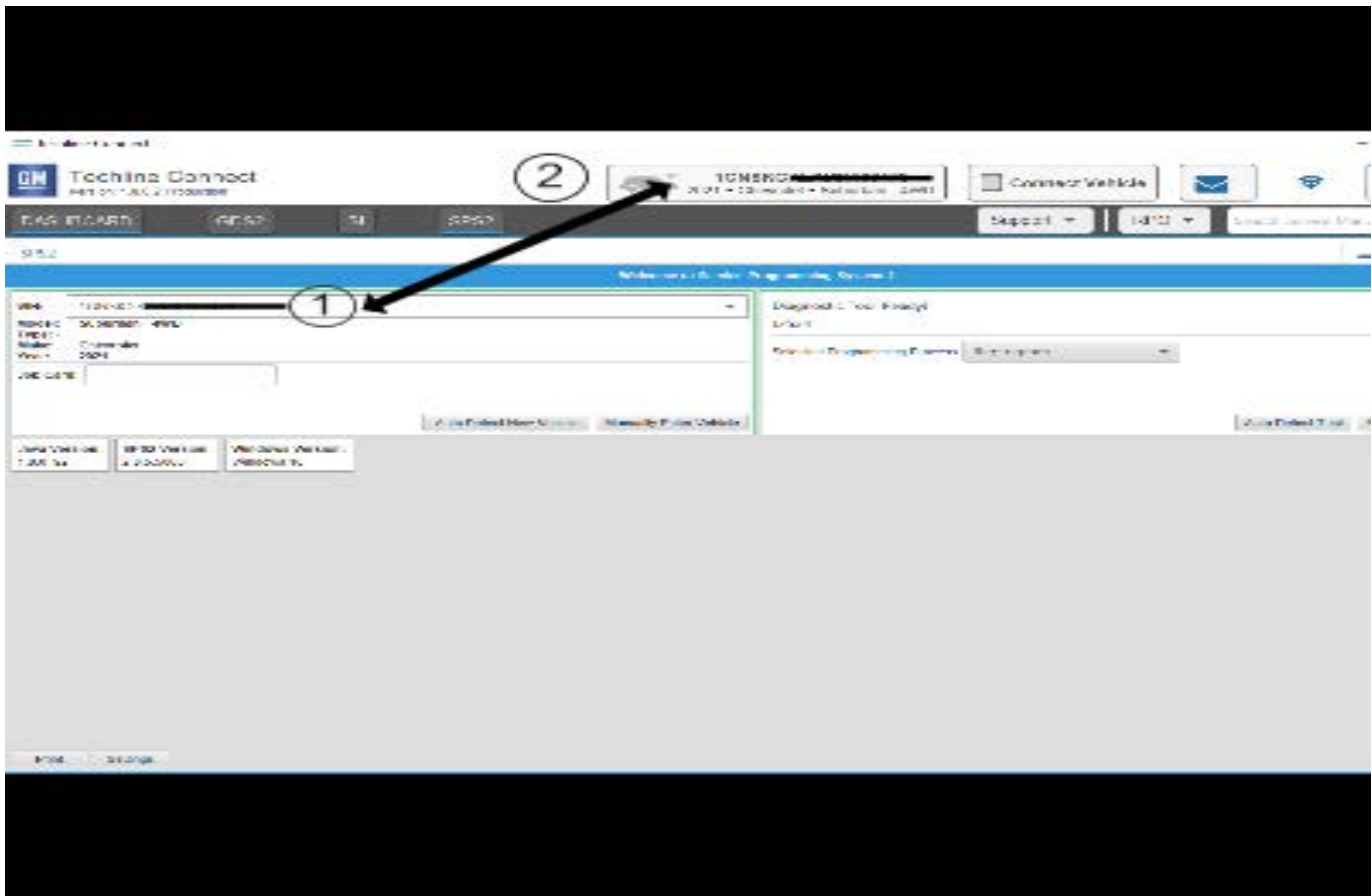
Caution: Be sure the VIN selected in the drop down menu (1) is the same as the vehicle connected (2) before beginning programming.
