Particulate Matter (PM) Sensor Troubleshooting Guide - US14+OBD16 And Newer Emissions

V-258-039

Exhaust Particulate Sensor, Repair

V-284-068

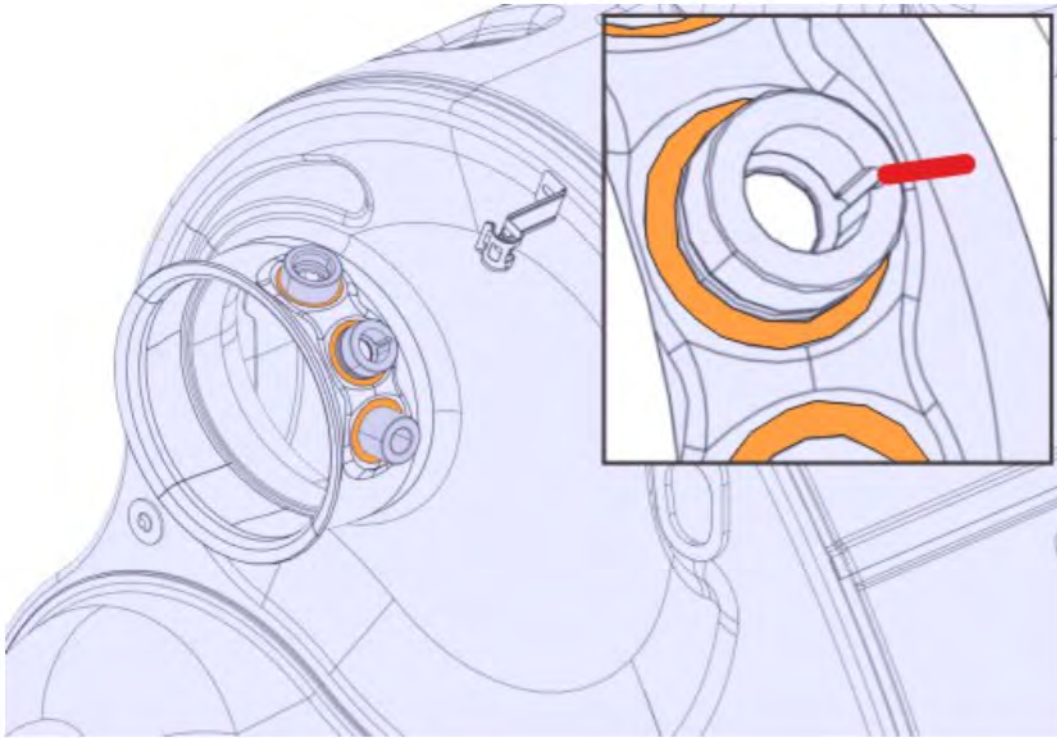
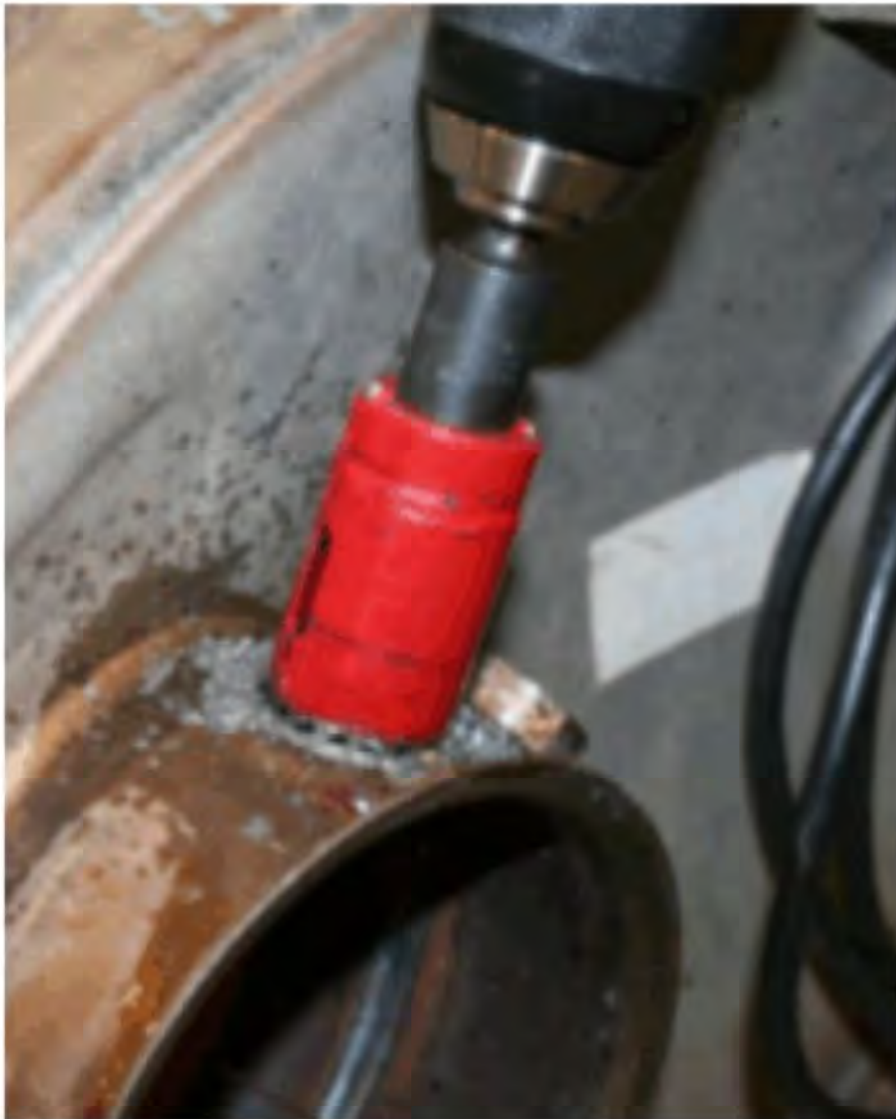
Note: If the PM sensor boss is damaged as shown in the illustration mark the position of sensor boss notch before removing the boss welding. The notch of PM sensor boss is always set in the 3'o clock position.

Note: When removing the sensor boss weld, check the depth frequently to prevent the damaged sensor boss from falling inside the aftertreatment muffler. Also ensure that the notch mark is not removed.

1. Remove the damaged boss welding.

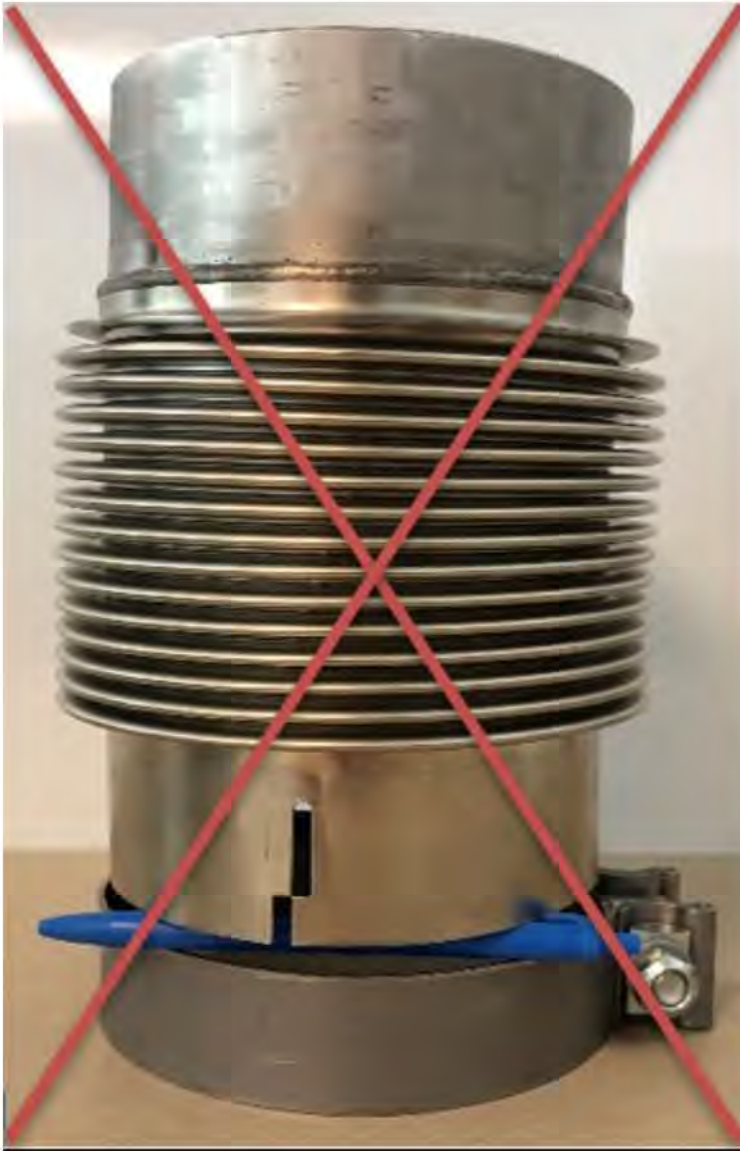
Scenario 1

This style Flex Pipe and Clamp will no longer work with the upper adjacent connecting pipe. The below parts in scenario 2 are required to perform this FSB.

Determine which Flex Pipe and Clamp the truck currently has installed on it. If the truck you are repairing has the Flex Pipe and Clamp shown in scenario 1, you will need to order the improved Flex Pipe (P/N 21142254) and Clamp (P/N 25172497). If the truck you are repairing has the Flex Pipe and Clamp shown in scenario 2, this truck already has the improved parts and ordering a new Flex Pipe and Clamp is NOT required.

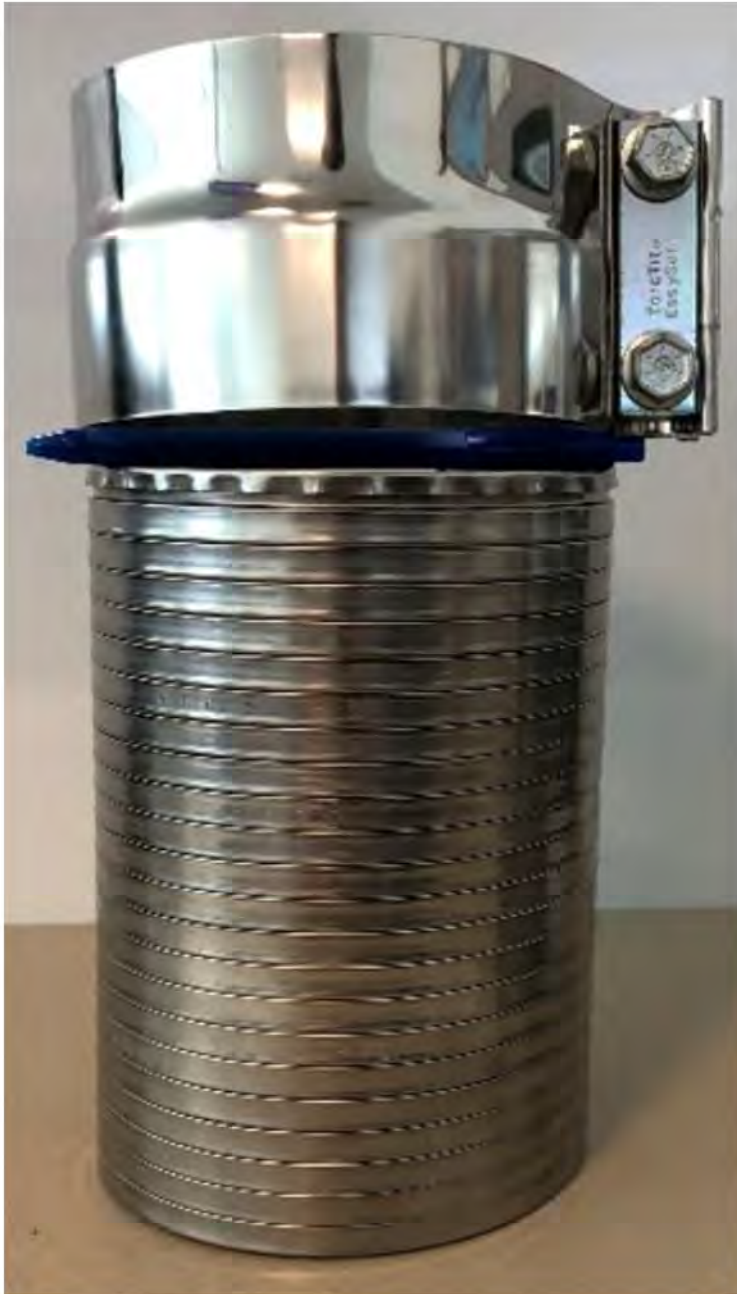
Scenario 2

This style Flex Pipe and Clamp only needs the upper adjacent pipe replaced. Reuse the existing Flex Pipe and Clamp, or order as needed.

Flex Pipe –
21142254

Clamp –
25172497

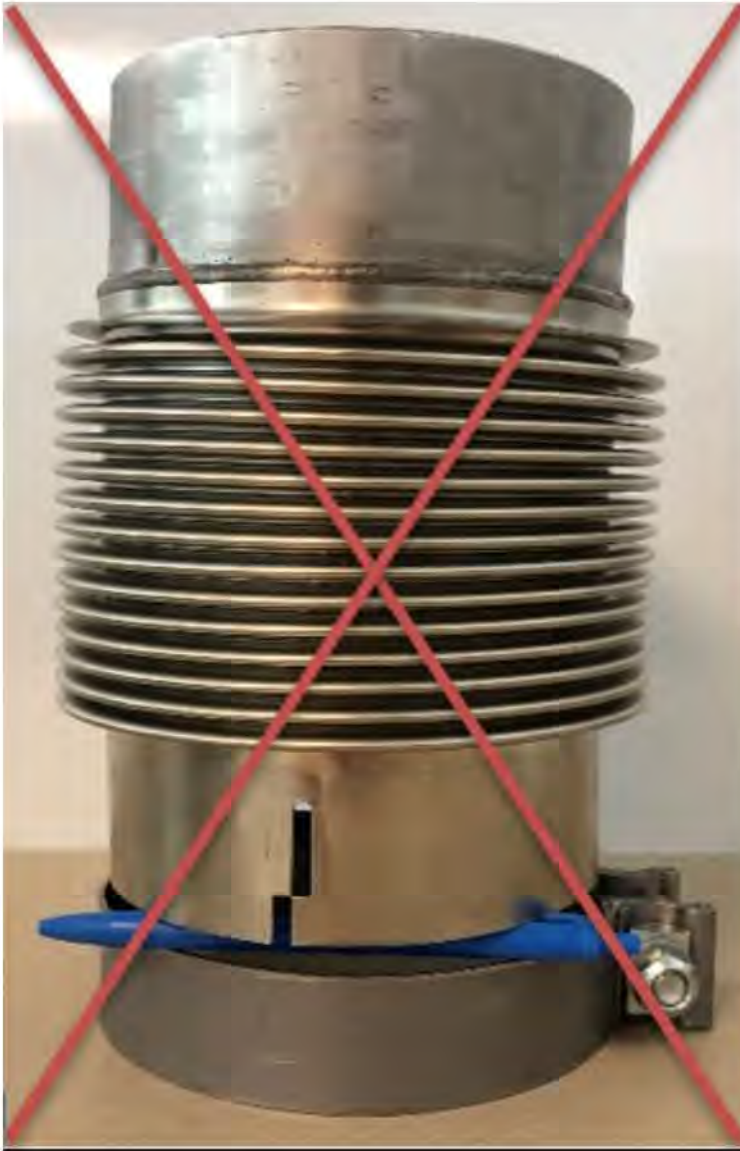
Scenario 1
	This style Flex Pipe and Clamp will no longer

work with the upper adjacent connecting pipe. The below parts in scenario 2 are required to perform this FSB.

Determine which Flex Pipe and Clamp the truck currently has installed on it. If the truck you are repairing has the Flex Pipe and Clamp shown in scenario 1, you will need to order the improved Flex Pipe (P/N 21142254) and Clamp (P/N 25172497). If the truck you are repairing has the Flex Pipe and Clamp shown in scenario 2 or 3, this truck already has the improved parts and ordering a new Flex Pipe and Clamp is NOT required.

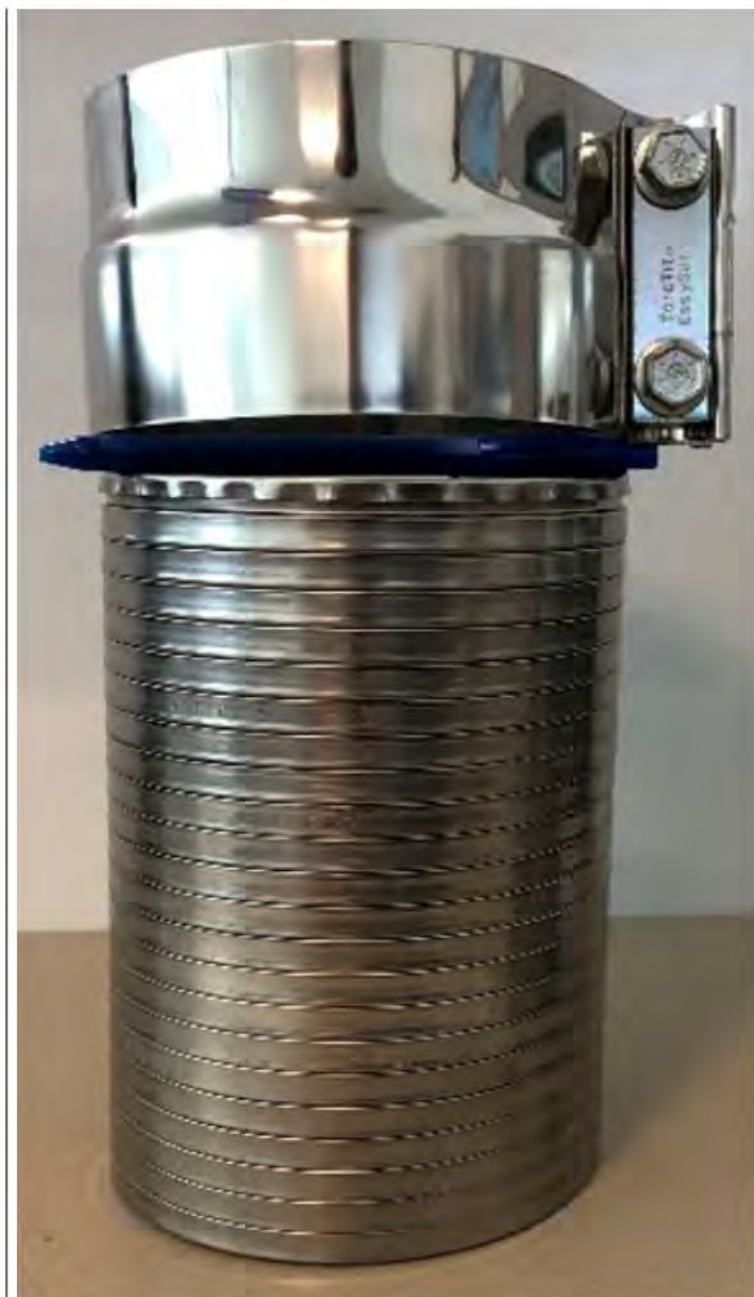
Scenario 2

This style Flex Pipe and Clamp only needs the upper adjacent pipe replaced. Reuse the existing Flex Pipe and Clamp, or order as needed.

Flex Pipe –
21142254

Clamp –
25172497

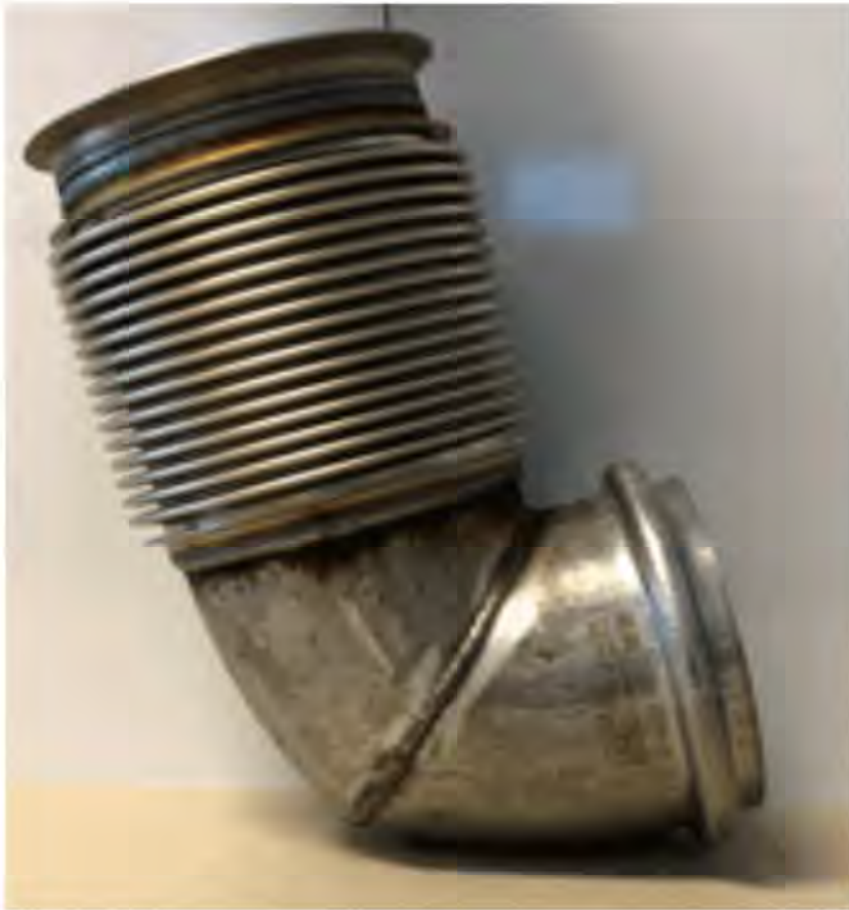
Scenario 3

This style Flex Pipe and Clamp only needs the upper adjacent pipe replaced. Reuse the existing Flex Pipe and Clamp, or order as needed.
