FT5240 Filler Neck Valve Issue

MQR	7621- 2446
-----	------------

Fuel Filler Neck Problem – Service Instruction

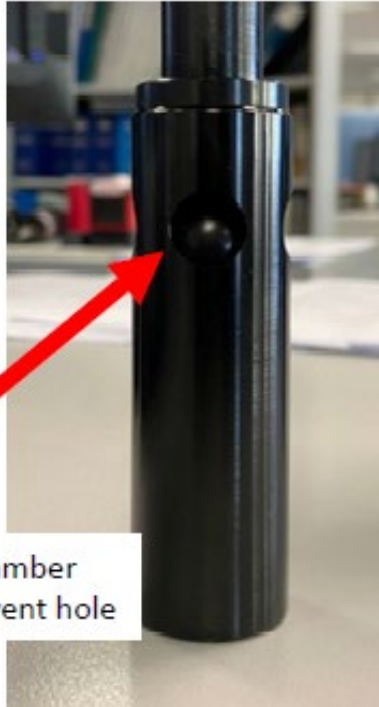
Defective LCV Valve

Float ball high in the ball chamber
No light through the chamber vent hole

- Inspect the LCV Valve.
 - Light should be seen through the vent hole.
 - If not, the LCV Valve spring needs to be replaced/modified.

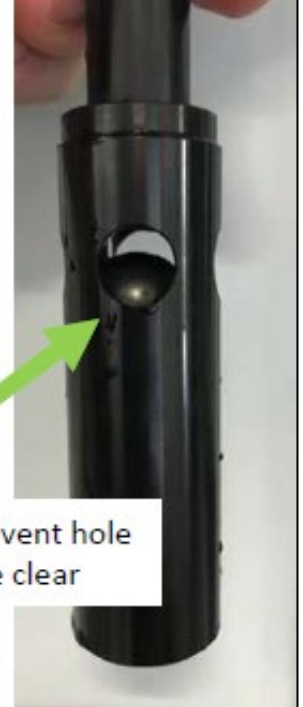
Good LCV Valve

Light visible through the ball chamber vent hole
At least 1/3rd of the hole should be clear
