# Service Alert

Subject:		
DO NOT UPDATE BCM WITH MDARS ON MX-30	Service Alert No.: SA-003/22	
	Last Issued : 03/11/2022

2019-2021 Mazda3 2020-2021 CX-30 2022 MX-30

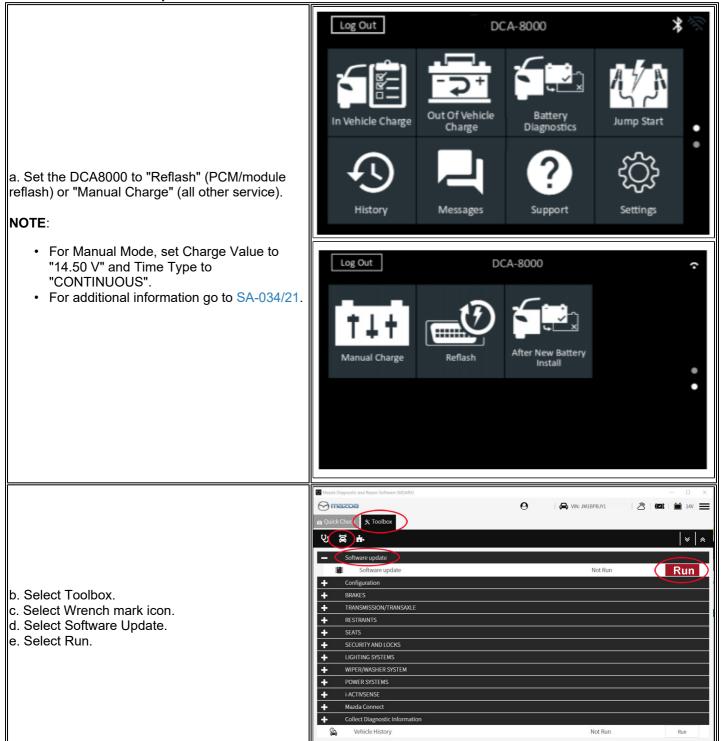
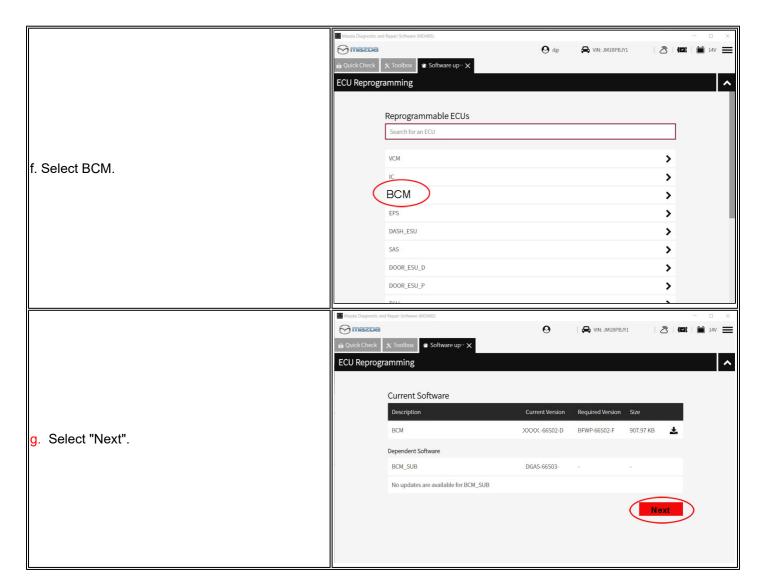
## **MDARS BCM Software Update**

Mazda3, CX-30	Prior to February 8, 2022, some vehicles may store DTC U0300:57 (Body control module (BCM) internal malfunction) and cannot be erased after a BCM replacement or MDARS BCM software update (NOT with BCM update for SSPC5 or 4621B using MDRT). This is caused by a BCM-VCM software error.
	Customers having this concern should have their vehicle repaired using the following repair procedure.
MX-30	Some MX-30 vehicles may store DTC U0300:57 (Body control module (BCM) internal malfunction) and cannot be erased after a BCM replacement or MDARS BCM software update. This is caused by a BCM-VCM software error. Mazda is aware of the issue and is working on a resolution. If there is an issue with this concern, Mazda recommends putting customer in a loaner vehicle at this time.
	<ul> <li>DO NOT perform BCM software update with MDARS until further notice.</li> <li>This SA will be updated with the newest repair information as it becomes available.</li> </ul>

- 1. Verifiy concern (DTC U0300:57 stored and cannot be erased after a BCM replacement or MDARS BCM software update before February 8, 2022).
- 2. Perform MDARS BCM software update (except MX-30).

3. Verify repair.
