Service Bulletin

Bulletin No.: 19-NA-076

Subject: Blue or Black Screen and Service Rear Vision System Message on Radio Display Shifting into Reverse

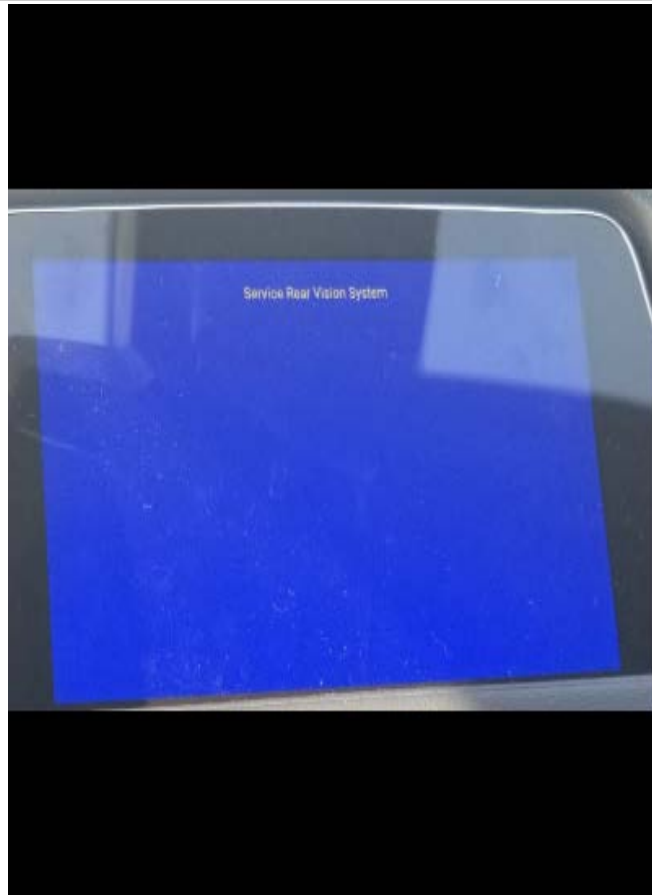
5733397

Blue Screen

If the **blue** or **black** screen condition exists, it will occur every time the rear view is displayed to the customer within the same power cycle and may return to normal functionality on the next power cycle after the A11 radio enters and exits a sleep cycle. A DTC of B395A Symptom Byte 08, 72 and 3A will be stored as history together in the A11 Radio.

Cause	The cause of the condition may be software anomalies in the Video Processing Module (VPM) or rear camera.
Correction	<ul style="list-style-type: none"> • For vehicles with UV2/UVI/UVS, reprogram the Video Processing Module (VPM). • For vehicles with UVB – replace the rearview camera.

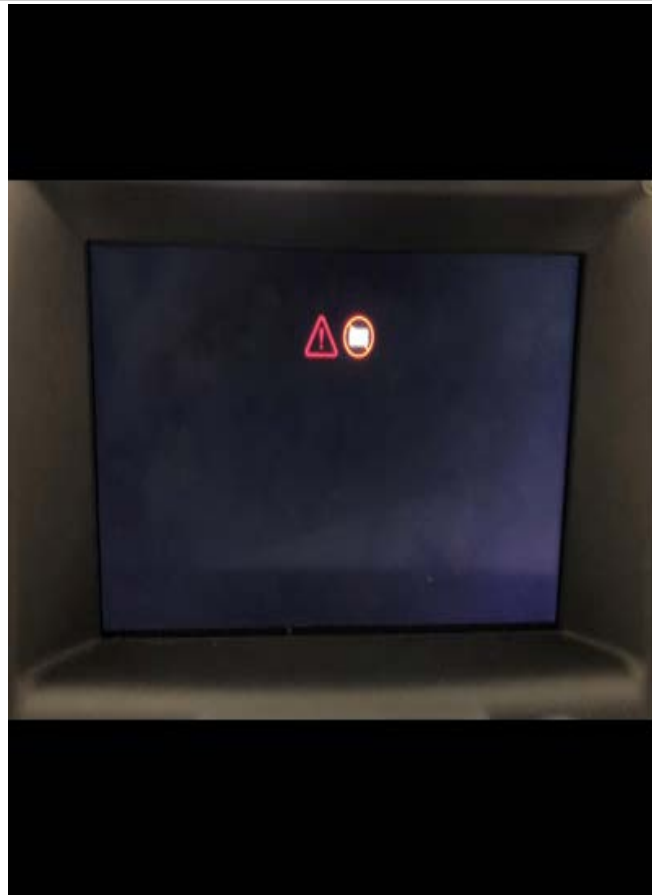
5733400

Black Screen

Some customers with select vehicles may notice that after having vehicle in idle for an extended period of time (length of time for black screen to occur depends on ambient temperature), a black screen with a red triangle and no camera icon will appear when the vehicle is put in Reverse and the camera icon will be crossed out on the radio center screen.
