Technical Service Bulletin

CLUNK NOISE FROM REAR SUSPENSION WHEN DRIVING AT LOW SPEED AND/OR TURNING

Bulletin No.: 02-001/22

2016-2021 MX-5 with VINS lower than JM1ND*****453987 (produced before February 4, 2021)

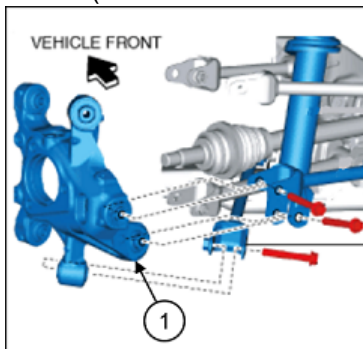
Some vehicles may exhibit a clunk noise from rear suspension when driving at low speeds and/or turning due to the rattling of the bush of the upper lateral link in the rear hub support. Dimensional variation of the bush boots in the rear hub support may cause insufficient sealing which allows water to enter the rear hub support, resulting in rust on the pillow-ball. The rust then accelerates the pillow-ball wear and causes a gap between the body and the bearing, resulting in the clunk noise during driving. To eliminate this concern, the boots in the rear hub support have been modified to improve sealing.

1. Verify the customer concern.
2. Replace the hub support (1) only on the side where the part is causing the noise according to the instructions on MGSS (WHEEL HUB COMPONENT REMOVAL/INSTALLATION).
