Subject: UNUSUAL NOISE WHEN RECIRCULATE SWITCH IS OPERATED	Bulletin No.: 07-001/22
	Last Issued : 03/03/2022

2016-2020 CX-9

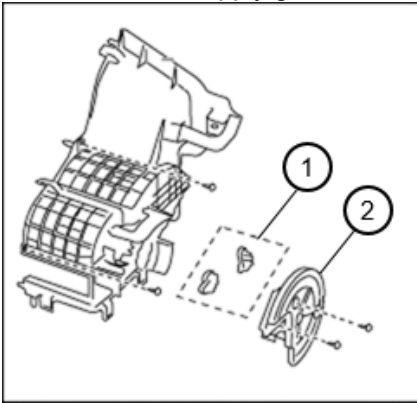
Some vehicles may exhibit an unusual noise in the front A/C unit when the recirculate switch is operated. This is caused by a damaged gear in the air intake actuator. Dust and sand adhered to the grease at the air intake link may disturb the movement of the air intake actuator, resulting in the damaged gear. To eliminate this concern, grease application to the air intake link mechanism to the link pin has been reduced.

1. Verify the customer concern.
2. Clean the dust and sand from the air intake link (1).
3. Replace the air intake actuator (2) according to the instructions on MGSS.
 - 2016-2020 CX-9 (BLOWER UNIT DISASSEMBLY/ASSEMBLY)
 - 2021 CX-9 (BLOWER UNIT DISASSEMBLY/ASSEMBLY)

NOTE: DO NOT apply grease to the air intake actuator (2).
