Technical Service Bulletin

Subject: FUEL-FILLER LID DOES NOT LOCK	Bulletin No.: 09-006/22
	Last Issued : 03/01/2022

2019-2021 Mazda3 (Japan built) with VINS starting with JM1
2020-2021 CX-30

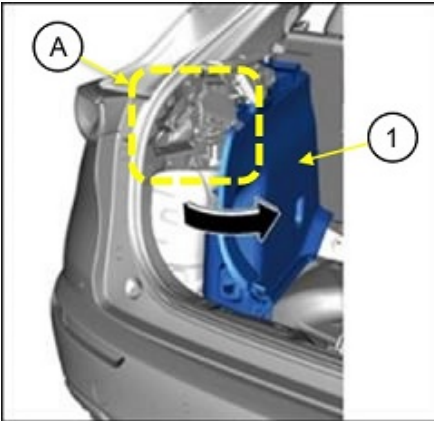
(1) Trunk side trim

Detail A: (2) Fuel-filler lid opener cable

1. Verify the customer concern by locking the doors and pressing the fuel-filler lid after 2 minutes to see if it opens.
 - If the fuel-filler lid can be opened, adjust the fuel-filler lid opener cable position using the Adjustment Procedure of Fuel-Filler Lid Opener Cable below.

2. After adjustment of the cable, wait for 2 minutes after locking the doors, then press the fuel-filler lid again to verify that the lid does not open.

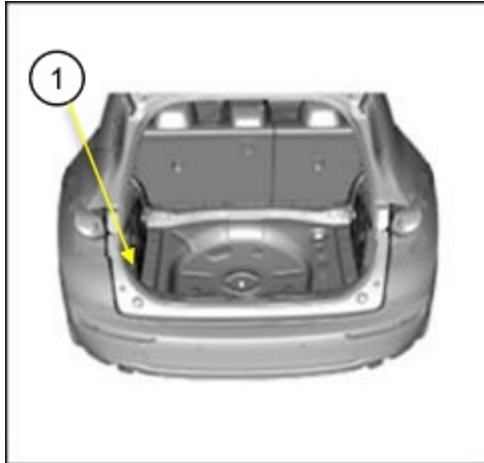
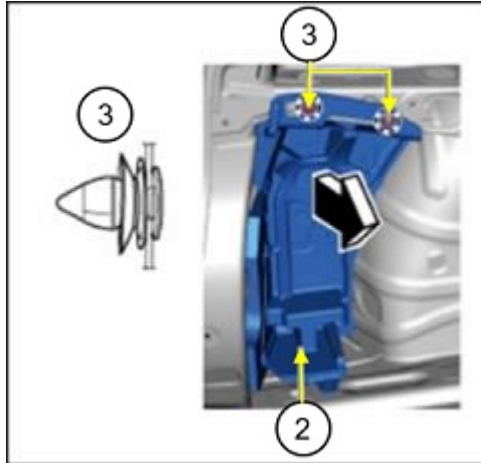
(1) Location of Trunk side insulator

(2) Trunk side insulator
(3) Clip (2pcs.)

3. Remove the trunk side insulator.

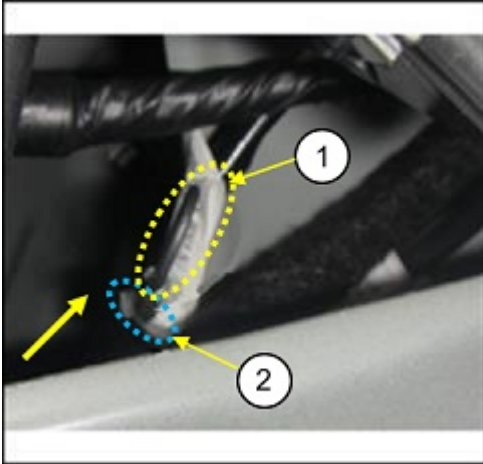
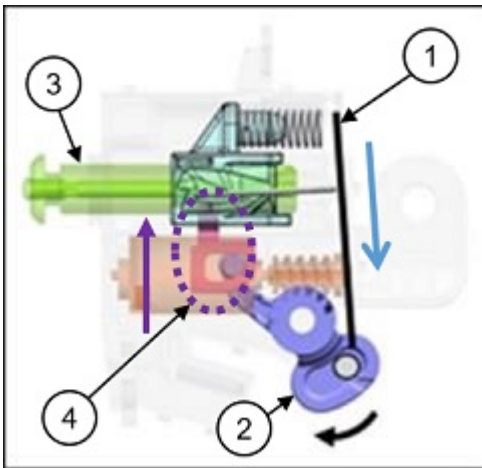
Inside of Fuel-Filler Lid Lock Actuator

TIP: By pushing the opener cable (1), the lock connected to the opener lever (2) inserts into the cam hole and the actuator rod (3) is locked.

- (1) Opener cable
- (2) Opener lever
- (3) Actuator rod
- (4) Lock

6. Secure the fuel-filler lid opener cable end (1) with another tie band (2) (return to the normal position).
