Subject: WHITE POWDERY DUST ON INNER SURFACE OF HEADLIGHT LENS	Bulletin No.: 09-007/22
	Last Issued : 03/01/2022

2018 (US spec) / 2019 (Mexico spec)-2021 Mazda6 with VINS lower than JM1GL*****617811 (produced before July 22, 2021)

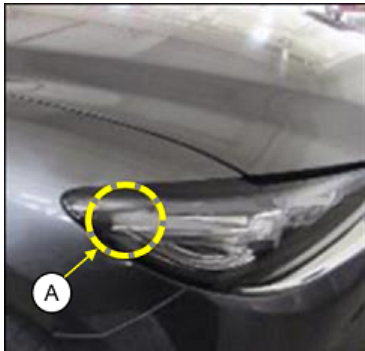
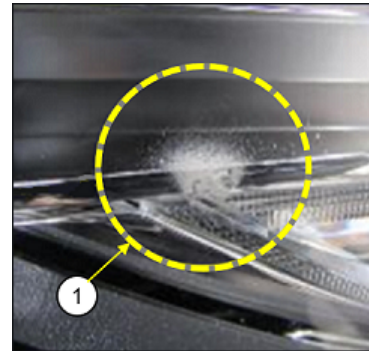
Detail A

Some vehicles may exhibit a white powdery dust (1) adhering to the inner surface of the headlight lens causing a poor appearance.

This is caused by the edge of the lens support part interfering with the inner lens of the headlight under a strong vibration during driving, scratching the inside of the inner lens. As a result, the resin powder adheres to the inside of the headlight lens. To eliminate this concern, the support rib location of the inner lens has been changed to prevent the interference. Customers having this concern should have their vehicle repaired using the following repair procedure.

1. Verify the customer concern (as shown in the figure in the DESCRIPTION).
2. Replace the front combination light on the defective side(s) with a modified one(s) according to the workshop manual (FRONT COMBINATION LIGHT REMOVAL/INSTALLATION).
3. Verify the repair.

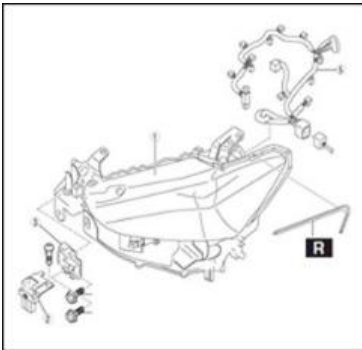
Replacement Parts Location:

- Protector, RH
- Protector, LH
