**Complaint - Over the Air (OTA) Software Update Failed: Observe Specified Procedure (192/20)**

Revision: This bulletin replaces bulletin Group 9 192/20, dated June 29, 2021.

Model Series: **Taycan (Y1A)**

Concerns: **All OTA (Over the Air) enabled control units**

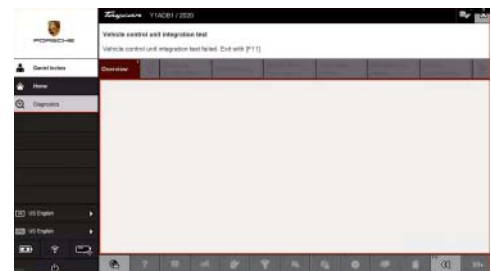
*Vehicle control unit integration test failed*

If the integration test fails, this is displayed as a result ⇒ *Vehicle control unit integration test failed.* Then complete the following steps:

- 7.1 In the Additional menu (F7), execute the "Maintenance of vehicle data with PIWIS ONLINE" function and write the current vehicle data record from the online system into the vehicle.
- 7.2 Carry out the integration test again.
- 7.3 In the event of a further fault, contact Technical Support.
