Subject: WATER ENTRY FROM THE REAR DOOR	Bulletin No.: 09-008/22
	Last Issued : 03/01/2022

APPLICABLE MODEL(S)/VINS

DESCRIPTION

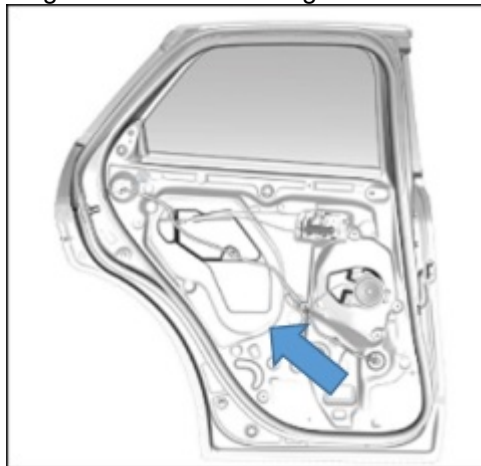
Some vehicles may exhibit water leaking into the passenger compartment from the rear door through the bottom of the service hole behind the rear door trim during rain or when washing the vehicle.

This is caused by one of the following:

- Since the material of the seal rubber is not resistant to surfactants, the rubber deteriorates when the vehicle is washed and allows water to penetrate into the seal rubber of the service hole cover.
- The lower tabs of the service hole cover may not have been completely engaged at the factory.

To eliminate this concern, the seal material of the service-hole cover has been changed (Japan built Mazda3) and a mass production change will be implemented in the future (Mexico built Mazda3 and CX-30).

Customers having this concern should have their vehicle repaired using the following repair procedure.

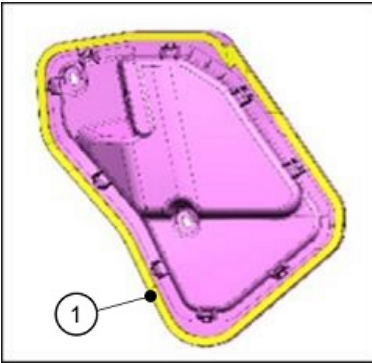
Mazda3

Japan built (JM1)
Modified service-hole cover
with seal material (1)

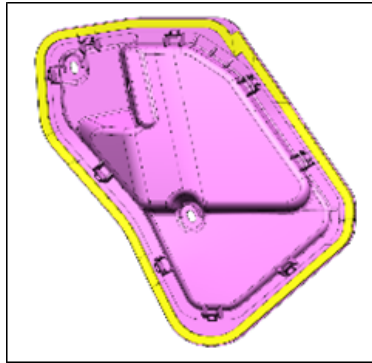
Mexico built (3MZ)
Non-modified service-hole cover

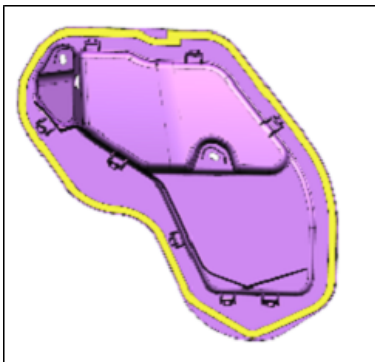
CX-30

Non-modified service-hole cover

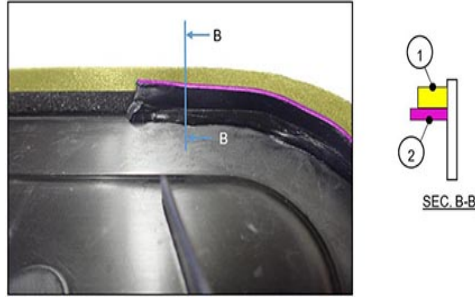
CORRECT (image is of CX-30)

The butyl tape (2) IS sticking up at or above the height of seal rubber (1).

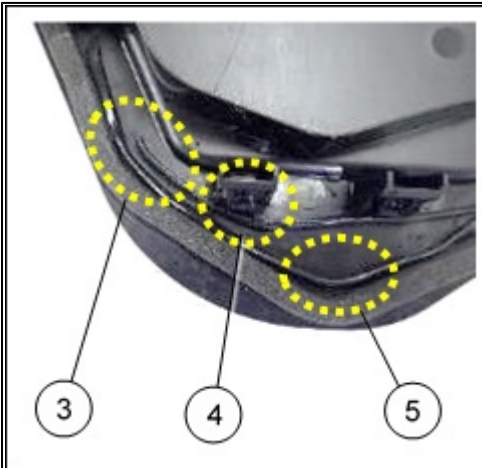
Examples of NOT CORRECT placement of tapes (image is of CX-30)

- (3) TAPE-2 does not adhere to TAPE-1.
- (4) TAPE-2 is away from the tab.
- (5) TAPE-1 does not adhere to the seal rubber.
