Subject: WIRELESS CHARGER FOR MOBILE DEVICES DOES NOT START CHARGING OR STOPS CHARGING IMMEDIATELY	Bulletin No.: 09-009/22
	Last Issued : 03/03/2022

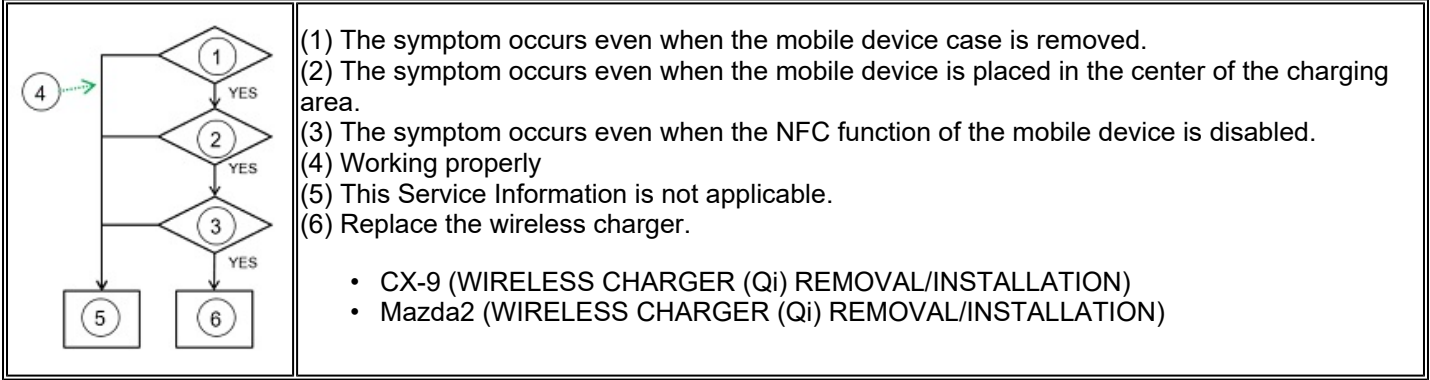
Some customer may experience the wireless charger does not start charging or stops charging immediately although the mobile device is in the chargeable area. This is caused by the logic for detecting foreign matter being too sensitive. Customers having this concern should have their vehicle repaired using the following repair procedure.

2. Troubleshoot using the following flow chart.
