Volvo Chassis - Technical Service Bulletin V-284 - 069, Exhaust Particulate Sensor, Repair

Exhaust Particulate Sensor, Repair

V-284-069

Volvo trucks with a 1-box exhaust after-treatment system (EATS) and built between January 1, 2017 and February 1, 2020

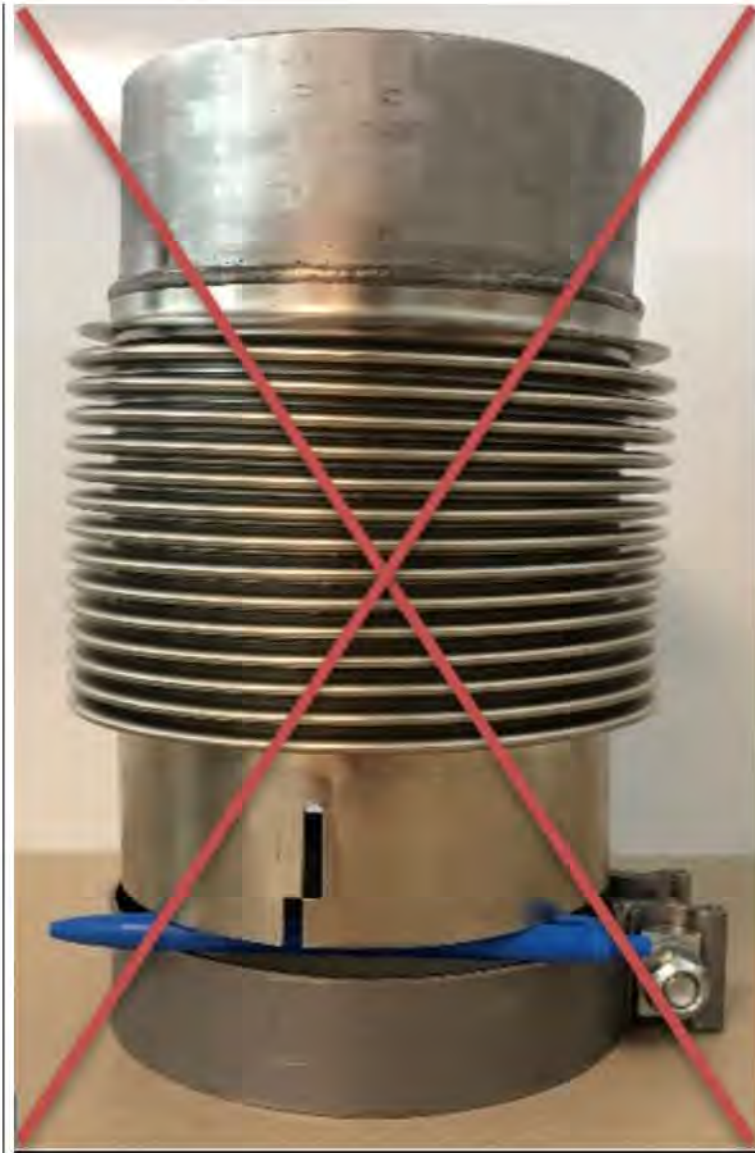
<p>Scenario 1</p> <p>This style Flex Pipe and Clamp will no longer</p>
--	--

Determine which Flex Pipe and Clamp the truck currently has installed on it. If the truck you are repairing has the Flex Pipe and Clamp shown in scenario 1, you will need to order the improved Flex Pipe (P/N 21142254) and Clamp (P/N 25172497). If the truck you are repairing has the Flex Pipe and Clamp shown in scenario 2 or 3, this truck already has the improved parts and ordering a new Flex Pipe and Clamp is NOT required.

work with the upper adjacent connecting pipe. The below parts in scenario 2 are required to perform this FSB.

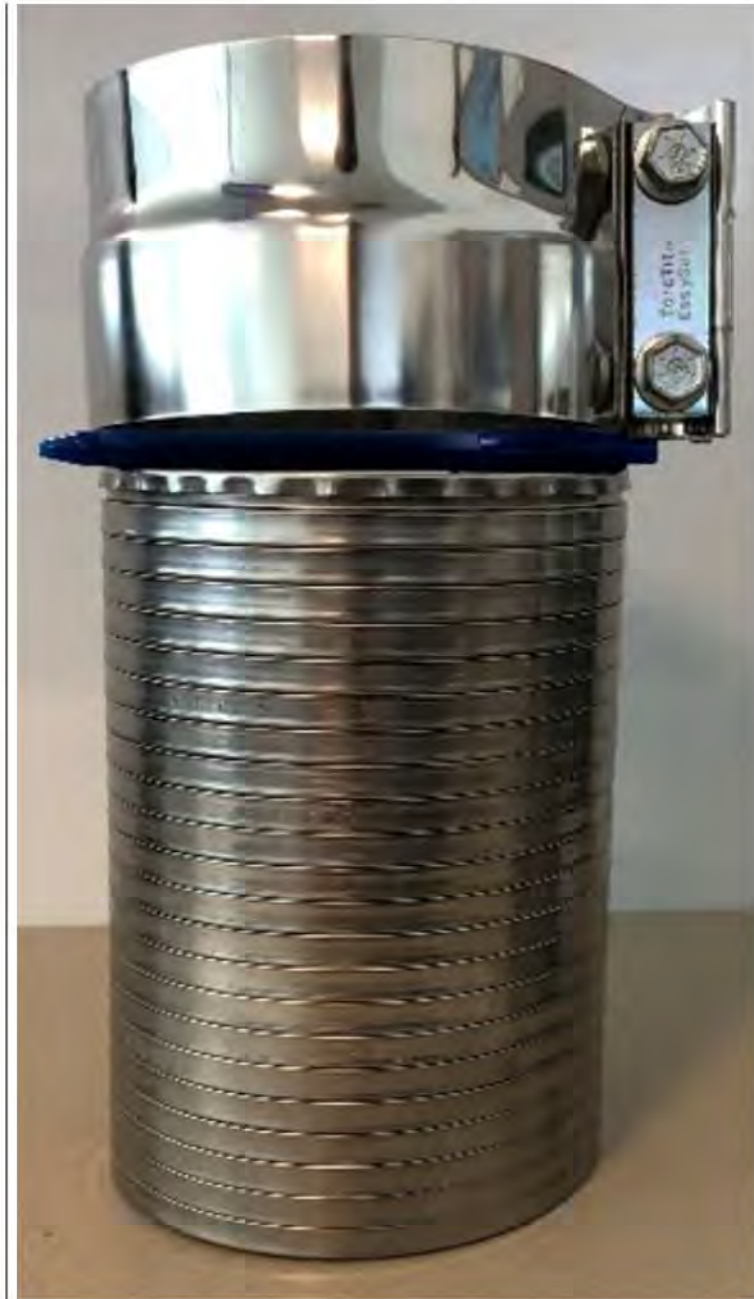
Scenario 2

This style Flex Pipe and Clamp only needs the upper adjacent pipe replaced. Reuse the existing Flex Pipe and Clamp, or order as needed.

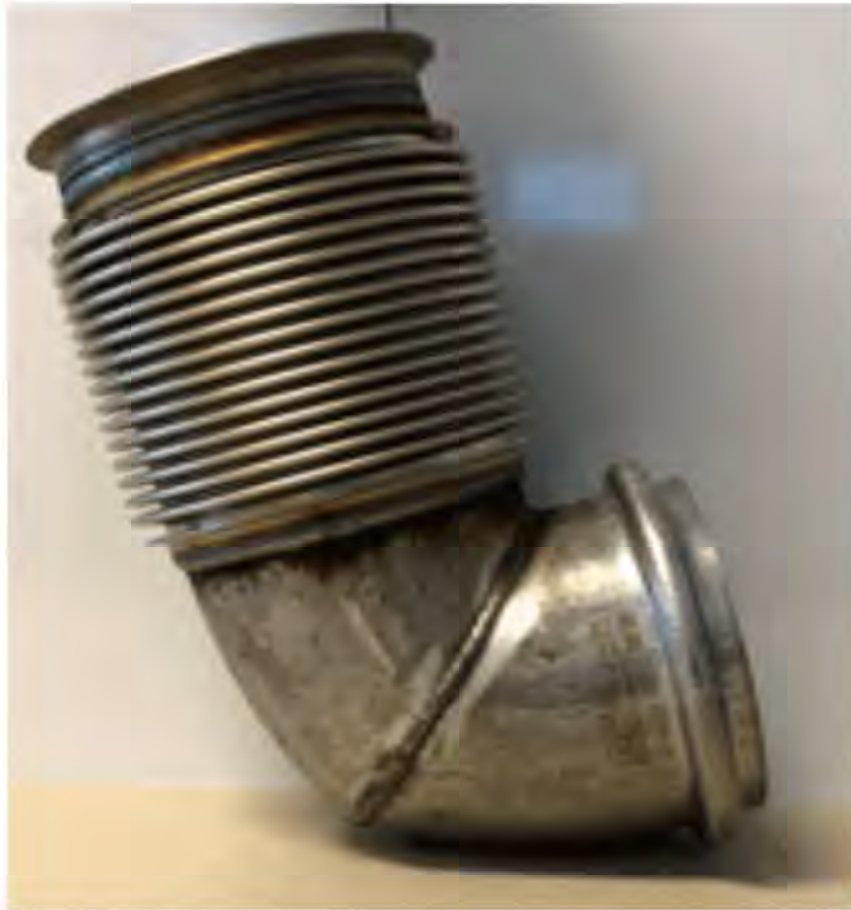
Scenario 3

This style Flex Pipe and Clamp only needs the upper adjacent pipe replaced. Reuse the existing Flex Pipe and Clamp, or order as needed.
