# Hood Cable Breaking or Binding

## V-821-001

(February 2022)

All Volvo Trucks built between February 5, 2018, and February 28, 2022

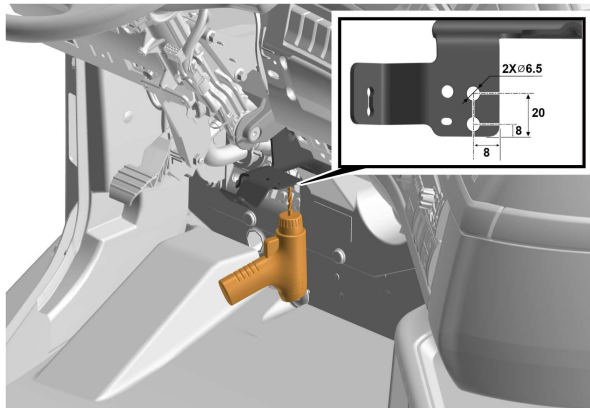
- 6 Follow procedure Function Group 8214, Information type Repair Hood Release Cable, Replacement in Impact to gain access to the cables.
- 7 Inspect cables for rubbing or binding around the steering shaft.
- 8 Replace Hood Release Cables as necessary following procedure Function Group 8214, Information type Repair Hood Release Cable, Replacement in Impact.
- 9 When installing new cable use new routing of cable shown below.
- 10 Drill two 6.5mm holes in the existing cable mounting bracket.
