MY19+: Central locking system non-functional via key or water entry at roof

Topic number	LI65.10-P-074539
Version	1
Function group	65.10 - Roof paneling
Date	3/9/22
Validity	Model 463 facelift as of model year 2019 without sliding sunroof (code F15) up to vehicle identification end number ...X362550
Reason for change

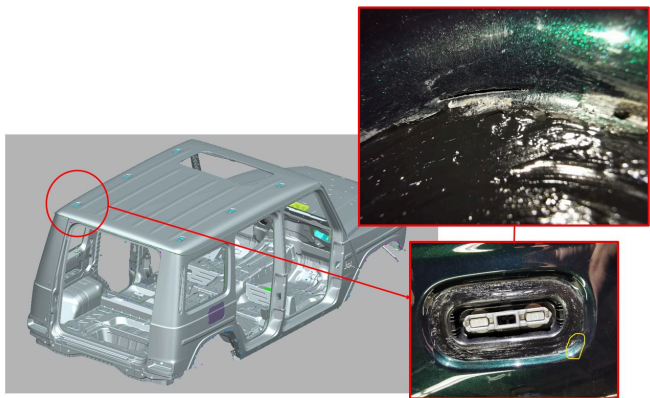
Picture 1

A crack may have developed in the roof panel at the rear left roof luggage carrier pan (see picture 1) which may lead to water entry and a possible unexpected behavior of the radio remote control function of the central locking system.

Check whether a potential crack is present.

In the event of a crack, please proceed as follows:

1. Expose the rear left roof luggage carrier pan from the inside (see picture 2)
2. Drill stop holes at each end of the indentation of the crack (see picture 3)

Hole diameter: Ø3 mm

3. Clean surface to be sealed both on the inside and the outside (surface must be free of dust, grease and lint)
4. Seal the crack both on the inside and the outside with a seam seal
5. Touch up the area in which the work was carried out with a touch-up paint pen
