## Staining/discoloration on chrome door/window trim

Topic number	LI72.00-P-074481
Version	1
Function group	72.00 - General
Date	3/3/22
Validity	Model 118
Reason for change

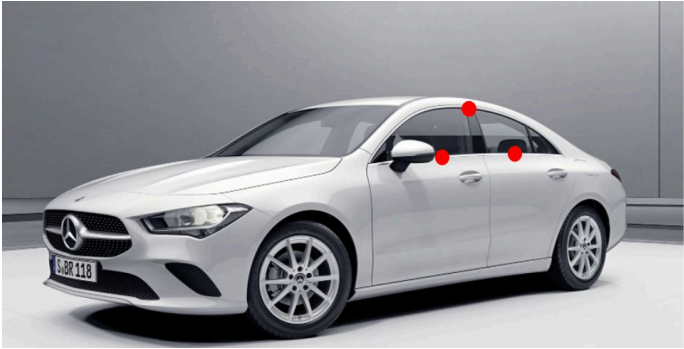
Attachments	
File	Description
<a href="#">Bild 1.JPG</a>

Staining at top and bottom of trim bars of doors. See example pictures 1, 2.

Discoloration of the protective coating of beltline door trim bars and upper door trim bars due to strong alkaline detergent in car washes.

1. Polish the trim bars with polish A 000 986 43 74.
2. If the complaint cannot be rectified by polishing, replace the door beltline trim bars, door upper trim bars and rear side window with trim element with the optimized parts listed in this document.

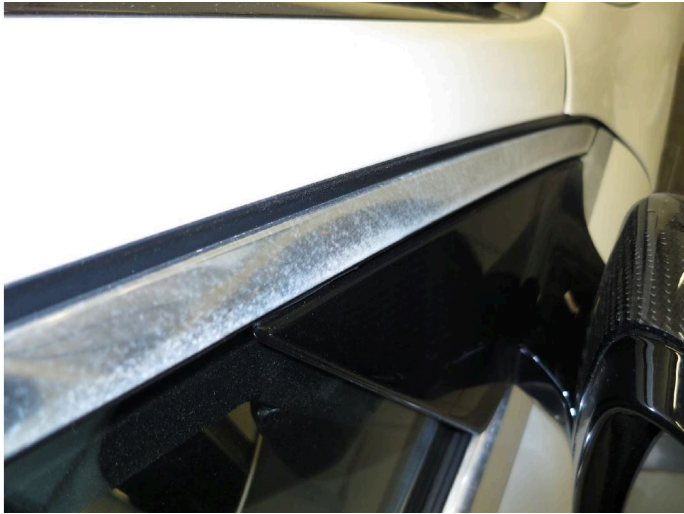
Overview of affected component parts
<a href="#">Bild 2.jpg</a>

Example of complaint relating to door upper trim strip in silver look
