G-FACELIFT 2018: Creaking Noise In Interior When Driving Off-Road

Topic number	LI83.30-P-074585
Version	1
Function group	83.30 - Air conditioning
Date	3/23/22
Validity	Model 463 FACELIFT as of model year 2019
Reason for change

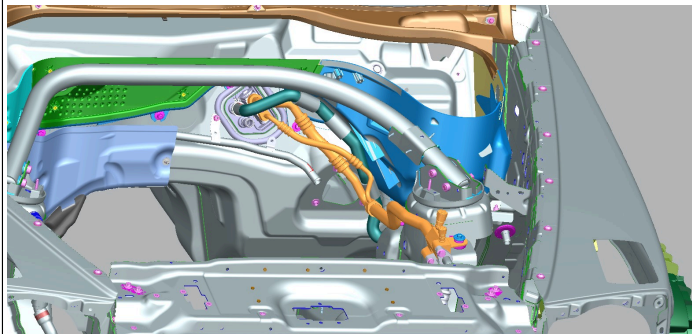
Attachments	
File	Description
Kältemittelleitung_1.jpg	Picture 1

A refrigerant line may be twisted when mounted in the engine compartment (see Picture 1, orange line) which can lead to the generation of a creaking noise on the air conditioner box. The noise may be heard in the interior on rough terrain or rough roads.

Release refrigerant line at fastening points (see Picture 2).

Slacken off line to release any binding or tension.

Tighten screws again, ensuring line does not move.
