# Service Bulletin

Bulletin No.: 20-NA-079

**Subject: Front Brake Squeal Noise Heard During Light Brake Pedal Application**

Brand:	Model:	Model Year:		Date Breakpoint		Engine:	Transmission:
		from	to	from	to		
Buick	Encore GX	2020	2022	SOP	February 14, 2022	All	All
Chevrolet	Trailblazer (VIN M)	2021	2022

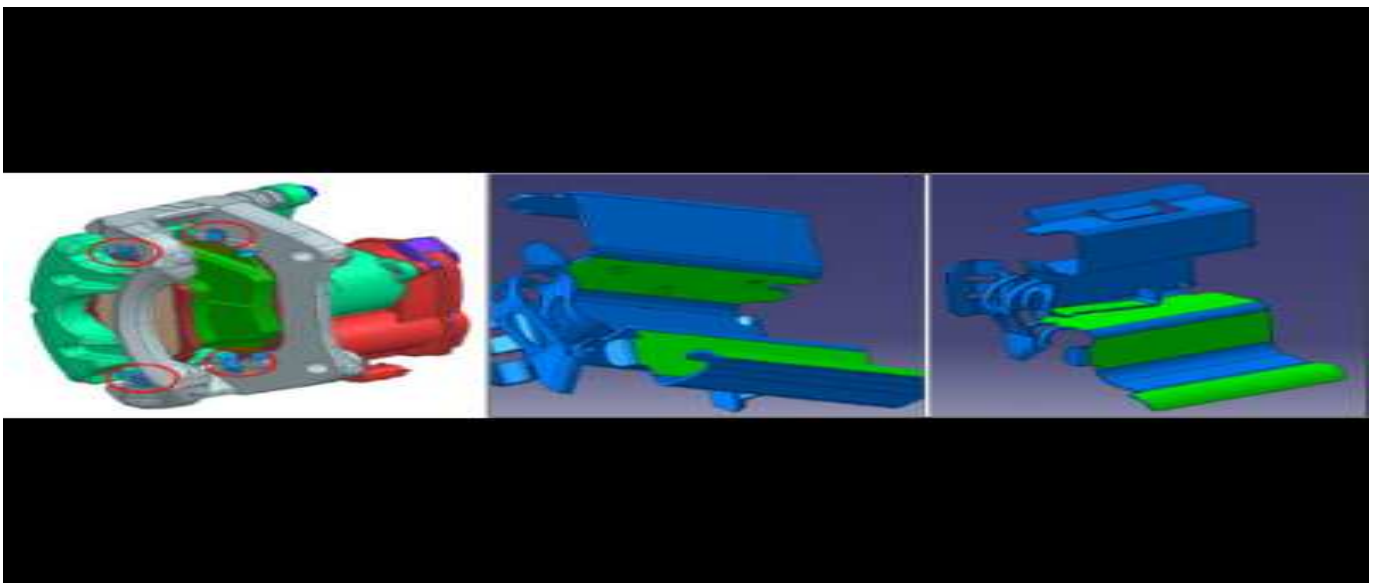
5964684

**Note:** There are 4 Pad abutments per caliper. The green area shown above designates the required grease positions.

**Note:** The recommended grease volume is about 1.1 g per caliper.

3. Apply Molykote M-77 Grease (GM P/N 19356408) on caliper pad spring abutment and clip as shown in the graphic above.
4. Install new front brake disc pads and sensors. Refer to *Front Disc Brake Pads Replacement* in the Service Manual
5. Verify brake noise has been eliminated.

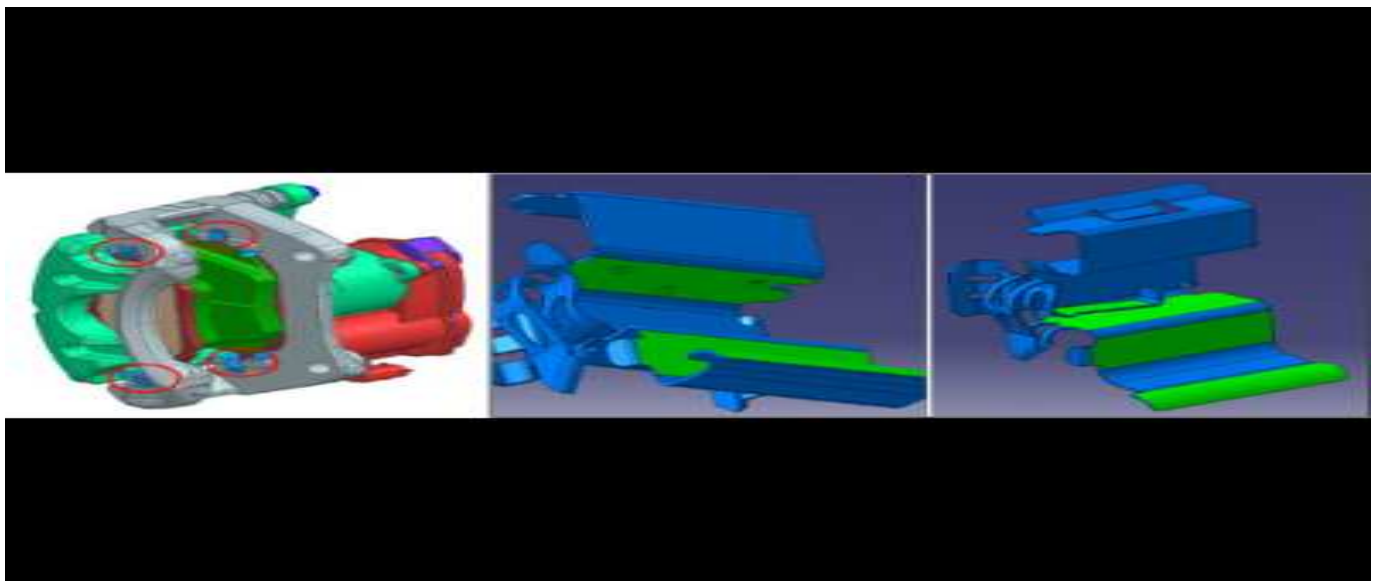
5964684

**Note:** There are 4 Pad abutments per caliper. The green area shown above designates the required grease positions.

**Note:** The recommended grease volume is about 1.1 g per caliper.

3. Apply Molykote M-77 Grease (GM P/N 19356408) on caliper pad spring abutment and clip as shown in the graphic above.
4. Then reinstall the existing pads. Refer to *Front Disc Brake Pads Replacement* in the Service Manual
5. Verify brake noise has been eliminated.
