# Service Bulletin

Bulletin No.: 21-NA-243

**Subject: Short Range Radar (SRR) with DTC U3000 49 Set**

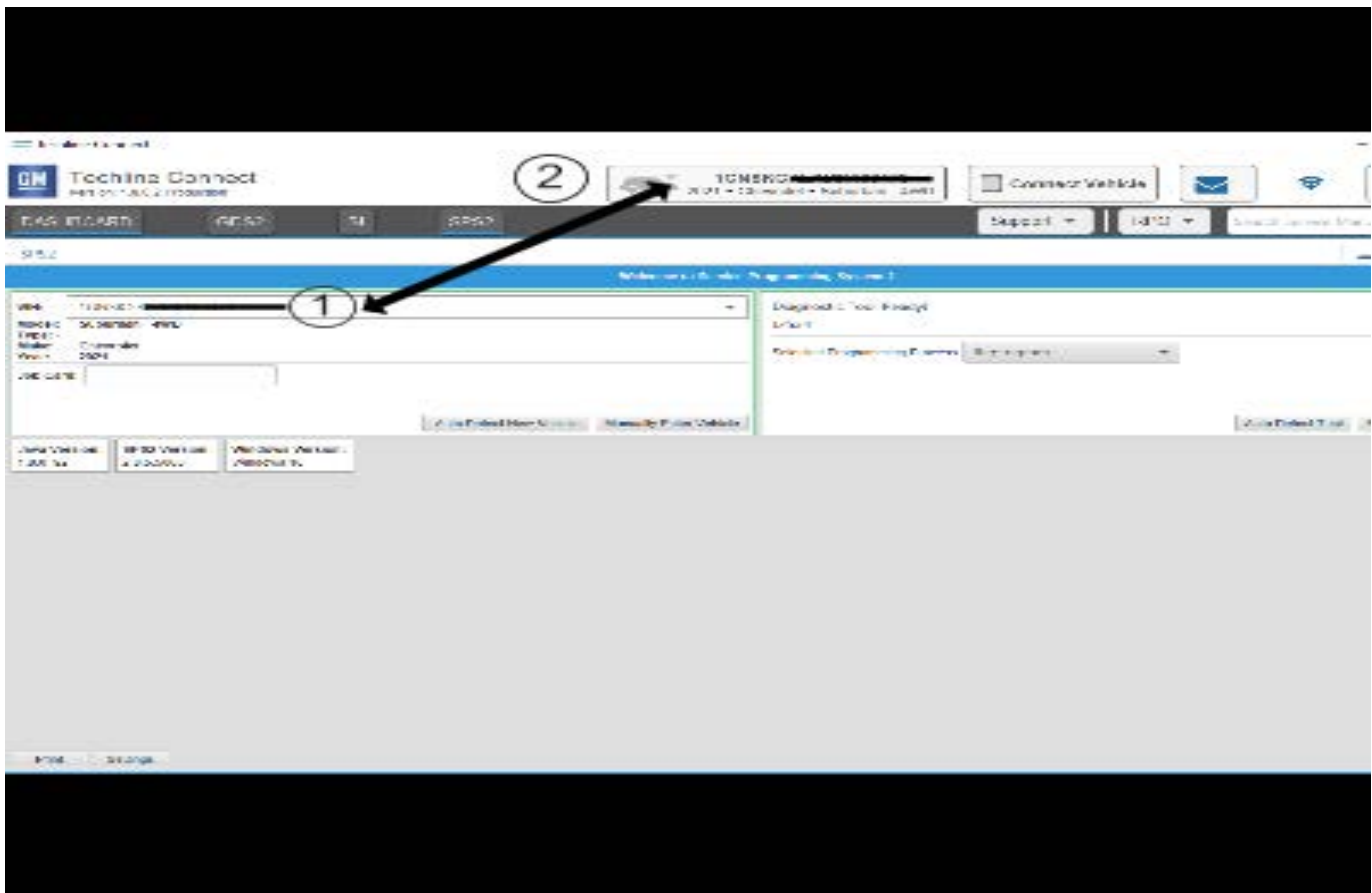
**Caution:** Be sure the VIN selected in the drop down menu (1) is the same as the vehicle connected (2) before beginning programming.

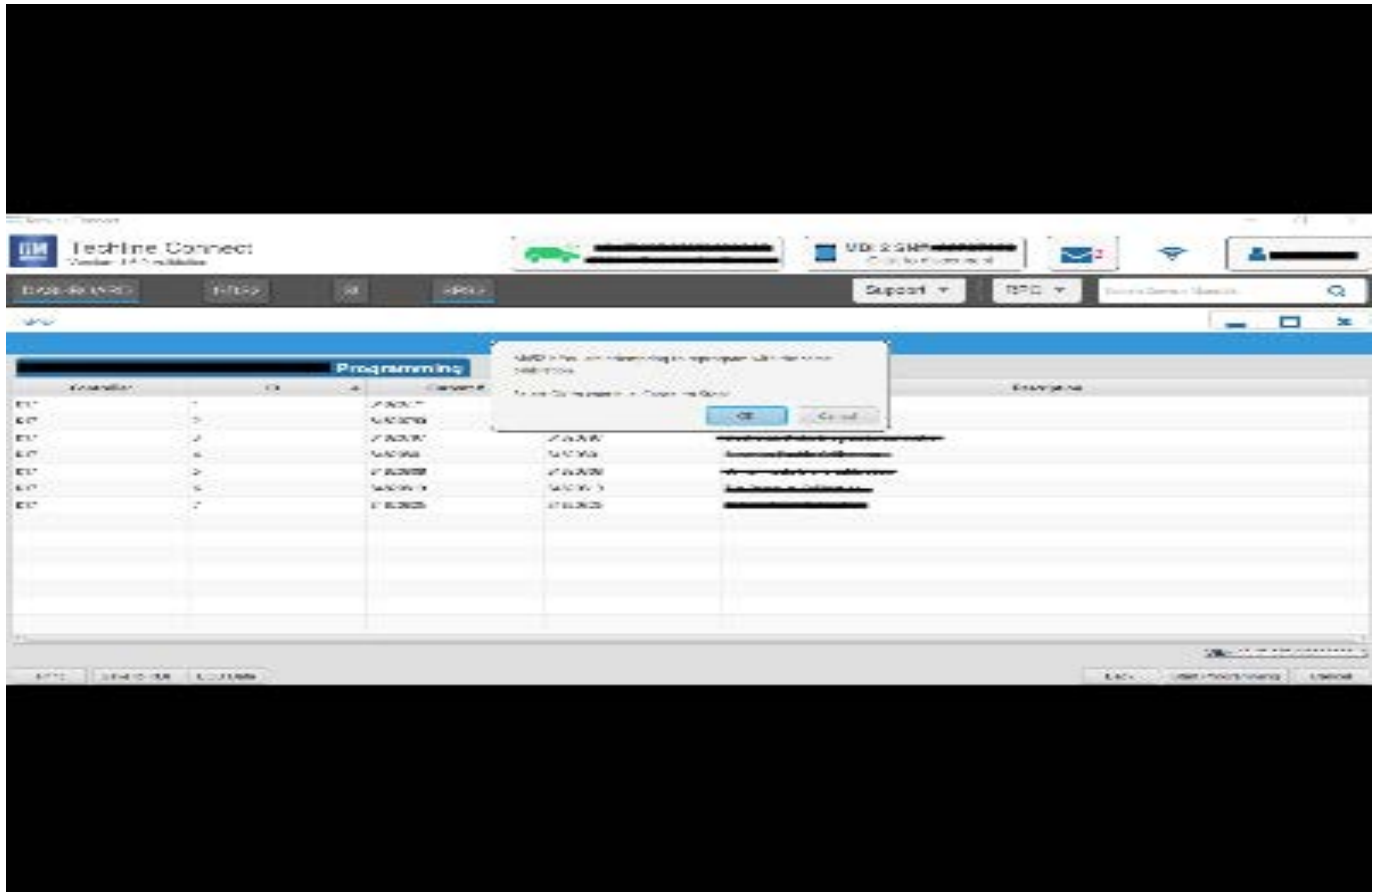
5644477

**Important:** Techline Connect and TIS2WEB screens shown above.
