Leaks in the Convertible-Top Compartment Lid and Noises While Driving: Replacing Tension Ropes (33/22)

Vehicle Type: **911 Carrera Cabriolet (992) / 911 Carrera 4 Cabriolet (992) / 911 Carrera S Cabriolet (992) / 911 Carrera 4S Cabriolet (992) / 911 Turbo S Cabriolet (992)**

Model Year: **As of 2021 up to 2022**

Concerns: **Convertible top tension ropes**

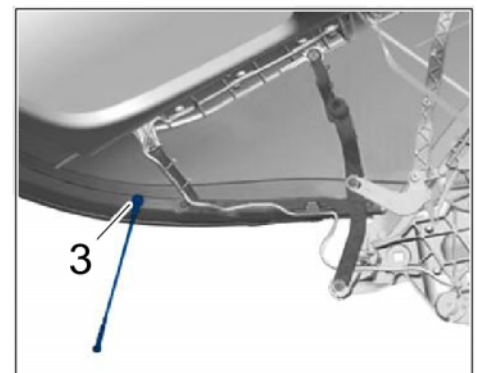
Tension rope

Information: Customers complain about leaks in the convertible-top compartment lid and noises while driving. This may be caused by a detached tension rope in the convertible-top compartment lid which is needed for tensioning the roof bow when the convertible top is closed.

- 3 Unclip tension rope ⇒ *Tension rope -3-*.
