# WARRANTY BULLETIN WARRANTY CAMPAIGN

Can-Am® On-Road Spyder™

Campaign no.: 2022-0005

Subject: **Spyder RT - LH Side Panel and Driver's  
Seat Gap Correction**

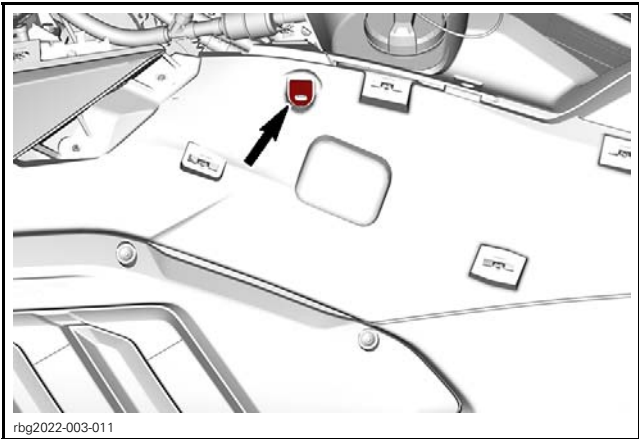
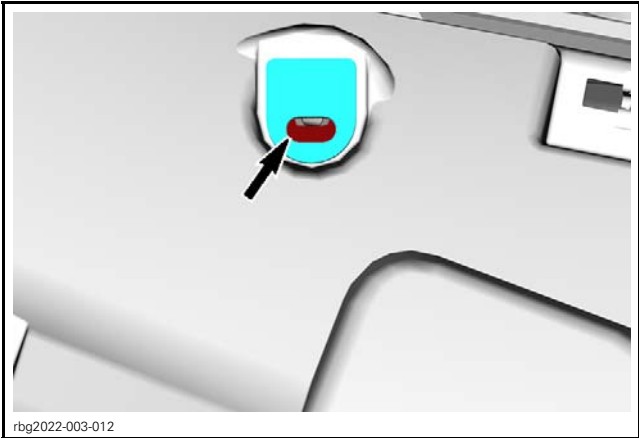
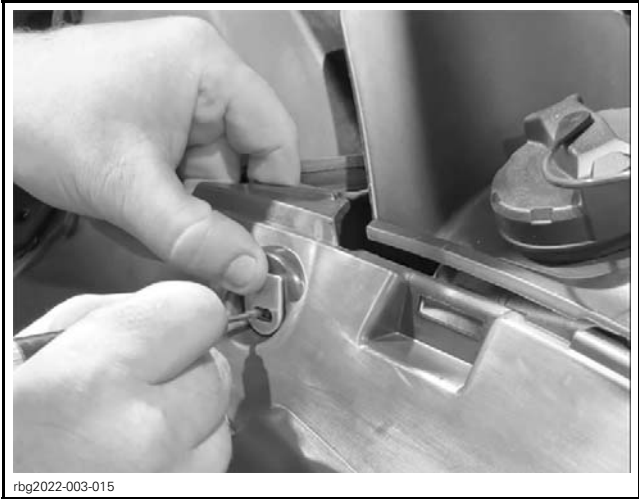
AREA TO BE ENLARGED THROUGH THE ADAPTER OPENING

12. Install the adapter (P/N 705017687) on LH central fairing and use it as a template to enlarge the lower part of the hole. You may use a small rotary tool to enlarge the hole.

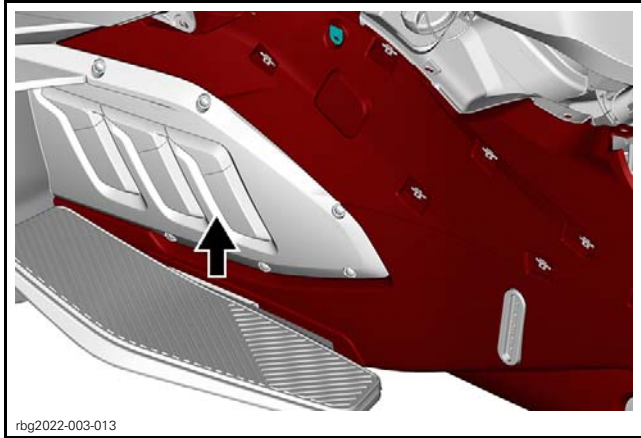
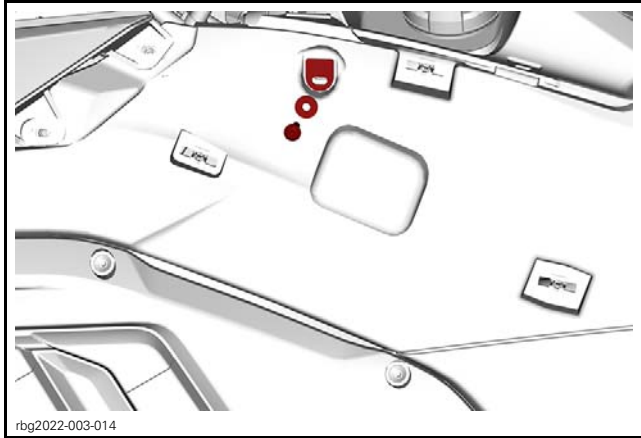
Some RT vehicles present a gap between the LH side panel and the driver's seat.

13. Apply a light upward pressure approximately to the bottom center of the LH central fairing (right about the middle of the driver's footboard) which allows the fairing to be raised and adjust then secure using the

adapter (P/N 705017687), the previously removed M6 X 25 screw and washer. Tighten to specification.

| TIGHTENING TORQUE | |
|---|---|
| M6 X 25 Screw | 3.5 N•m ± 0.5 N•m<br>(31 lbf•in ± 4 lbf•in) |
