Service Bulletin

Bulletin No.: 22-NA-009

Subject: Information on New Torque Specification and Installation Procedure for ACDelco Spin-On Oil Filters

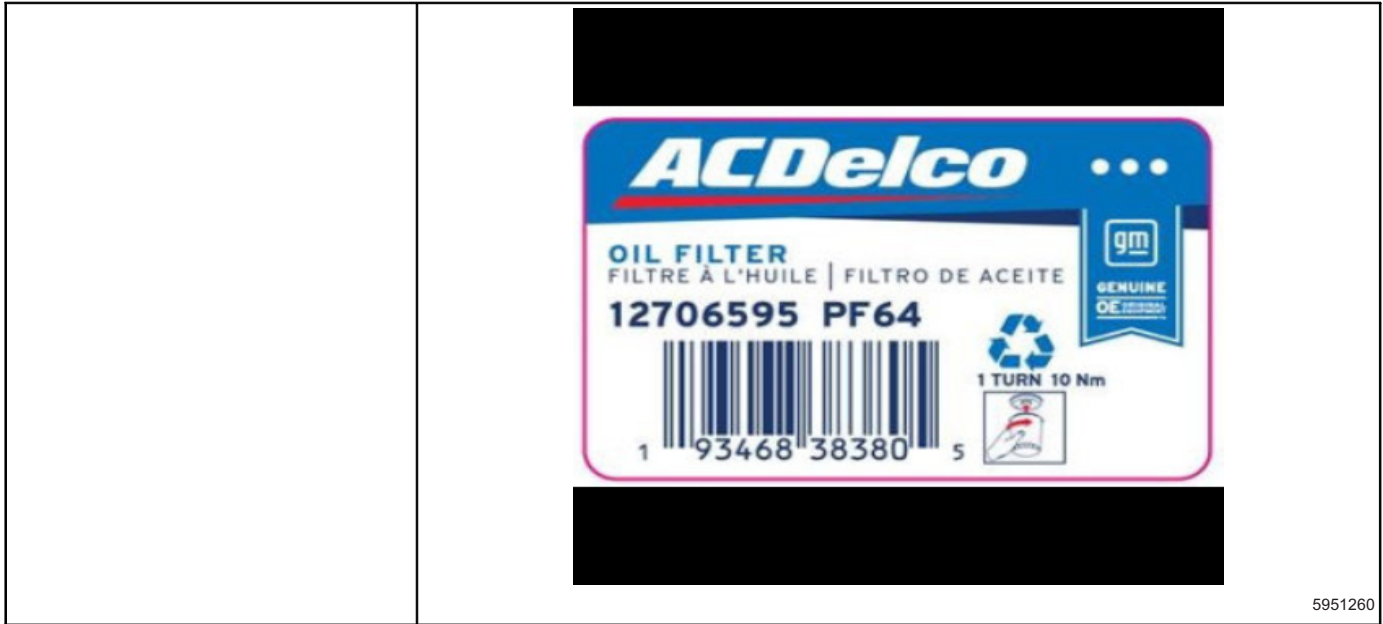
Involved Region or Country	North America, Europe, Uzbekistan, Russia, Middle East, Iraq, Israel, Palestine, Argentina, Brazil, Bolivia, Chile, Colombia, Ecuador, Paraguay, Peru, Uruguay, Venezuela, Japan, Cadillac Korea (South Korea), GM Korea Company, China, Taiwan, Thailand, Singapore, Philippines, Australia/New Zealand, Egypt, Other Africa, South Africa
Condition	Some customers or dealers may comment on an oil leak coming from underneath the front of the vehicle after a prior oil service was performed. This leak can take several thousand miles to occur.
Cause	This may be caused by an oil leak coming from between the oil filter gasket and mounting surface. — Technicians may also notice that the filter is very easy to remove and can sometimes be removed by hand.
Information	To correct this condition, engineering has released a revised installation specification for all Spin-on oil filters PF64, PF63, PF48, PF66, UPF64R, UPF63R, UPF48R and UPF66R. The new specification will be as follows: <ol style="list-style-type: none"> 1. Lubricate the NEW oil filter gasket with clean engine oil. 2. Install Oil Filter 1 full turn after gasket makes contact with the sealing surface on the filter mounting flange. If installing with a torque wrench, this should be approximately 10 N•m of torque. This installation specification will be updated in Service Information (SI) and the label on the oil filters (example shown below) will be updated as well.
