SERVICE BULLETIN

APPLICABILITY: 2019-22 Crosstrek Hybrid

NUMBER: 06-86-22

SUBJECT: Squeaking Sound from Brake Pedal

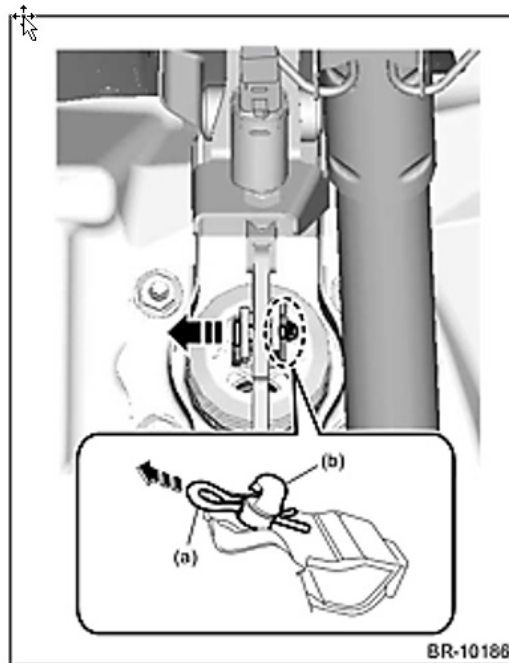
(a) Snap pin (b) Clevis pin

- Record the customer's seat memory positions, radio station presets and Navigation favorites (where applicable).
 - While supporting the battery sensor, loosen and disconnect the ground cable terminal to the battery sensor.
1. Remove the lower dash trim panels and related components as necessary for access to the brake stroke sensor arm following the procedures in the applicable Service Manual.
 2. Disconnect the brake lamp switch connector.
 3. Disconnect the brake stroke sensor connector.
 4. Remove the snap pin (a) and clevis pin (b), then separate the brake pedal from the operating rod.

- When handling the operating rod, never apply excessive force to it.
- Do not tilt the operating rod over 3° (degrees) as brake booster internals may be damaged.
- The clevis pin is a **one-time use only** part and will require replacement.
