Service Bulletin

Bulletin No.: 22-NA-059

Subject: Check Engine Lamp Illuminated in DIC with DTCs C0588/C0589/C058A Set

Brand:	Model:	Model Year:		VIN:		Engine:	Transmission:
		from	to	from	to		
Buick	Encore GX	2020	2022				
Chevrolet	Trailblazer	2021	2022

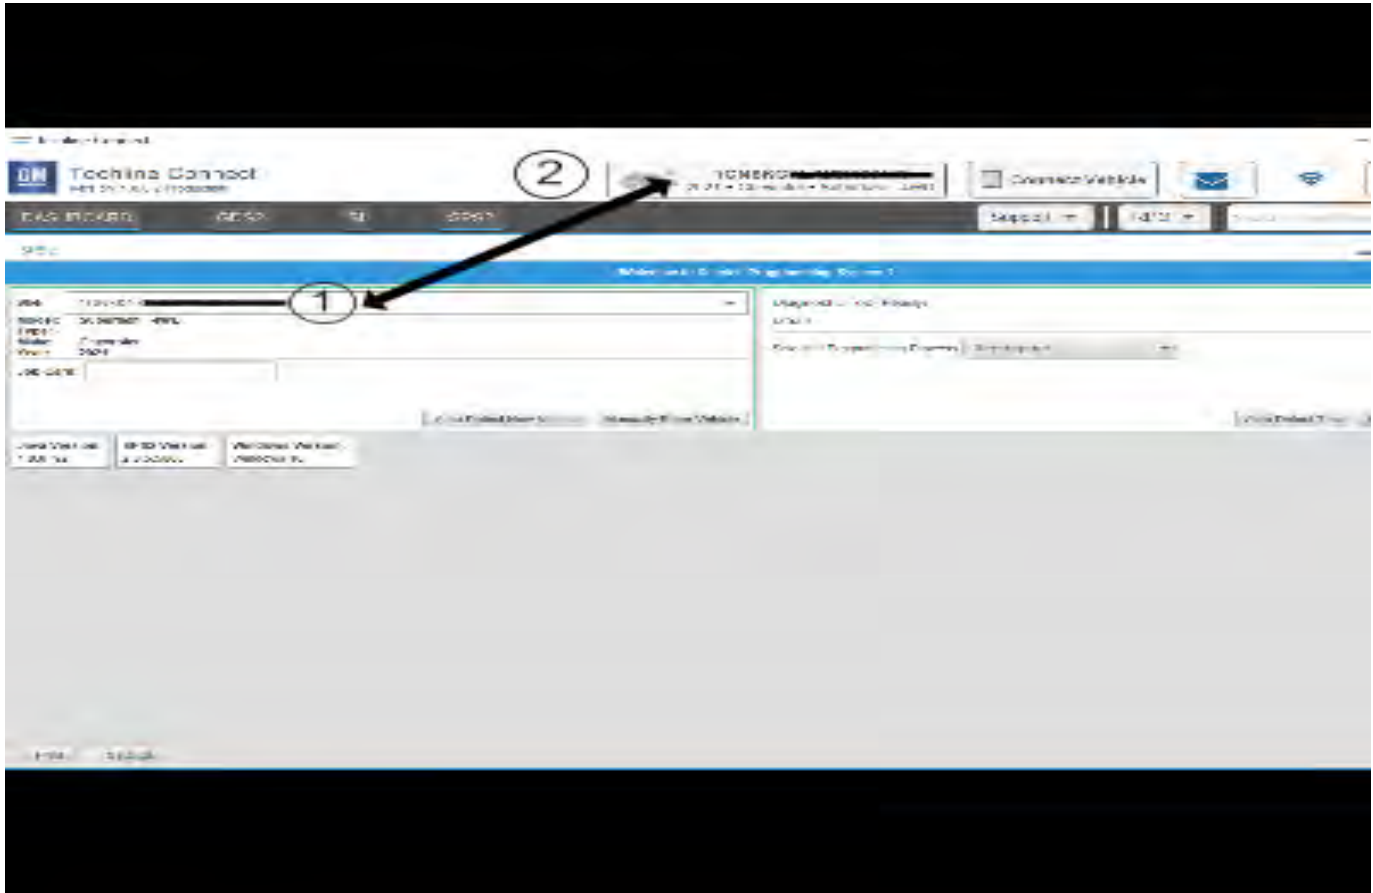
5743643

Caution: Be sure the VIN selected in the drop down menu (1) is the same as the vehicle connected (2) before beginning programming.

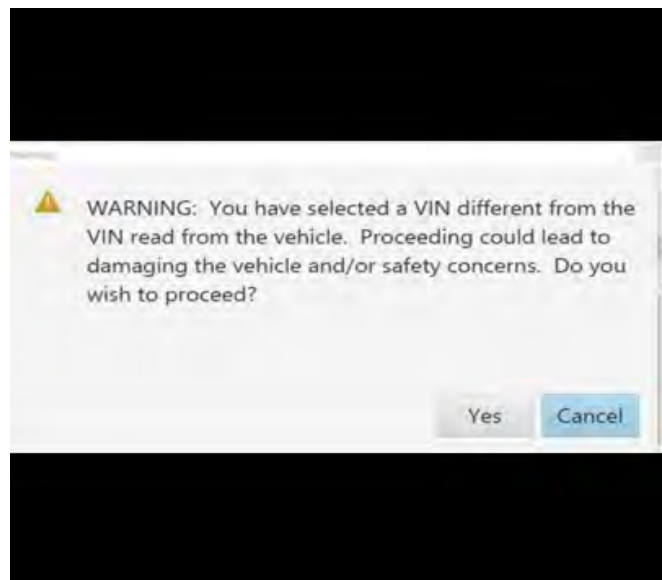
5877000

Important: If the vehicle VIN DOES NOT match, the message below will be shown
