SERVICE INFORMATION BULLETIN

APPLICABILITY: 2019-22MY Ascent
2020-22MY Legacy & Outback 2.4L

NUMBER: 02-190-22

SUBJECT: Proper Diagnosis of Oil Level Switch Leaks

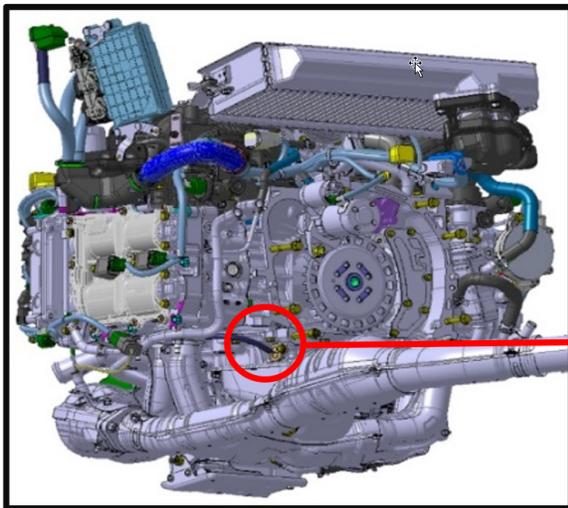
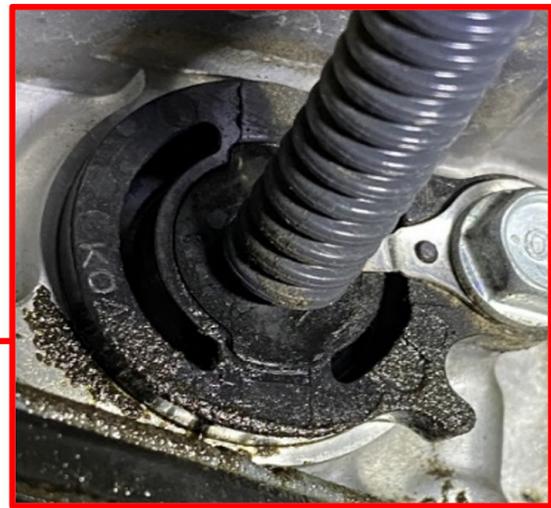
This Service Information Bulletin announces the proper diagnostic procedures regarding oil leakage from the oil level switch area. There is a slight clearance between the center epoxy portion of the oil level switch and its exterior. Engine oil flows through the switch and can cause the clearance to become saturated in oil. During engine operation, the switch temperature increases and the clearance between the epoxy and the exterior shrinks due to thermal expansion. As this clearance shrinks, the previously saturated oil is forced out and gives the appearance of a leaking oil level switch.

Pictured above is an example of an oil level switch **NOT** leaking oil but can be perceived to have a leak.

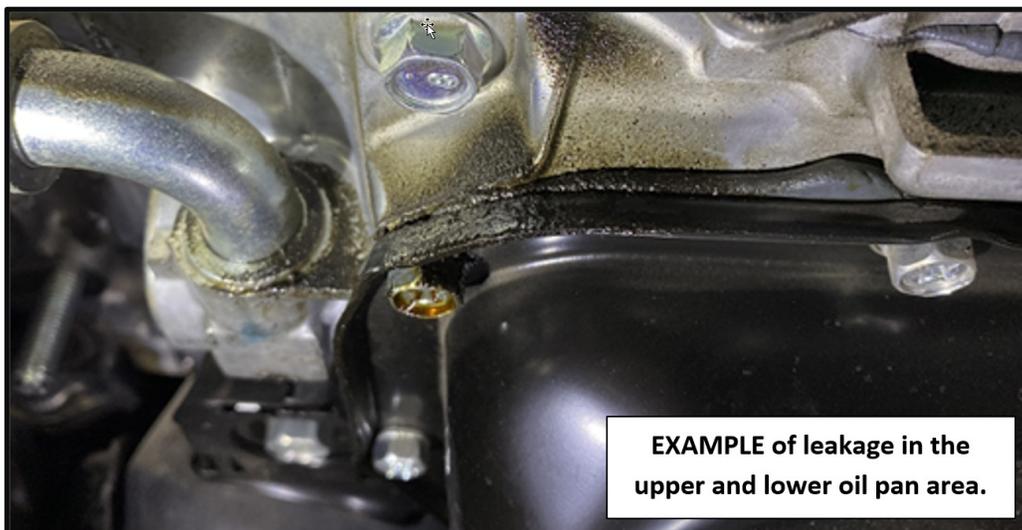
Please follow the procedure below if you find any engine oil on the level switch when an oil leak is being detected. First clean the area and apply a leak seeking powder for easier observation.

1. Observe contact surfaces of the following:
2. Oil Level Switch, Lower Oil Pan, Upper Oil Pan, Engine Block, Cylinder Heads, and Transmission.
3. Confirm if engine oil is leaking from anywhere other than the oil level switch.
4. If any leaks are found, drain the engine oil, and replace and/or reseal the leaking part(s) as necessary.
5. When replacing the leaking component, take special care not to damage the oil level switch by contacting it with other parts while removing and installing, as the float may become damaged. As for the oil level switch, if there's no cracks or damage found during visual inspection, clean and reinstall the switch.
6. Correct the engine oil level. Perform a road test. Re-inspect for any leaks.
