Service Bulletin

Bulletin No.: 22-NA-064

Subject: In-Vehicle MyBrand App Login Error IOK Radio

Brand:	Model:	Model Year:		VIN:		Engine:	Transmission:
		from	to	from	to		
Chevrolet	Suburban Tahoe	2022	2022				
GMC	Yukon Yukon XL	2022	2022

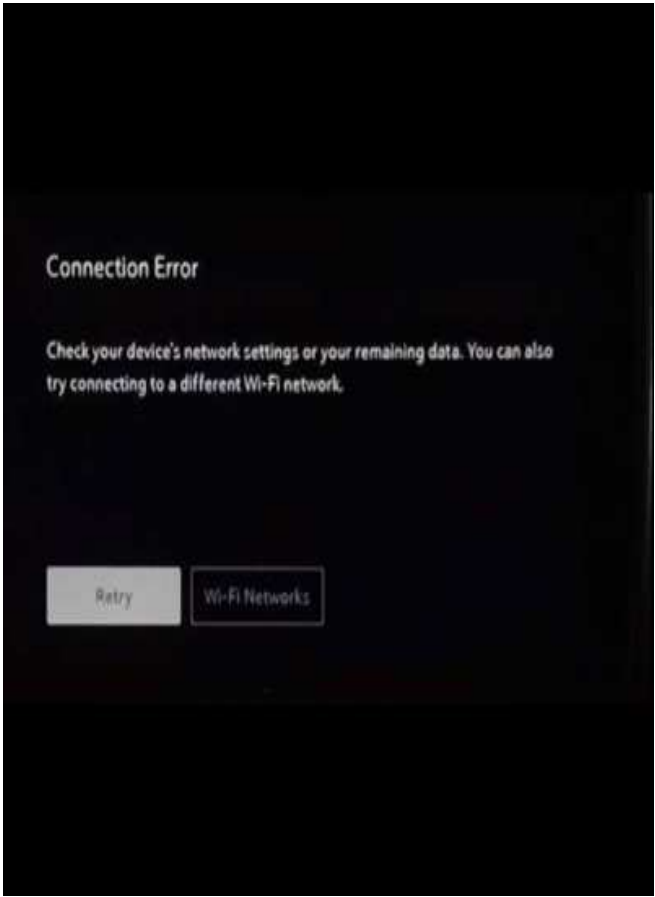
Involved Region or Country	Canada, Mexico, Middle East
Additional Options (RPOs)	Equipped with Radio RPO IOK
Condition	<p>Some customers may comment that they are unable to login to the In-vehicle MyBrand application and will notice a connection error message on the radio display:</p>

Cause	The cause of the condition may be a software anomaly in the radio.
Correction	Do not replace the radio for this particular concern. Dealers are asked to reprogram the radio with the latest calibration available.

1. Reprogram the Radio. Refer to *A11 Radio: Programming and Setup in the Service Manual*.

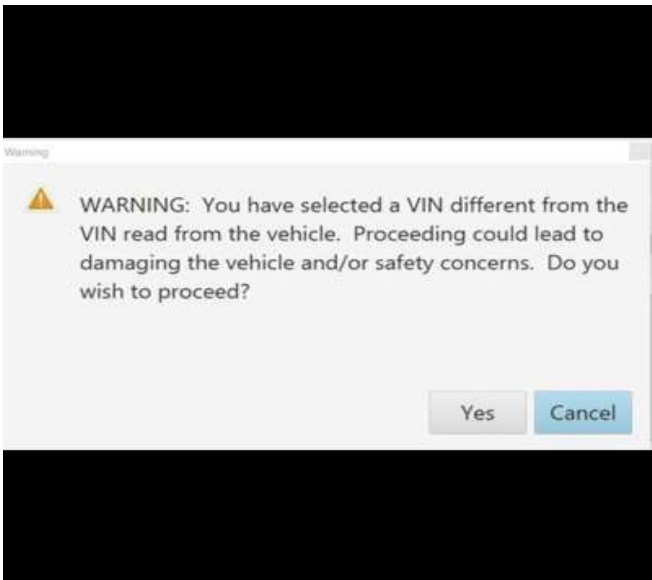
5877000

Important: If the vehicle VIN DOES NOT match, the message below will be shown
