# Service Update

## N222365900 High Voltage Battery Software Update

Release Date: April 2022

Revision: 00

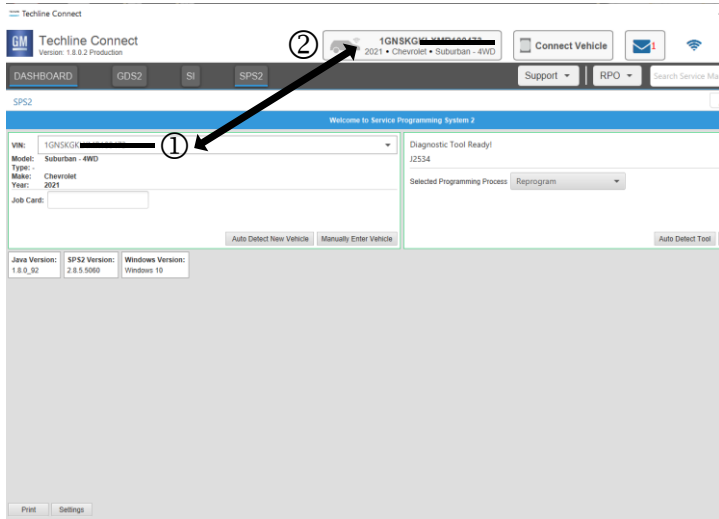
5743643

**Caution:** Be sure the VIN selected in the drop-down menu (1) is the same as the vehicle connected (2) before beginning programming.

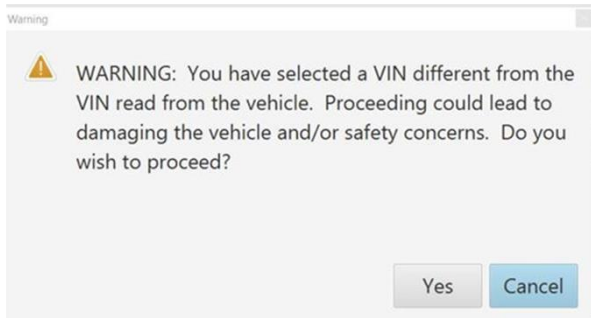
5877000

**Important:** If the vehicle VIN DOES NOT match, the message below will be shown.

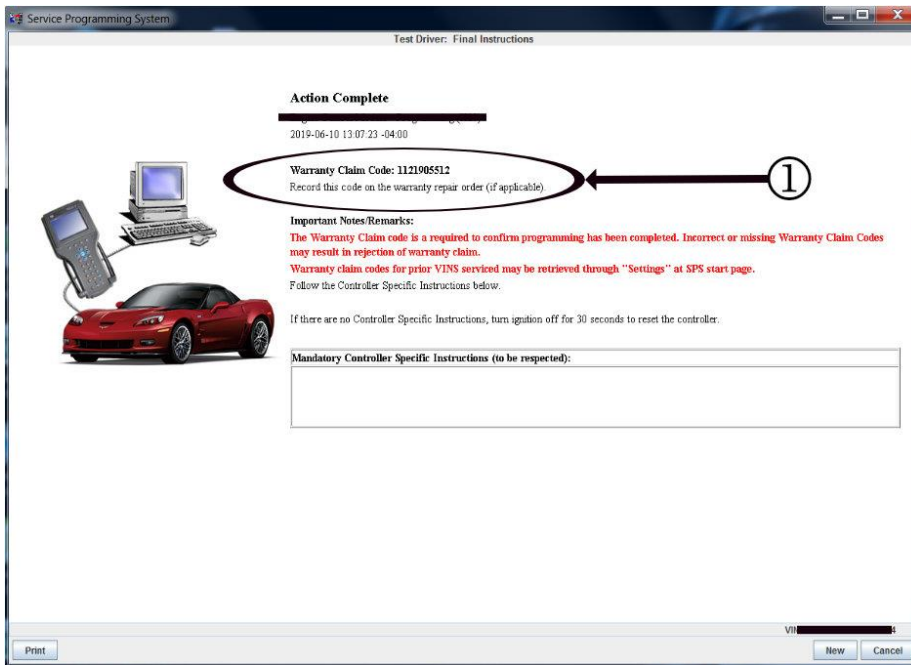
5431209

**Important:** To avoid warranty transaction rejections, you **MUST** record the warranty claim code provided on the Warranty Claim Code (WCC) screen shown above on the job card. Refer to callout 1 above for the location of the WCC on the screen.

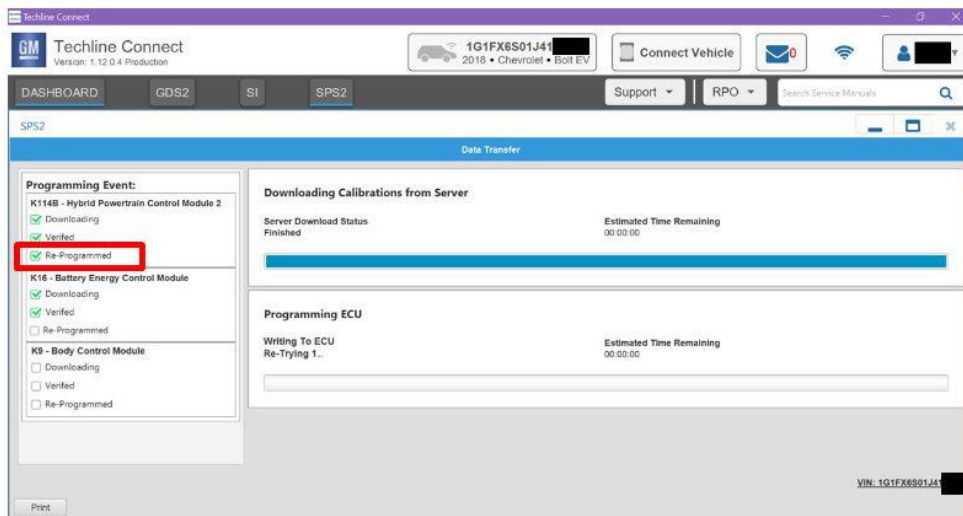
5924567

**Note:** The first module in the sequence is the K114B HPCM2 which is programmed with Ignition OFF and the brake pedal depressed to keep communications awake. The second module in the sequence is the K16 BECM, which is programmed with Ignition ON/Propulsion OFF. The third module is the K9 BCM, which is also programmed with Ignition ON/Propulsion OFF.

1. Reprogram the sequential multiple modules through SPS/Techline Connect (SPS and Techline Connect screens shown) by selecting **“ZFA – Field Action Multimodule Coordinated Sequence”** on the select controller screen and select **“Programming”** for the Select Function/Sequence”. Select **“Next”** and follow all on screen instructions. In SPS, scroll down to view all instructions prior to programming.

2. Remain in the vehicle with the brake pedal depressed during the programming of the K114B HPCM2. When the green check mark indicates the K114B HPCM2 has been re-programmed, as shown in the image, release the brake pedal and transition to Ignition ON/Propulsion OFF.
3. After programming has fully completed, clear DTCs. Let the vehicle sleep for 1 minute after removing the MDI, powering OFF, and closing all doors.
