Service Bulletin

Bulletin No.: 15-06-01-002L

Subject: Engine Misfire/Tick Noise, Malfunction Indicator Lamp (MIL) Illuminated - DTC P0300 Set

Models: 2015-2020 Cadillac Escalade
2016-2019 Cadillac CTS-V
2014 Chevrolet Silverado 1500
2014-2019 Chevrolet Corvette
2015-2018 Chevrolet Silverado
2015-2020 Chevrolet Suburban, Tahoe
2016-2021 Chevrolet Camaro
2019 Chevrolet Silverado LD
2014 GMC Sierra 1500
2015-2018 GMC Sierra
2015-2020 GMC Yukon, Yukon XL
2019 GMC Sierra Limited
Equipped with 5.3L Engine (RPOs L83, L8B) or 6.2L Engine (RPOs L86, LT1, LT4)

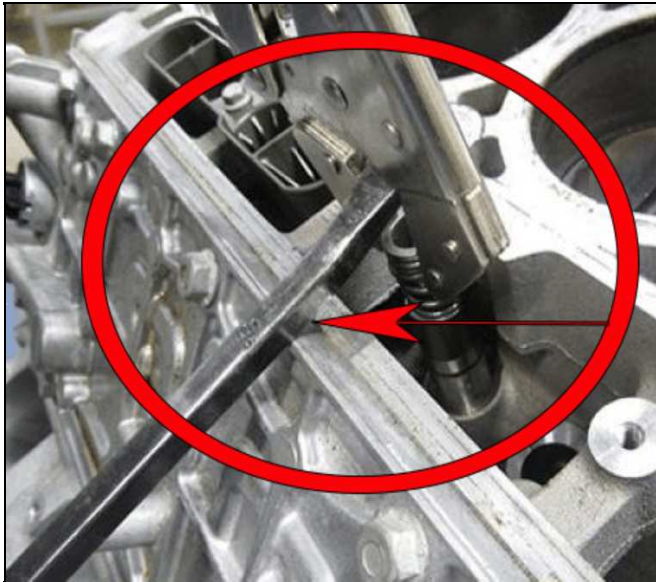
4921302

Note: Be sure **NOT** to pry on the sealing surface of the block, as shown in the illustration above.

2. Use vice grips with a small pry bar.
