# Service Bulletin

Bulletin No.: 21-NA-016

**Subject:** Malfunction Indicator Lamp (MIL) Illuminated – DTC P00C7, P0236 and/or P1101 Set

Brand:	Model:	Model Year:		VIN:		Engine:	Transmission:
		from	to	from	to		
Buick	Encore GX	2020	2020	—	—	1.3L Turbo (L3T)	—
Chevrolet	Trailblazer (VIN M)	2021	2021	—	—	1.3L Turbo (L3T)	—

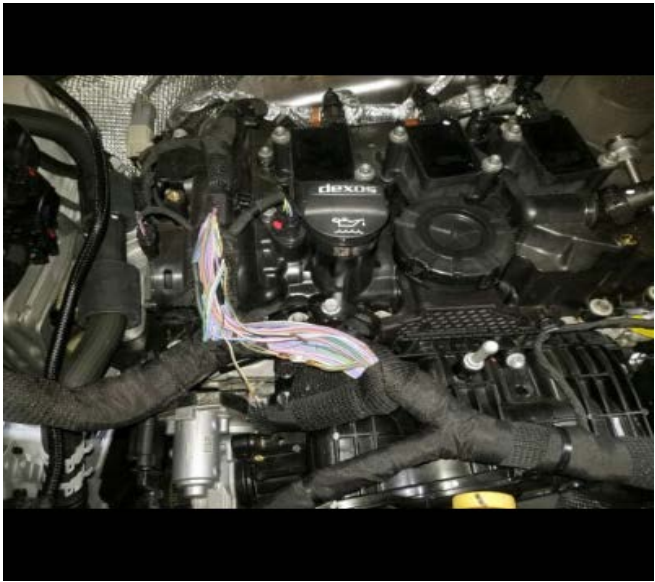
</div> <p style="text-align: right; font-size: small;">5672206</p> <p>This condition may be caused by a poor crimp retention at splice J113 in the engine harness.</p> <p>– Poor crimp retention may allow circuit 548 to skew the turbocharger boost sensor data.</p>
