Service Bulletin

Bulletin No.: 21-NA-038

Subject: Humming Noise Heard Coming from Front End of Vehicle When Driving at Highway Speeds

Brand:	Model:	Model Year:		VIN:		Engine:	Transmission:
		from	to	from	to		
Chevrolet	Blazer	2020	2022	SOP	3GNKBFRS5NS172574	LSY	All

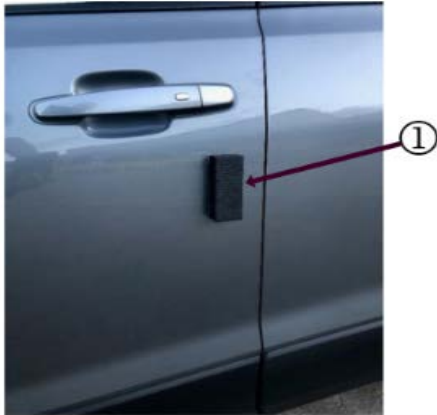
5736488

Note: The foam block used for this repair will be cut from an existing GM left side door foam protector block (1) that arrives on every new vehicle delivery. The foam block is removed from the vehicle during PDI and should be retained for use in this repair procedure. The original foam block is large enough to complete approximately 4 repairs.

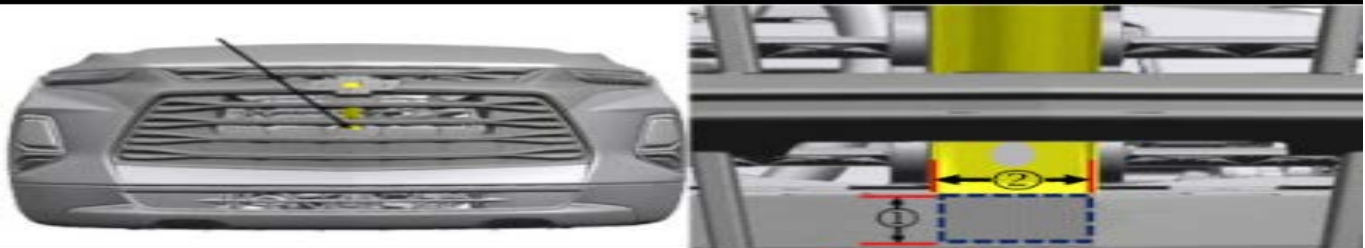
5736490

Note: The location of the foam block is designated by the arrow and the dashed box in the graphic above.

Correction	After verifying the condition, install a foam block between the back vertical wall of grille lower close-out panel and the body center fascia support bracket, following the steps in the service Procedure below.

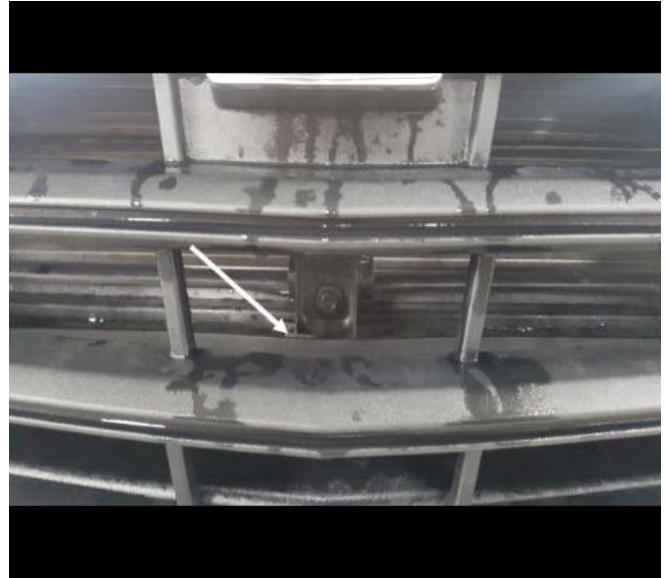
5736497

Note: In the graphic above, the foam block is purposely exposed to show the location where to insert it between panel and body fascia support bracket.

2.3. This foam block will create a pre-load to the grille close-out panel and prevent it from vibrating/fluttering.

2.2. With the other hand (or a tool such as 90-degree needle nose pliers, to help assist) insert the foam block between the close-out panel rear vertical wall and the center fascia support bracket.
