Service Bulletin

Bulletin No.: 22-NA-068

Subject: Diagnostic Tips For Park Assist Off Message / Unwanted Or False Park Assist Alerts / No DTCs

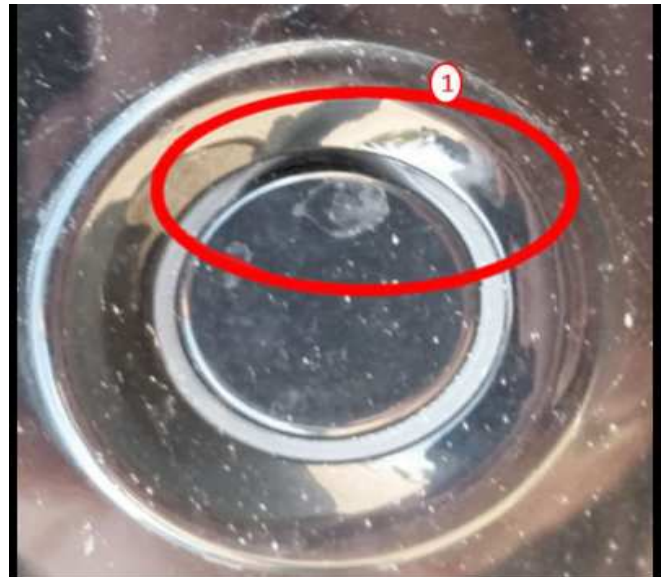
5794928

- Perform a visual inspection of the park assist sensor(s) and bezel(s). Look for any stone chips/dents, paint chips, damage, etc., as well as, any issues with the silicone ring. See example (1) below of a silicone ring which is not properly installed. If any issues are found then repair as necessary.

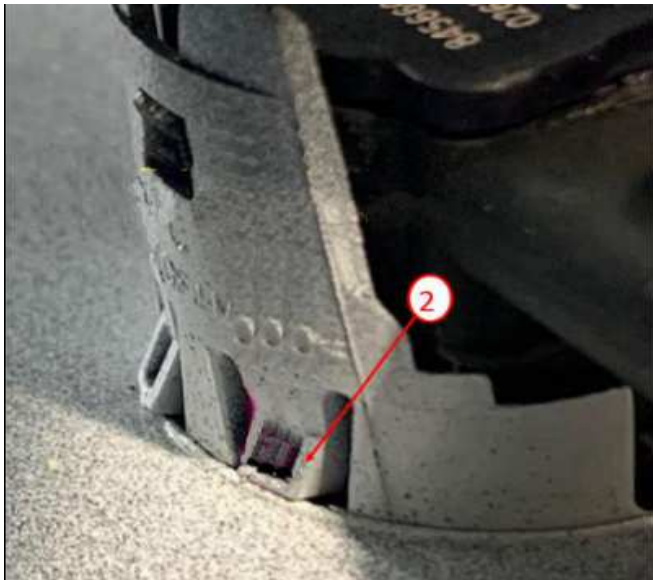
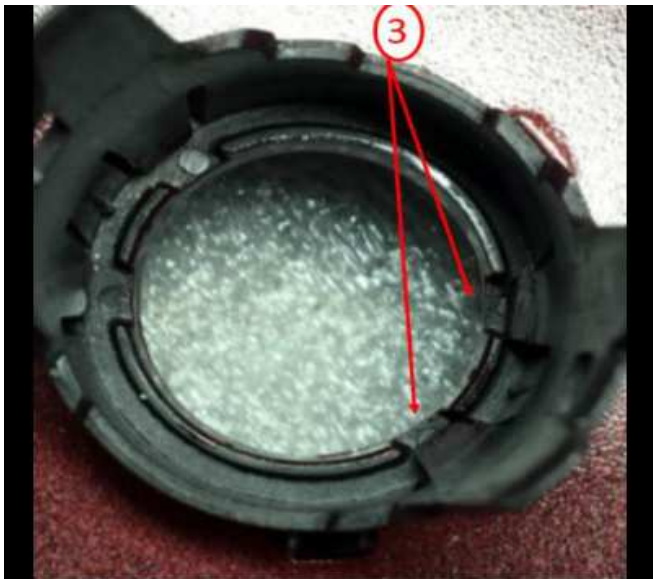
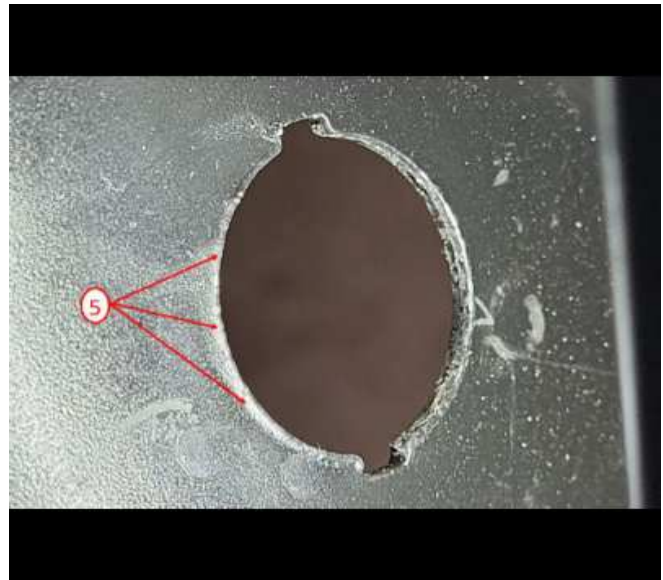
- Inspect the park assist sensor bezel(s) for not being properly mounted in the bumper hole. If the bezel is not properly mounted into the bumper hole it can lead to a sensor grounding out or the sensor getting squeezed. The bezel has four locking tabs that secure the bezel to the bumper. Make sure all four mounting tabs are fully engaged. See example (2) for a mounting tab that is not fully engaged (view from the back side of the bumper/bezel). If any tab is not fully engaged it can protrude into the opening where the park assist sensor mounts and cause it to ground out or get squeezed. See example (3) for a tab not fully engaged and protruding into the opening for the sensor. If any of the bezel mounting tabs are not fully engaging, inspect the following:

If any of these concerns exist, then use a file or grinding wheel to remove any burrs or flashing. If needed, enlarge the bumper hole opening. On any exposed/bare metal apply an Anti-Corrosion Treatment, see Document ID: 2096919. After repairing any bumper hole or bezel issues then reinstall the bezel and make sure the four mounting tabs are fully engaged and then reinstall the park assist sensor. There is no need to replace the bezel or sensor unless they are damaged.

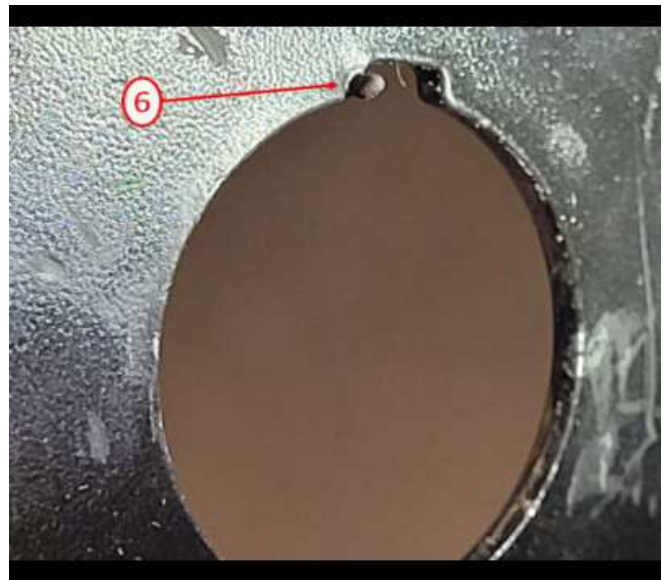
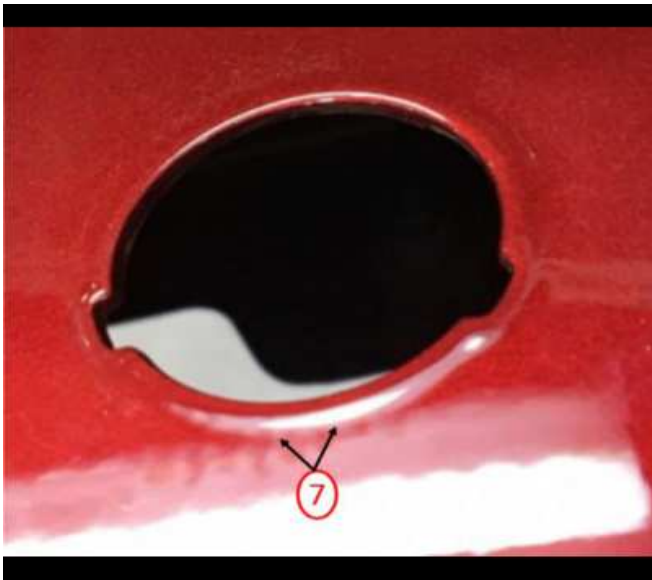
- Burrs on the back side of the bumper hole, see example 5 and 6
 - Excessive paint/clear coat on the bumper around the mounting hole, see example 7.

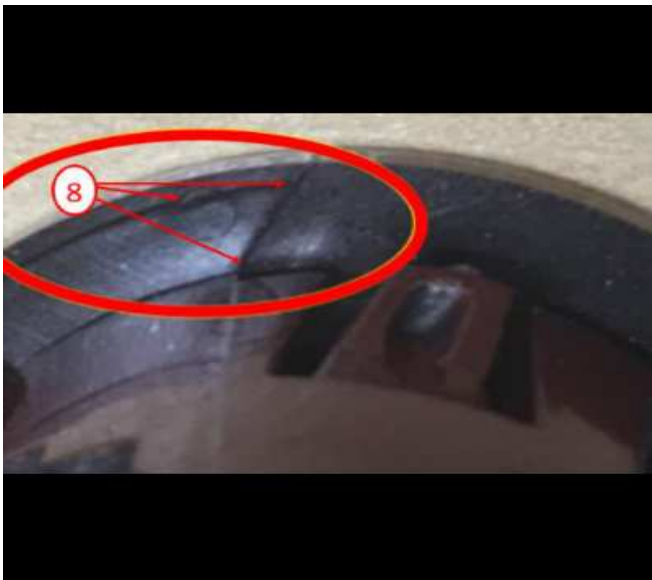
- Plastic flashing on the park assist sensor bezel itself, see examples 8 and 9.
- Inspect the bumper hole for being slightly too small. The bezel should easily slide into the bumper hole without force.

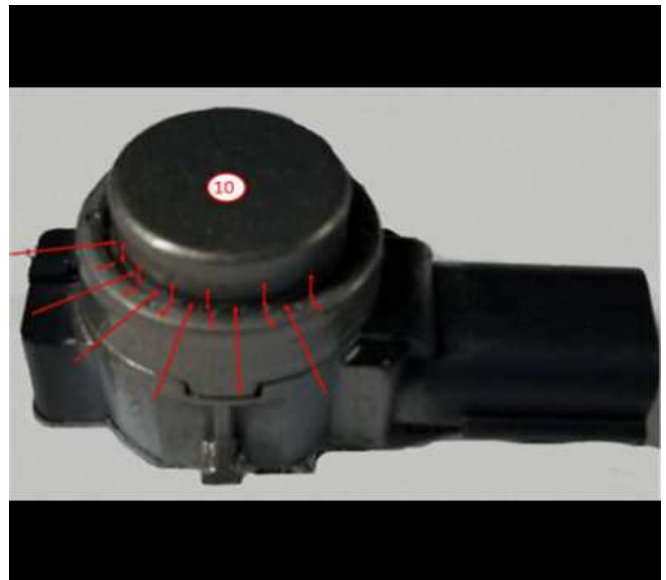
5794942

3. If the park assist sensors have been painted, it is important that only the tip of the sensor is painted and clear coated. The tip of the park assist sensor is isolated from the rest of the sensor body by an internal decoupling ring. If paint or clear coat is allowed to run or drip down the sides of the sensor's tip and/or into the gap between the body and sensor tip, as shown below, this can cause the sensor to ground out.
