| <b>VEHICLE MODEL</b> | : CX35 MY2020, CX45 MY2020 |
| <b>MANUAL SECTION</b> | : 08.02 Climate control – control system |
| <b>BULLETIN TYPE</b> | : <b>Field Change Program</b> |
| <b>SUBJECT</b> | : <b>Optimization of driver’s cab climate control system operation</b> |

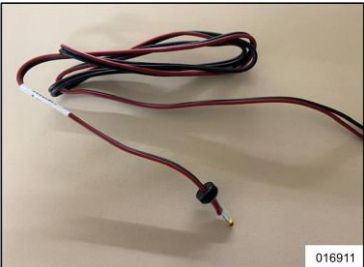
| <div></div> <div>Figure 1</div> | | |
|---|---|---|
| 11259251 | Outlet temperature sensor | 1 |
