2nd Row Seat Load Through Frame Available as Lower Level Assembly

17MY-Onwards Discovery, Discovery Sport, Range Rover, RR Sport, Defender

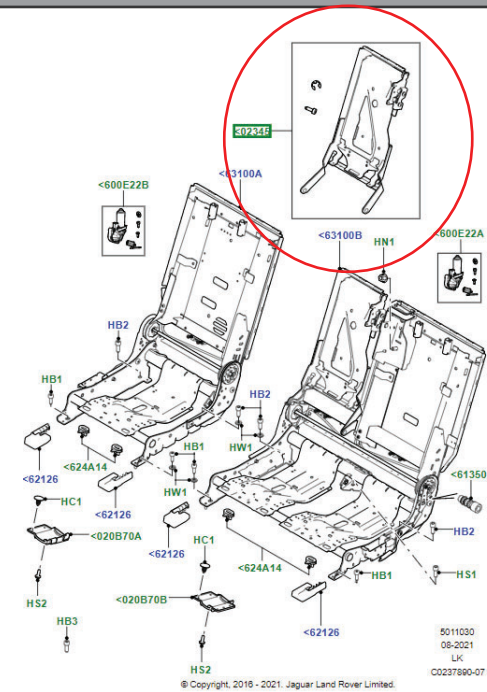
- A customer may report that the load through center seat does not fold properly.

- This may be caused by the latch or latch release cable malfunction.

- Previously the complete 60% 2nd row seat frame on 60/40 seated models had to be replaced to service the latch or latch cable. Now the load through back section is available as a lower level service part.
- Please refer to the Electronic Parts Catalog (EPC) with the VIN for the correct lower level assembly part number should a customer express a concern.
- The replacement procedure has been added to the Workshop Manual, section 501-10: Seating > Removal and Installation > Second Row Center Seat Backrest.
