TECHNICAL TOPICS BODY/CHASSIS

2nd Row Seat Pivot Mechanism Available as Lower Level Assembly

17MY-Onwards Discovery, Discovery Sport, Defender

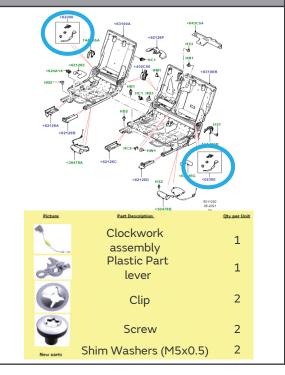
A customer may report that the 2nd row seat makes a ratcheting noise or is difficult to manually folding/unfolding the seat.

This may be caused by a seat pivot 'Clockwork' mechanism assembly.

- The 2nd row seat 'Clockwork' assemblies have now been released as a lower. level service part.
- Please refer to the Electronic Parts Catalog (EPC) with the VIN for the correct lower level assembly part number should diagnosis of a customer concern identify a seat pivot 'Clockwork' mechanism failure.
- The replacement procedure has been added to the Workshop Manual, section 501-10: Seating > General Procedures > Second Row Seat Recline Mechanism.
