Subject: BOOM PIVOT PIN INSPECTION (NOT FOR CIRCULATION)

Models: Camel Max

Date: 03/15/2022

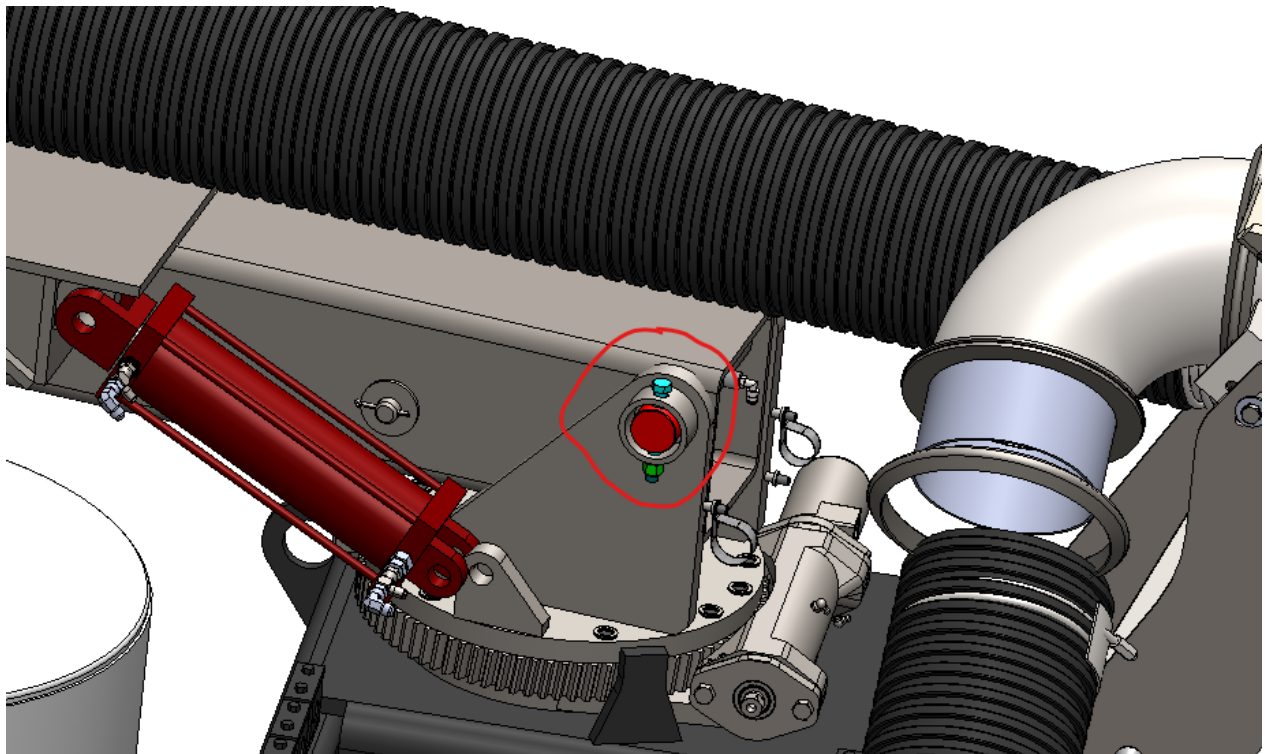
FIGURE 1

The boom pivot pin is secured by a bolt and a clinched nut installed through the pivot pin on the driver's side of the truck, as shown below. The above listed units may have a clinched nut that does not meet Super Products standard.

Using a torque wrench set to 65 foot-pounds, attempt to loosen the clinch nut. If the clinch nut turns, remove the clinch nut, discard, and install a new clinch nut (provided with this bulletin). Tighten clinch nut and torque to 70 foot-pounds. If the existing nut did not loosen, ensure it is tightened to 70 foot-pounds.
