Technical product information

Topic	Bentayga - PDC system not working or PDC system false detection
Market area	Russische Föderation (5RU),Australia E04 Bentley rest Asia and Australia (6E04),China 796 VW Import Comp. Ltd (Vico), Beijing (6796),Germany E02 Bentley rest Europe (6E02),Japan E03 Bentley Japan (6E03),Korea, (South) E08 Bentley South Korea (6E08),United Arab Emirates E06 Bentley Middle East and Africa (6E06),United Kingdom E01 Bentley UK (6E01),United States E05 Bentley USA and rest America (6E05)
Brand	Bentley
Transaction No.	2059392/2
Level	EH
Status	Approval
Release date

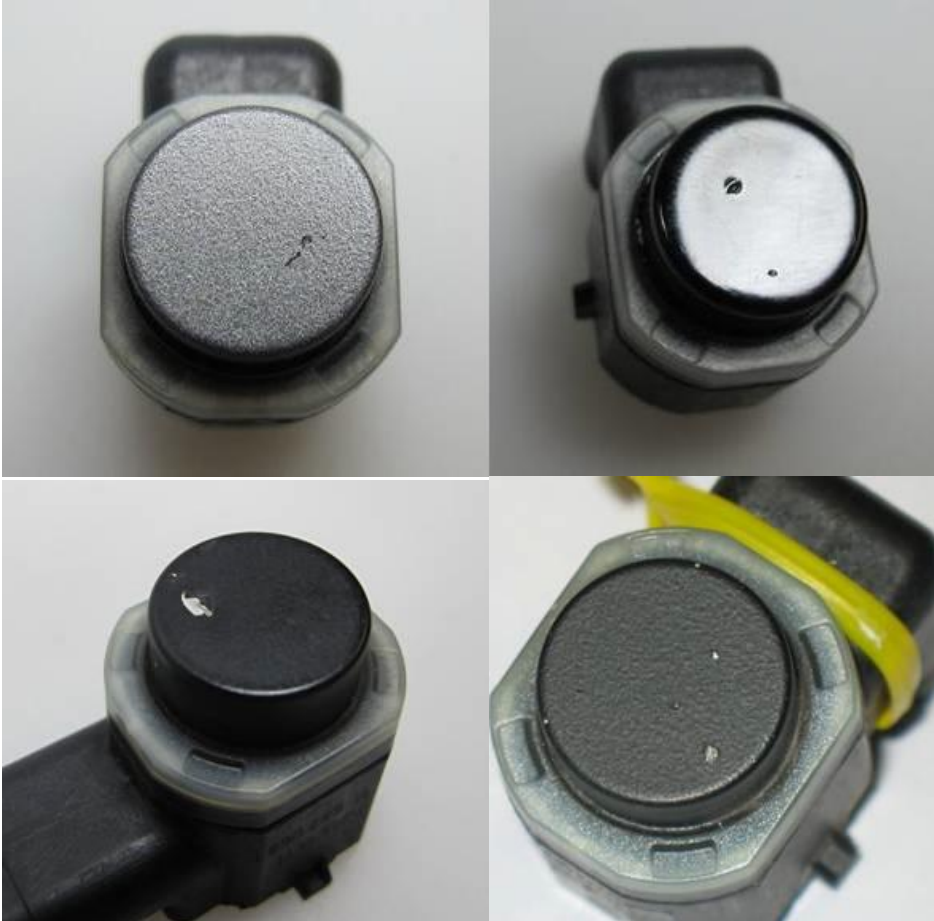
IMPORTANT: With the following examples stone chips led to the failure of the sensor:

Stone chips and scratches are not complaints in the sense of warranty. Therefore dirty sensors should be cleaned and not replaced

Any sensors which are replaced for stone chips, scratches or any other type of damage will not be approved for warranty payment

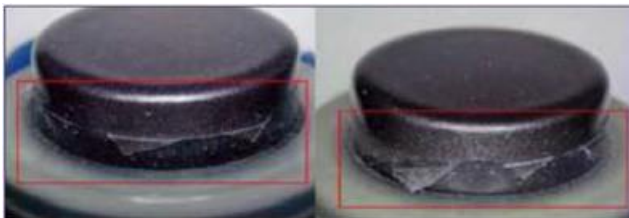
9. when painting sensors ensure to paint within area specifications, removable layers of paint on the membrane can lead to false signals
