# Technical product information

<b>Topic</b>	Bentayga Hybrid - Emission control system warning lamp illuminated within the DIP - Potential wiring clash condition
<b>Market area</b>	Bentley: worldwide (2WBE)
<b>Brand</b>	Bentley
<b>Transaction No.</b>	2065715/1
<b>Level</b>	EH
<b>Status</b>	Approval
<b>Release date</b>

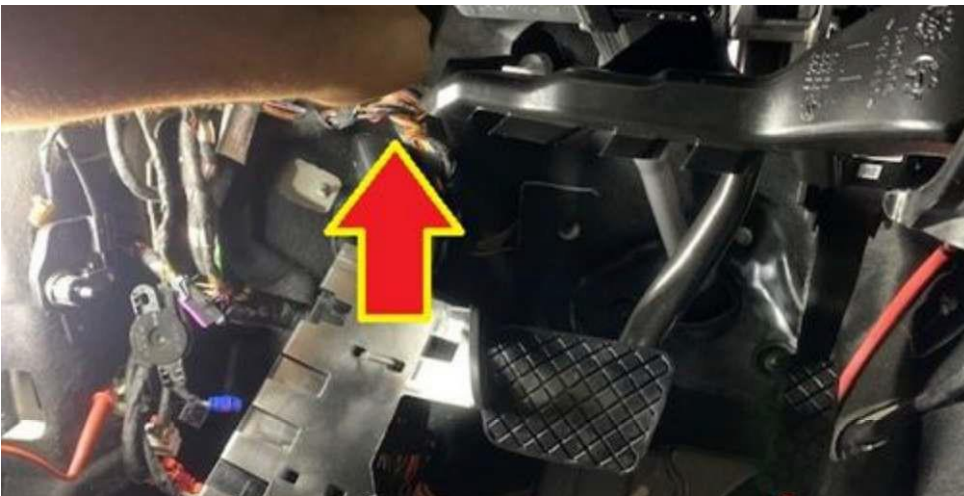
- Referring to the applicable Rep.Gr the operative should gain access to the location shown in Figure 2 (Underside of the dashboard left hand side)

- Check for damaged wiring/contact between the body/surrounding components and the wiring harness

NOTE: Please be aware the wiring harness can contact the body/surrounding components however the actual symptom(s) may be different depending on the wire(s) which are damaged/chaffed

1) Using the applicable wiring diagram, conduct wiring integrity checks to confirm the wire(s) which are damaged/chaffed

2) Referring to Rep.Gr 97 - Repair the damaged wire(s)

- 3) Remove all sharp edges which could damage the main wiring harness
- 4) Reposition and secure the main wiring harness
