# Technical Service Bulletin

SUBJECT:		No:	<b>TSB-21-42A-011REV</b>
<b>MODIFIED HOOD FOR HOOD FLUTTER - 2022 OUTLANDER - REVISED</b>		DATE:	<b>December 2021</b>
		MODEL:	<b>2022 Outlander</b>
<b>CIRCULATE TO:</b>	<input type="checkbox"/> GENERAL MANAGER	<input checked="" type="checkbox"/> PARTS MANAGER	<input checked="" type="checkbox"/> TECHNICIAN
<input checked="" type="checkbox"/> SERVICE ADVISOR	<input checked="" type="checkbox"/> SERVICE MANAGER	<input checked="" type="checkbox"/> WARRANTY PROCESSOR	<input checked="" type="checkbox"/> SALES MANAGER

*This bulletin supersedes TSB-21-42A-011, issued December 2021 and explains how to verify reinforced versus non reinforced hoods and also advises of VIN clean point NZ051835 for production line installation of the reinforced hood. Revisions are italicized and indicated by ◀.*

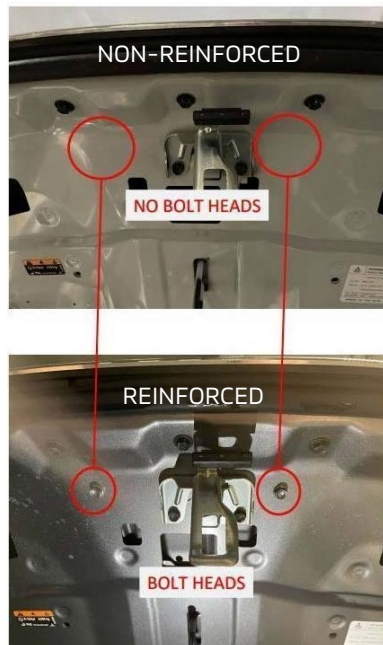
*Method to determine if hood is reinforced (bolt heads) or non-reinforced (no bolt heads):* ▶

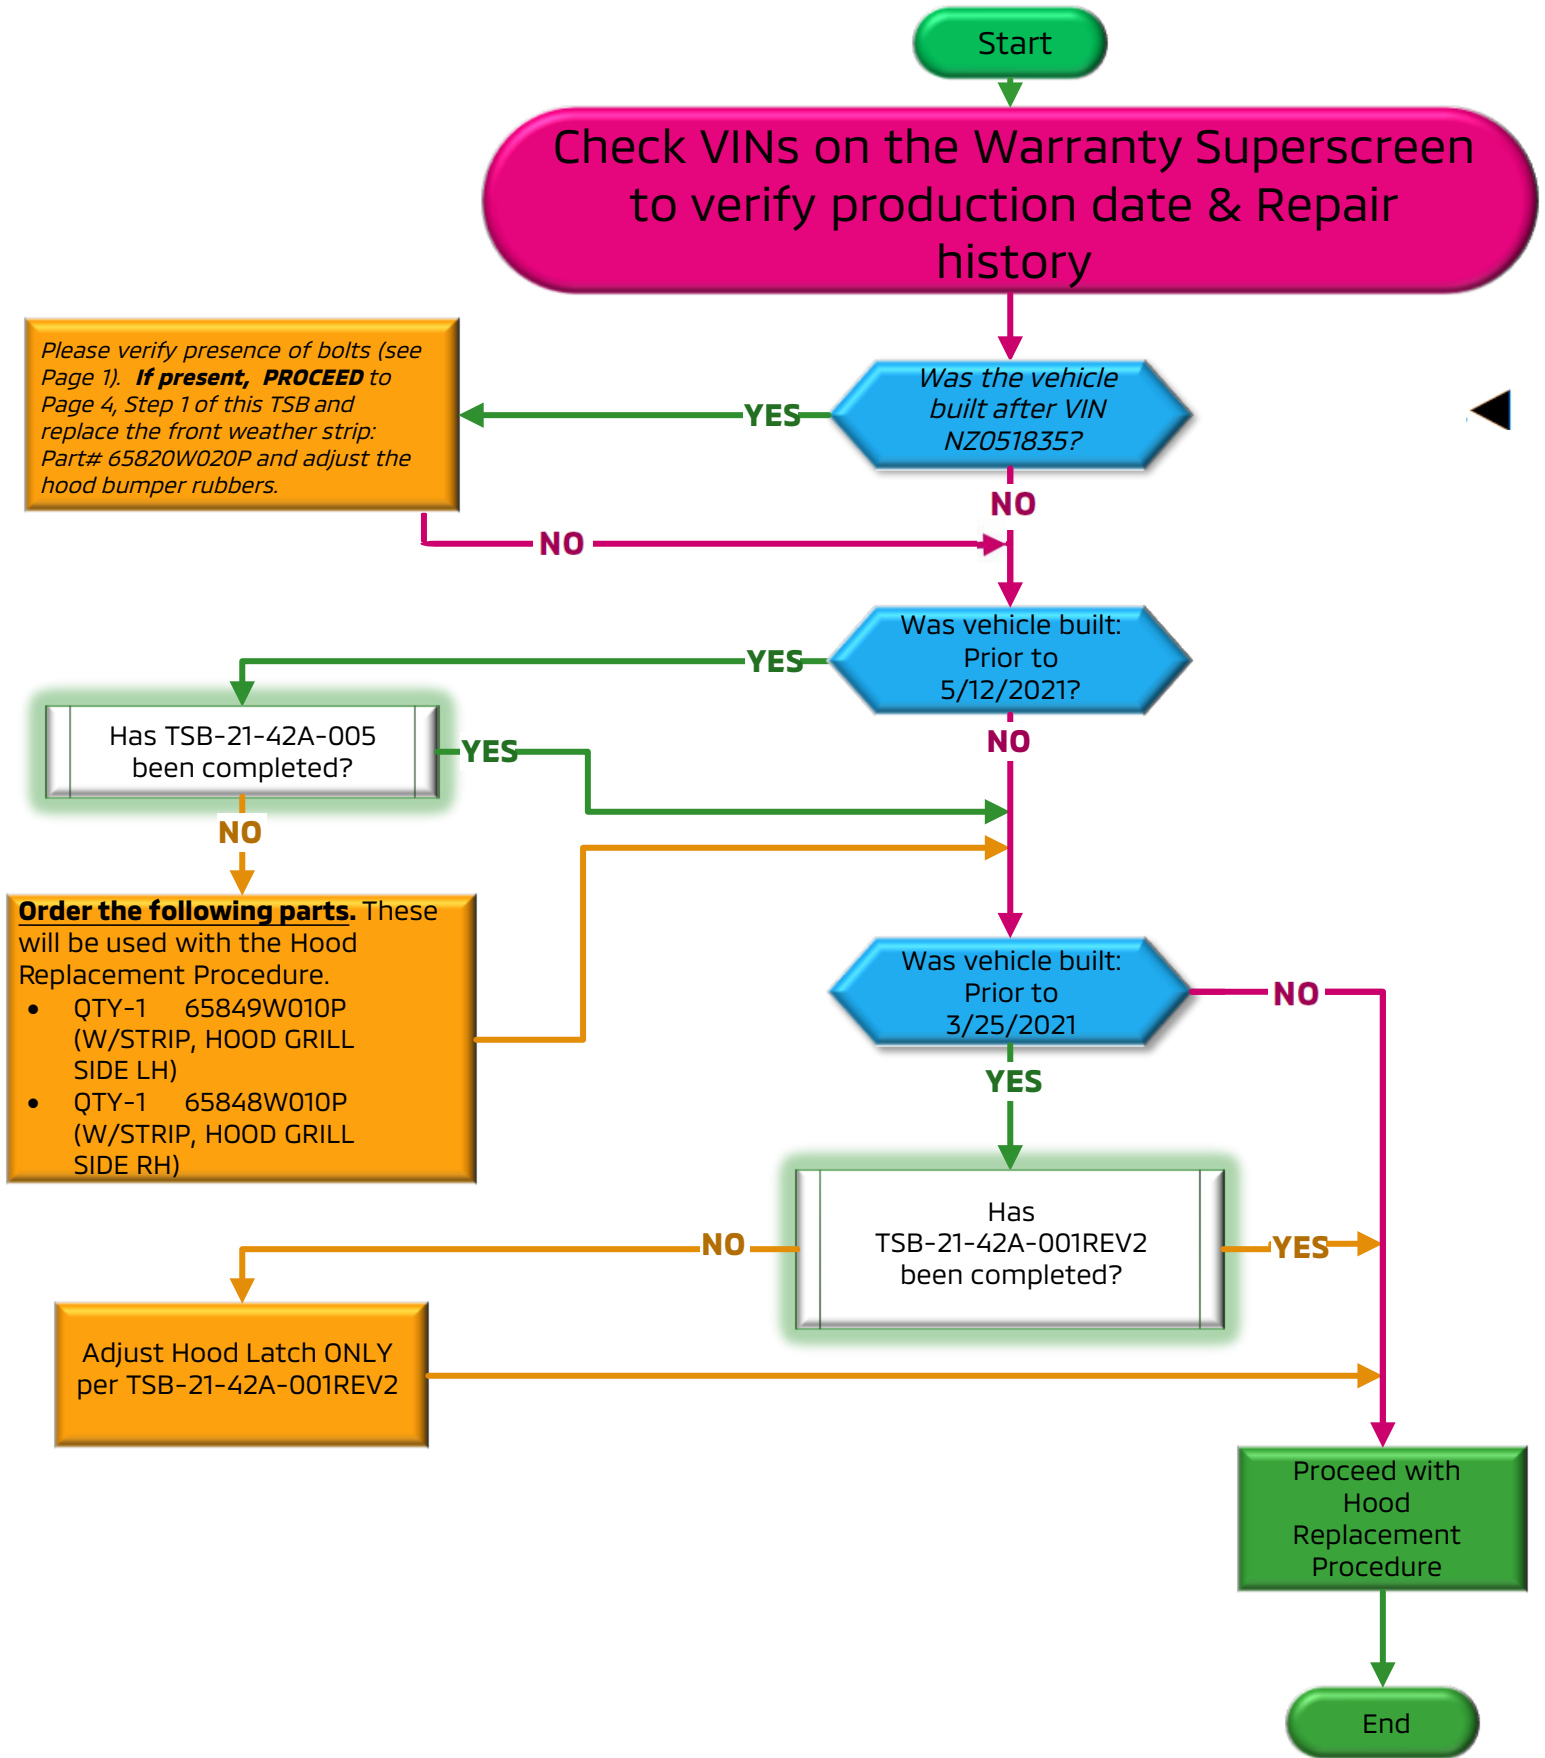
Please refer to the flow chart (page 2 of this bulletin) prior to proceeding with the procedure to determine/confirm the next appropriate steps.
