# Technical product information

<b>Topic</b>	P245000 - EVAP System Switching Valve "A" Performance/Stuck Open DTC logged - Bentayga V8 Kovomo
<b>Market area</b>	China 796 VW Import Comp. Ltd (Vico), Beijing (6796),United States E05 Bentley USA and rest America (6E05)
<b>Brand</b>	Bentley
<b>Transaction No.</b>	2063657/2
<b>Level</b>	EH
<b>Status</b>	Approval
<b>Release date</b>

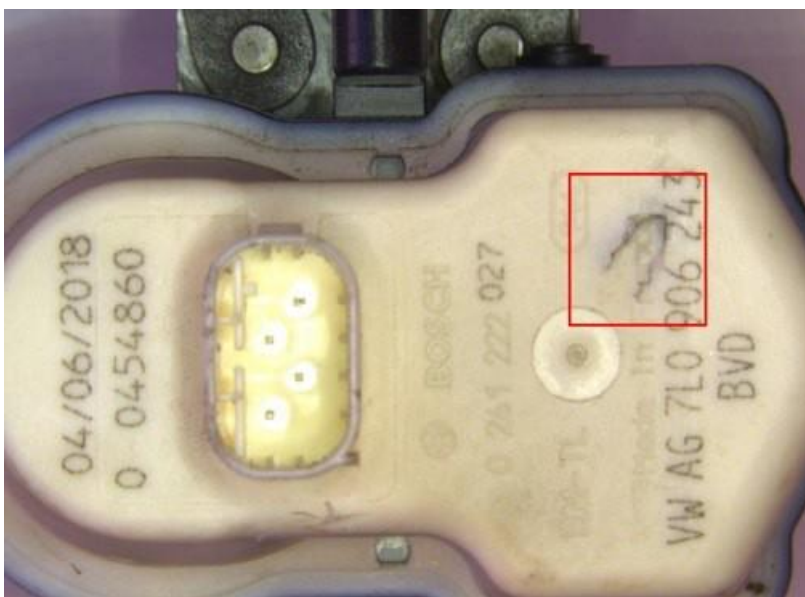
Figure 2

Additional request has been included within the Measure section (step 4) to inspect the leak detection pump (LDP) for impact damage (if removed)

- 1) Referring to the applicable wiring diagram conduct a wiring integrity check of the Leak Detection Pump wiring circuit and connectors
- 2) Perform a smoke test of the leak detection system - Monitor for any leaks
- 3) If no faults were found - Refer to Rep.Gr 20 - Replace the leak detection pump (V144)
- 4) Inspect the LDP for impact damage when extracted, the operative must provide feedback and photographic evidence (see example shown in Figure 2) via a new or existing DISS query
