## Technical product information

| <b>Topic</b> | Seat belt presenter – Intermittent operation |
| <b>Transaction No.</b> | 2034323/6 |

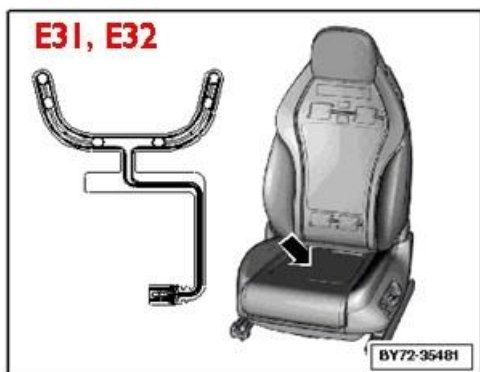
Figure 1

3. First check the occupancy sensor, E31, is function correctly (see Figure 1)

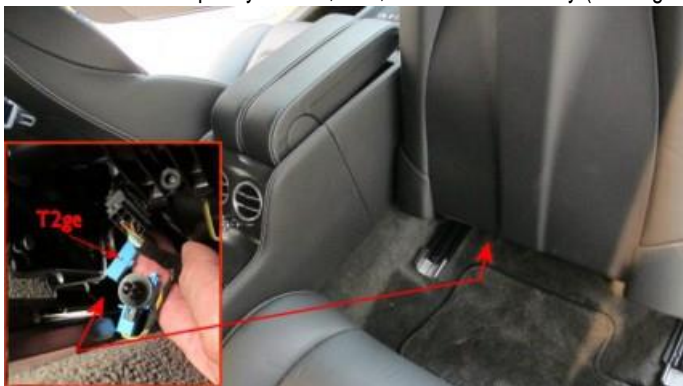
Figure 2

- Disconnect connector T2ge at the occupancy sensor (E31 Drivers, E32 Passengers). The 2 way connection can be identified by its blue connector housing located under the seat frame adjacent to the inboard seat runner (see Figure 2)

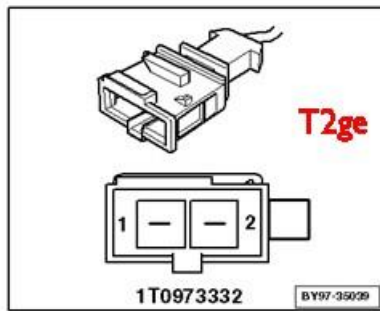
Figure 3

- With T2ge connector disconnected and an occupant sat in a natural position on the seat, with their back against the backrest, measure the resistance through the occupancy sensor (see Figure 3)

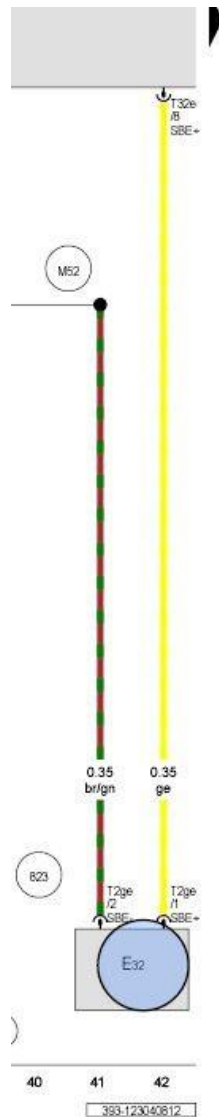
Figure 4

- If the resistance of the sensor with the seat occupied is greater than 90 Ohms then the sensor is faulty and should be replaced
- Once the occupancy sensor is known to function to specification (operation 2) then remove and discard the original seat adjustment control unit with memory (J136 Drivers, J521 passengers) and replace with the latest level part (part number 4W0.959.760)
  - The J136, J521 seat control unit is located under the seat frame reference workshop manual Rep. Gr. 72 Front seat control unit (J136, J521) – To remove and fit
