Technical product information

Topic	Warning light illuminated within the DIP - DTC C103711 - Evident within Address 74
Market area	Russische Föderation (5RU),Australia E04 Bentley rest Asia and Australia (6E04),China 796 VW Import Comp. Ltd (Vico), Beijing (6796),Germany E02 Bentley rest Europe (6E02),Japan E03 Bentley Japan (6E03),Korea, (South) E08 Bentley South Korea (6E08),United Arab Emirates E06 Bentley Middle East and Africa (6E06),United Kingdom E01 Bentley UK (6E01),United States E05 Bentley USA and rest America (6E05)
Brand	Bentley
Transaction No.	2064338/2
Level	EH
Status	Approval
Release date

New Continental GT /GTC and New Flying Spur

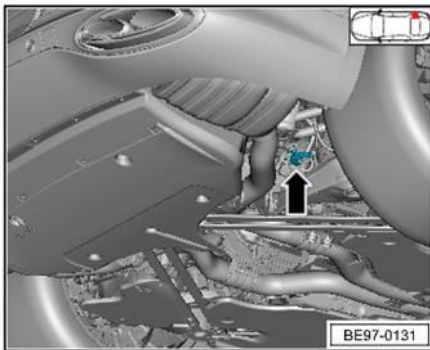
- Rear Right Height sensor (G77) connection – Visual and pull check
- Referring to Figure 1 - Perform a wiring integrity check between sensor (G77) and J775

3) If no fault is found during the wiring checks - Replace the level sensor (G77) - Rep.Gr 43

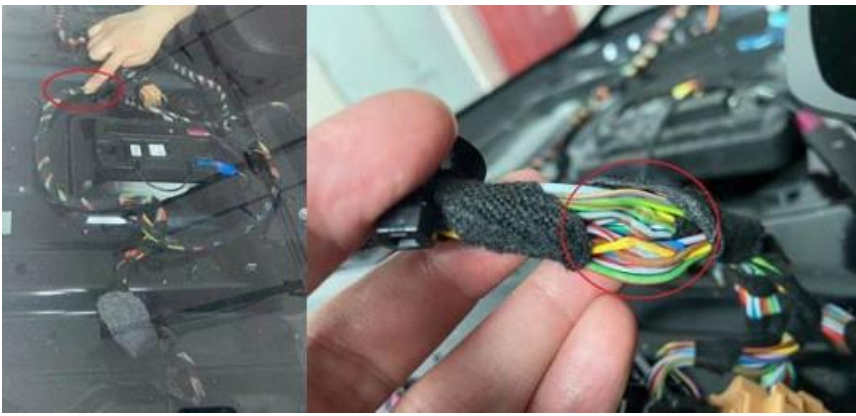
- Broken wires
- Kinked wiring
- Loose Rear Right Height sensor G77 connection
- Defective Rear Right Height sensor G77

- Figure 2 shows examples of damaged wiring under parcel shelf

2) In the event that wiring is found to be damaged, the wiring should be repaired as per the applicable Rep.Gr

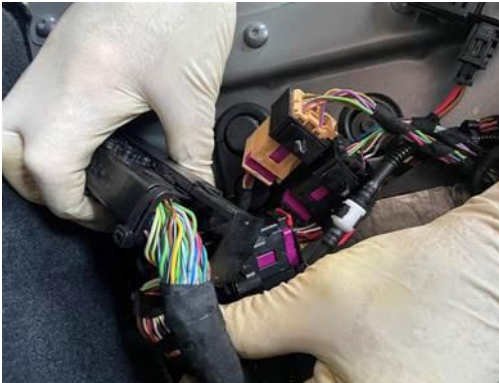
Figure 3

TIP: Inspect the wiring around the Chassis control unit bracket for any issues/damage (Figure 3)
