Technical product information

V8 Kovomo - New Continental GT/GTC - New Flying Spur

V8 Kovomo - Emission control warning illuminated within the DIP - Exhaust Gas Temperature Sensor DTC's evident

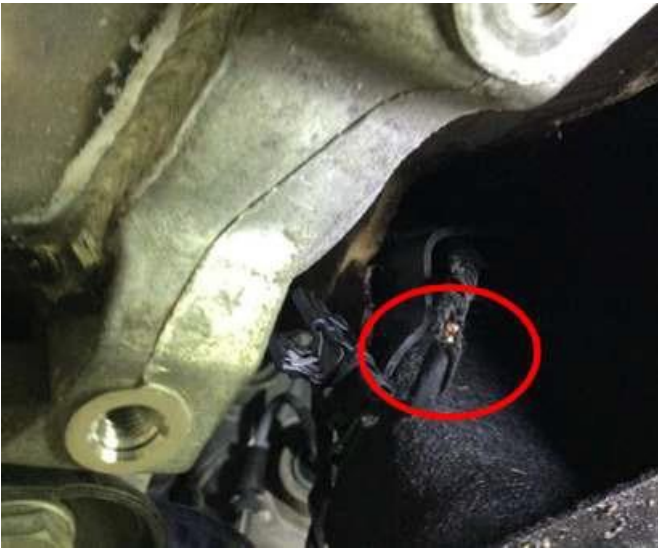
After further investigation the wiring harness leading to the Exhaust gas temperature sensor (Bank 1 and/or Bank 2) runs close to the sub-frame may rub/contact the edge of the bracket inside of the wheel arch cover/liner

See the examples shown in Figure 1 (Chaffed/damaged wiring Bank 1) And

- 1) Check Bank 1 and Bank 2 Exhaust Gas Temperature sensor wiring harnesses for damage/chaffing
- 2) Referring to Rep.Gr 97 - Repair the applicable damaged wire(s)
- 3) Once repaired - Reposition and secure the Exhaust Gas Temperature sensor wiring harness, ensuring the harness cannot contact any surrounding components which could result in chaffing/damage

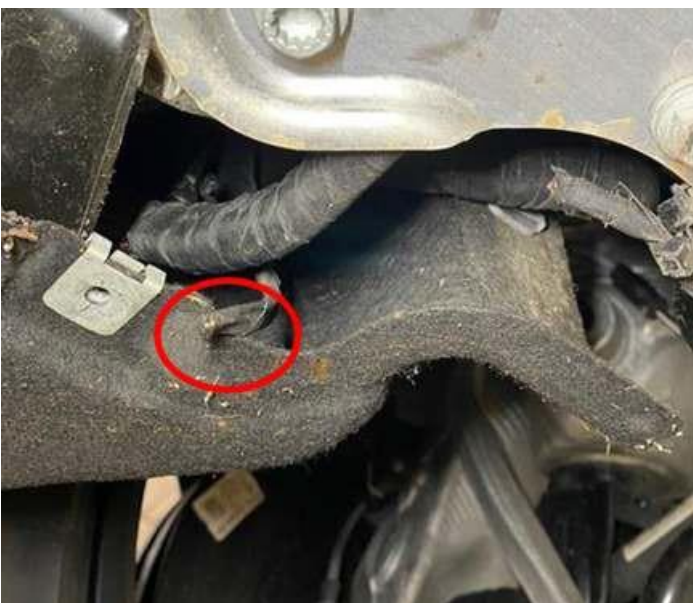
Figure 2 (Broken/damaged wiring Bank 2)
