<b>HYUNDAI</b> <b>Technical Service Bulletin</b>	GROUP <b>BODY</b>	NUMBER <b>22-BD-002H</b>
	DATE <b>MARCH, 2022</b>	MODEL(S) <b>TUCSON (NX4a)</b>
<b>SUBJECT:</b> REAR CENTER COMBINATION LAMP MOISTURE INSPECTION AND REPLACEMENT

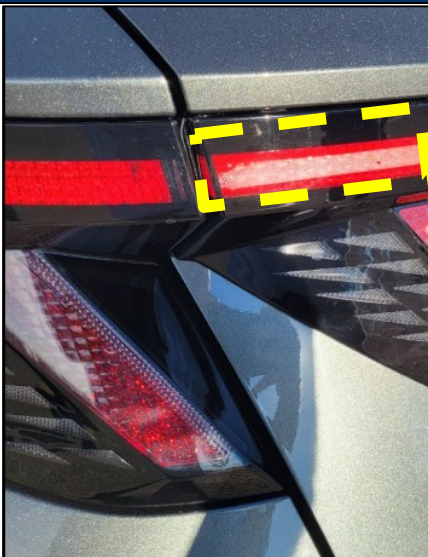
Light fogging or a faint hazy appearance. No water droplets and/or water streaks.	Visible water droplets and/or water streaks. Water may be accumulating at the bottom of the lamp assembly.
