<b>HYUNDAI</b> <b>Technical Service Bulletin</b>	<b>GROUP</b> <b>AUTOMATIC TRANSMISSION</b>	<b>NUMBER</b> <b>22-AT-002H</b>
	<b>DATE</b> <b>MARCH, 2022</b>	<b>MODEL</b> <b>SONATA (DN8A)</b> <b>SANTA FE (TMA)</b> <b>TUCSON (NX4A)</b>
<b>SUBJECT:           AUTOMATIC TRANSAXLE ATF LEAK AT REAR COVER</b>

***This TSB supersedes TSB 21-AT-017H to require a photo of the ATF leak.***

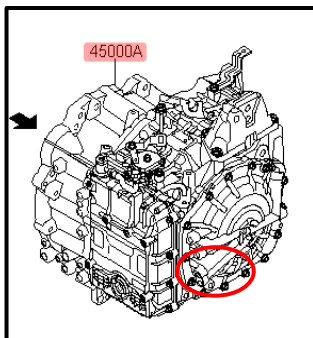
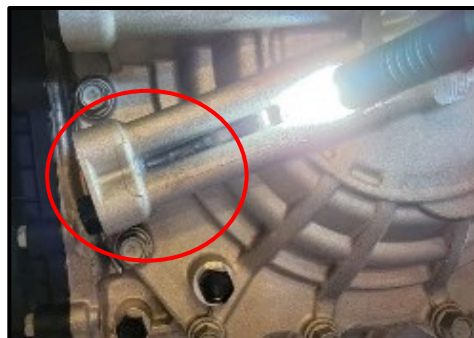
**DESCRIPTION:** Certain vehicles equipped with 8-speed automatic transmission may experience an automatic transmission fluid (ATF) leak at the rear cover. This type of leak is caused by a porous casting on the rear cover of the transmission.

If you are servicing an affected vehicle listed below with an ATF leak as described, follow the Service Procedure below.

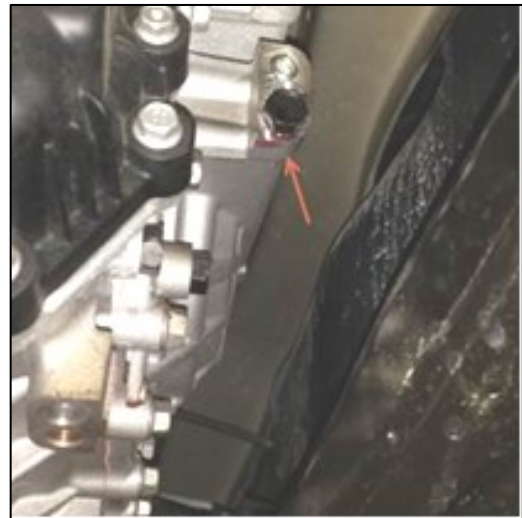
1. If the transmission is leaking from the rear cover near the black pressure port check plug, go to Step 2 and take a photo of the leak and send to the Techline Repository.

DO NOT replace the rear cover of the automatic transaxle. The rear cover controls the end-play on the disk set and clutch pack. If the selectable spacers are not changed to correct the end play for the new rear cover, the durability of the transmission could be affected.
