<b>HYUNDAI</b> <b>Technical Service Bulletin</b>	<b>GROUP</b> <b>AUTOMATIC TRANSMISSION</b>	<b>NUMBER</b> <b>22-AT-003H</b>
	<b>DATE</b> <b>MARCH, 2021</b>	<b>MODEL</b> <b>SONATA HYBRID (DN8 HEV)</b> <b>SANTA FE HYBRID (TM HEV/PHEV)</b> <b>TUCSON HYBRID (NX4 HEV/PHEV)</b>
<b>SUBJECT:</b> AUTOMATIC TRANSAXLE OIL TEMPERATURE SENSOR DTC P071100, P071200 & P071300

**DESCRIPTION:** If you are servicing an applicable vehicle with a “Check Engine” light on and one or more of the DTC listed below, follow the Service Procedure and replace the harness with an integrated oil temperature sensor.

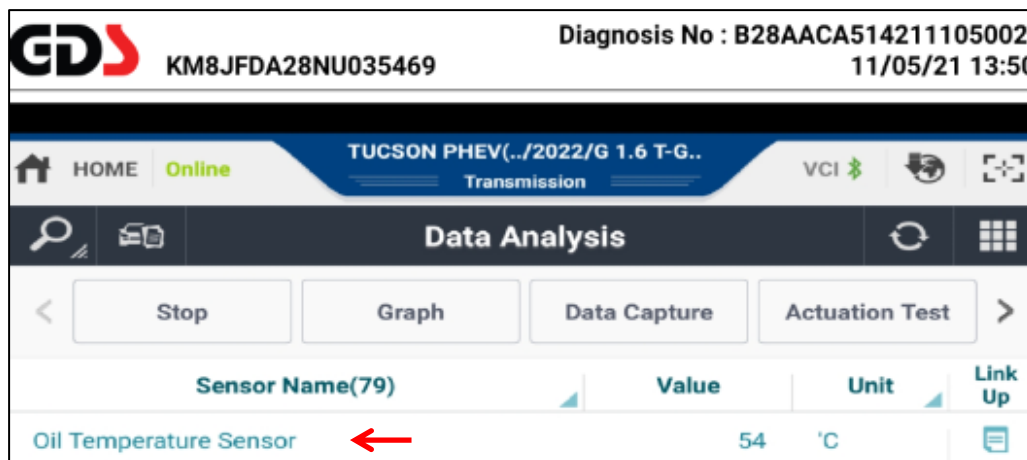
1. Attach a GDS and select **DTC Analysis** and **A/T** menu. Record the DTC and description. Delete the DTC.
2. From the GDS home screen, select **Data Analysis** and **A/T** menu and the parameters shown below. If the parameters show:
  - Continuous and changing output while driving, the wiring **currently** has no open/short circuits. Go to Step 4.
  - No continuous and changing output, go to Step 3.
