| <b>HYUNDAI</b><br><b>Technical Service Bulletin</b> | GROUP<br><b>BODY ELECTRICAL</b> | NUMBER<br><b>22-BE-001H</b> |
| | DATE<br><b>MARCH, 2022</b> | MODEL(S)<br><b>PALISADE (LX2)</b> |
| <b>SUBJECT: INOPERATIVE THIRD ROW SEAT TROUBLESHOOTING GUIDE</b> | | |

**Description:** Some 2020-2022 Palisade (LX2) third row seats may be inoperative or may not fully reach the open or folded position. This bulletin provides information for troubleshooting the third row seat.

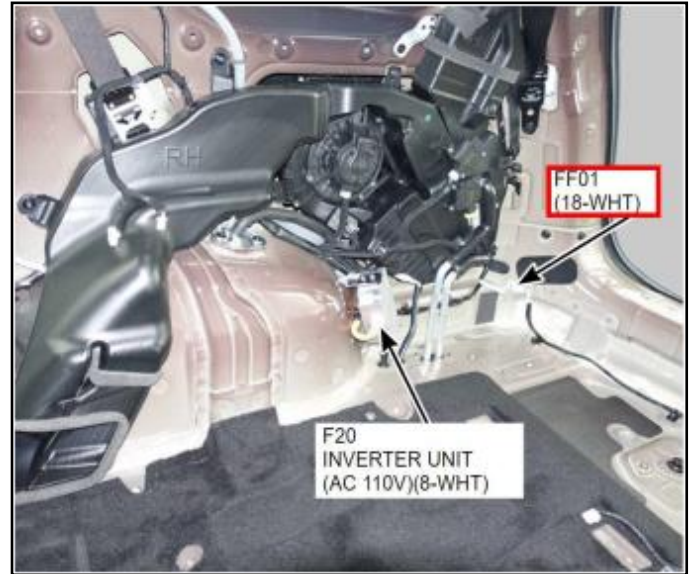
1. Check the rear floor harness connector FF01.

See picture to the right for illustration of the FF01 connector location.

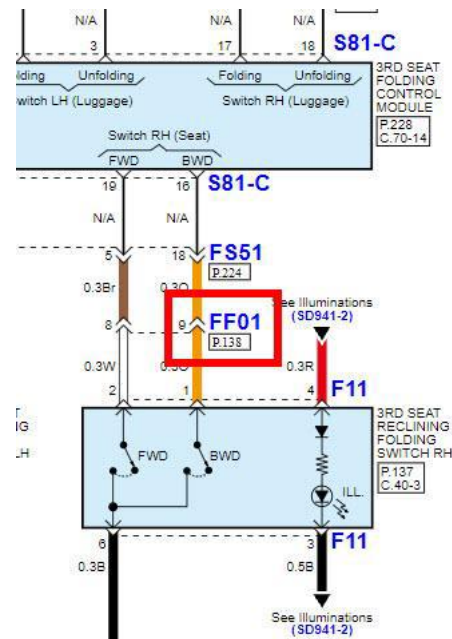
2. Electronic Diagram for reference of the FF01 connector.

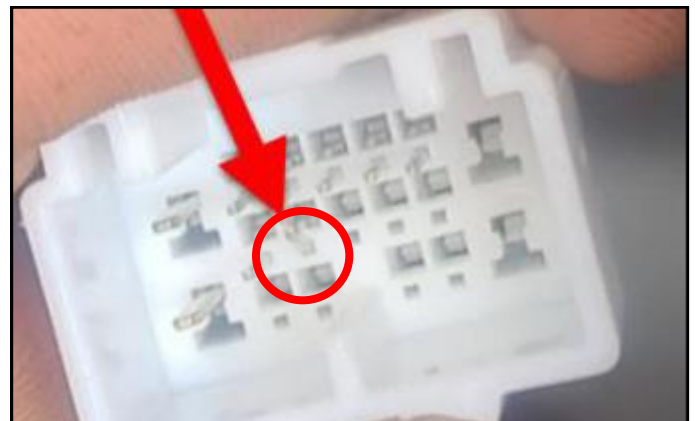
3. The picture to the right illustrates an example of the bent pin condition.

Use a small needle nose plier to straighten the pin.

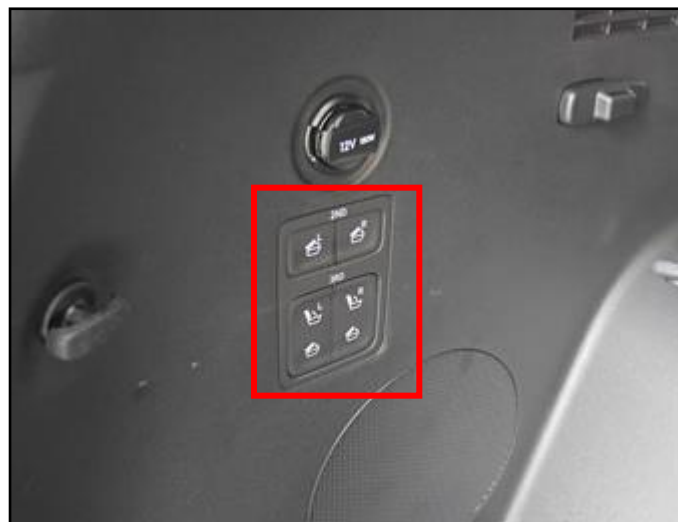
1. Remove the rear seat controller switches located in the rear driver side near the tailgate.

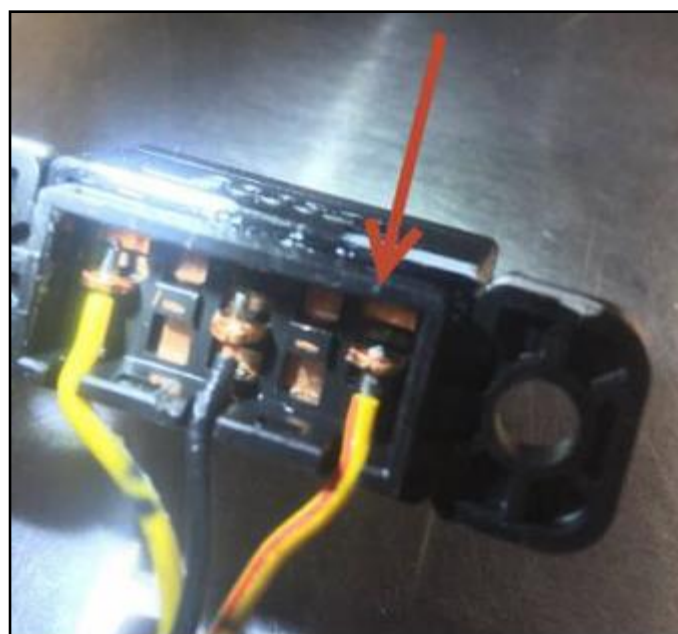
2. Scenario A: Inspect the wire soldering quality.  
The example to the right is of insufficient soldering of the wire to the switch pin.

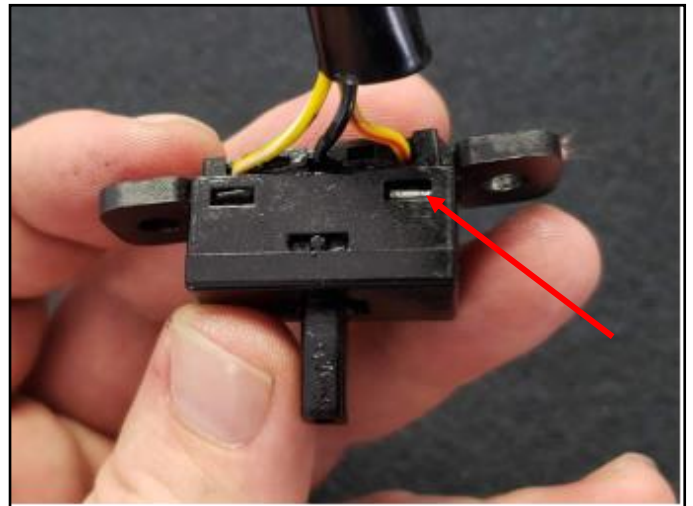
4. Scenario B: Inspect the switch to confirm a rigid assembly.

In the example to the right, the switch locking tab is broken resulting in a switch with poor internal contact.
